## Armrest In Center Console (Front) Only Opens On One Side Or Not At All - Model Series 167

Topic number	LI68.20-P-070037
Version	5
Function group	68.20 Center console
Date	10-29-2020
Validity	BR167
Reason for change	Accounting number changed
Reason for block

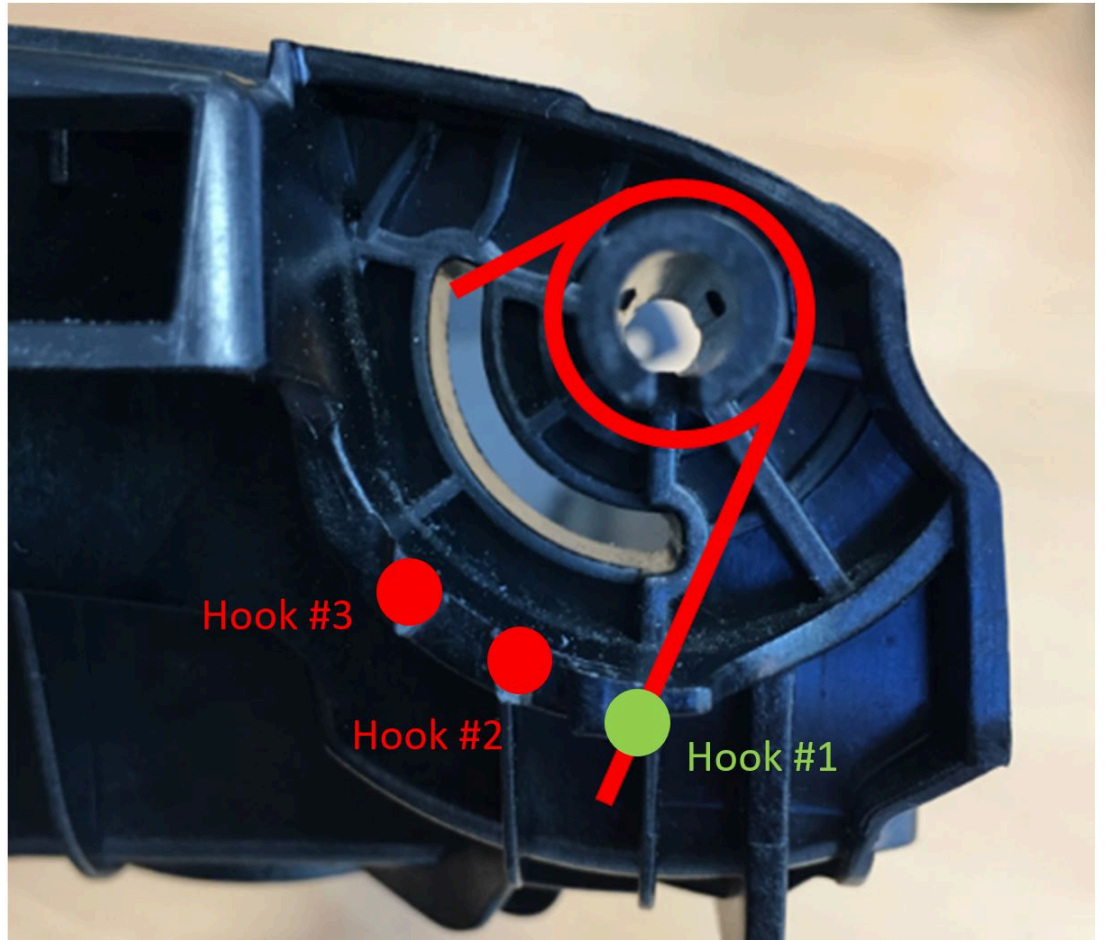
Hook.JPG:

Cause 2: The pop-up spring could not be correctly hooked into the catch hook. Consequently, it may have slipped off its shaft.

Hook.JPG	Attach spring at hook number 3
assembled armrest.jpg	View to the hooks when armrest is assembled

- Replacement of component part.
- Before installation of the replacement part, hook the pop-up springs into hook 3 (see picture in attachment).

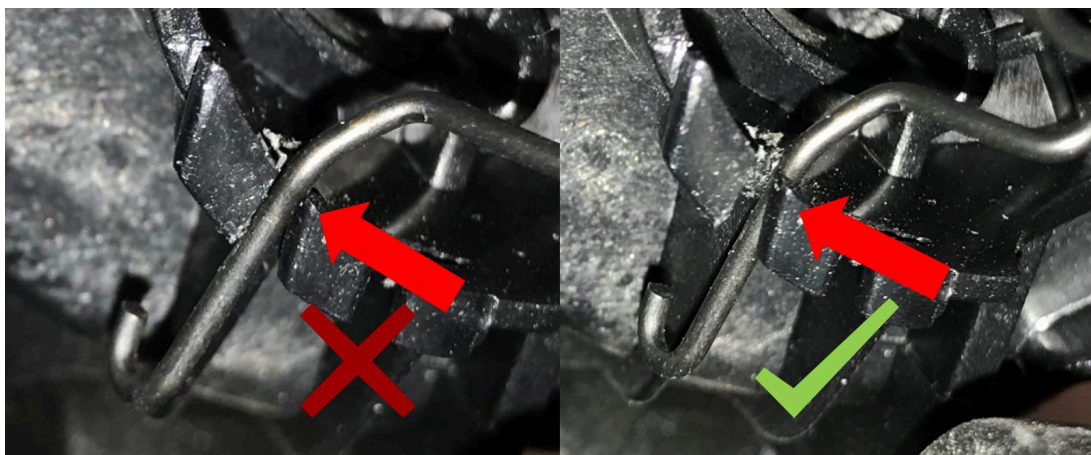
wrong and correct installation of spring.jpg:

Attachments	
File	Description
wrong and correct installation of spring.jpg	Wrong and correct installation of spring

When hooking in the spring make sure that it is positioned correctly behind the catch hook (see picture "Wrong and correct installation of spring").
