Front bumper/facia fit above headlamps

Topic number	LI88.20-P-071570
Version	2
Function group	88.20 Bumpers
Date	11-19-2020
Validity	BR290
Reason for change	Remedy added. Removed PTSS case request.
Reason for block

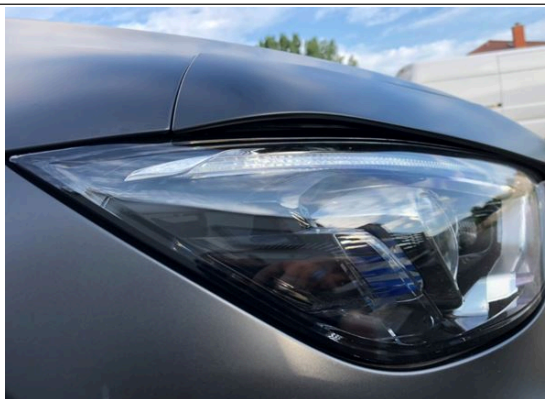
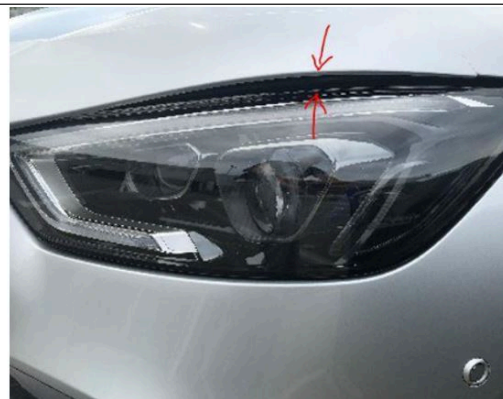
Beanstandung.JPG:

Bulging of front bumper above headlamps (see attachment). Function of headlights not blocked or impaired.

Attachments	
File	Description
Beanstandung.JPG	Bulging on bumper above the headlamp

Bonding between bracket and bumper may be separating.

Detach front bumper and check whether the brackets can be easily removed without damaging or deforming the bumper.

A) If the brackets can be easily removed without damaging or deforming the bumper --> Carry out the following re-work:

1. Clean the inner side of the bumper and the new brackets and then apply primer.
2. Attach 3M tape as per Attachment 1.
3. Apply additional beads of adhesive (A 006 989 08 71 - Sikaflex ® 265) between and next to the 3M tape, as per Attachment 2.
4. Bond the brackets to the inner side of the bumper and allow to cure sufficiently.

B) If the brackets cannot be removed without damaging or deforming the bumper (bond too strong) --> Perform procedure A, and replace the bumper.
