Technical Service Bulletin

Subject: MULTI-MODEL - ENGINE RUNS ROUGH AND CHECK ENGINE LIGHT ON WITH DTCS P0201 AND P0204 OR P0202 AND P0203	Bulletin No.: 01-004/17
	Last Issued: 02/21/2017

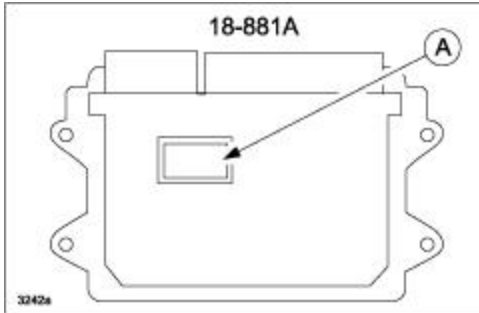
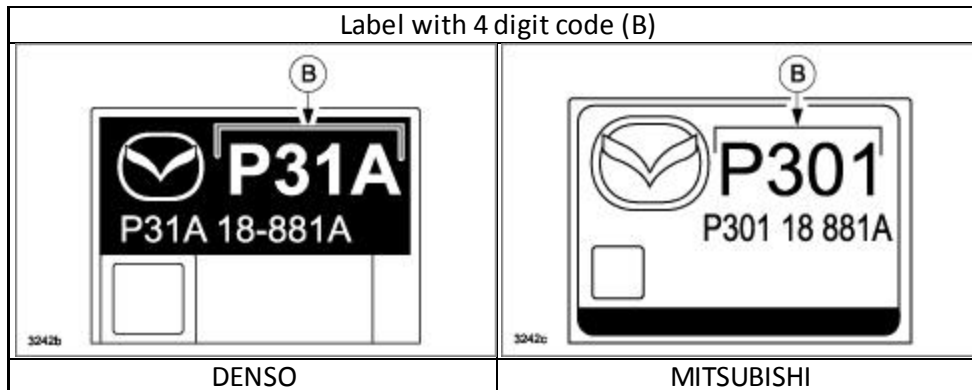
2. Check if the PCM is “DENSO” produced. Inspect the PCM label (A) and check the 4-digit code (B) to confirm this code matches with the first 4 digits of DENSO PRODUCED PCM part numbers specified in the GEPC.

- CX-5: PCM REMOVAL/INSTALLATION [SKYACTIV-G 2.0, SKYACTIV-G 2.5]
- Mazda3: PCM REMOVAL/INSTALLATION [SKYACTIV-G 2.0, SKYACTIV-G 2.5]
- Mazda6: PCM REMOVAL/INSTALLATION [SKYACTIV-G 2.5]
- If the PCM is “DENSO”, replace the PCM according to the instructions on MS3 online.

- If the PCM is NOT “DENSO”, this TSB is not applicable. Perform diagnosis for other concerns according to the instructions on MS3 online.
