Subject: 15-003/17 - LDWS AND HBC WARNING LIGHTS ON AND DTC C1001:92	Bulletin No.: 15-003/17
	Last Issued: 05/11/2017

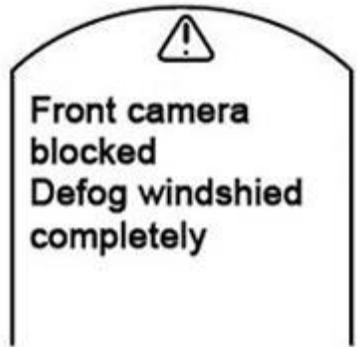
Current FSC Detection

<p>High Beam Control (HBC)* and/or Lane Departure Warning System (LDWS)*malfunction. Defrost the windshield. Have the vehicle checked by a Studio if this indicator stays on. *Existence of these features depends on models/trim levels.</p>
0%	Running	None	None	None

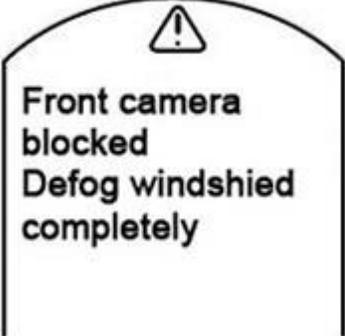
New FSC Detection

High Beam Control (HBC)* and/or Lane Departure Warning System (LDWS)* malfunction. Defrost the windshield. Have the vehicle checked by a Studio if this indicator stays on. *Existence of these features depends on models/trim levels.

Extended system running range			
0%	Running	None	None	None
