**Complaint - Cylinder Head Cover Near the Injector holes Leaking: Subsequent Work on Cylinder Head (180/18)**

Vehicle Types: **Panamera (971)/Panamera 4 (971)/Panamera 4 E-Hybrid (971)/Panamera 4S (971)/Panamera 4 Sport Turismo (971)/Panamera 4 E-Hybrid Sport Turismo (971)/Panamera 4 S Sport Turismo (971)**

Subject: **Cylinder head cover**

Information: **Complaint about injector hole leaks**

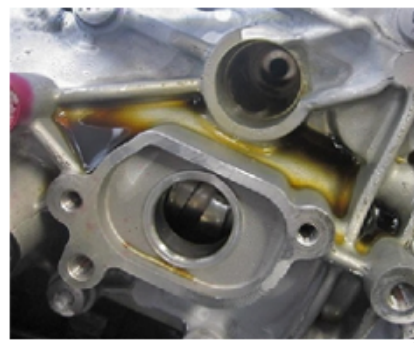
2.3.1 Oil must have collected in the vicinity of the injector of the affected cylinder and the insulation on the bottom of the cylinder head cover should be fully soaked.

*Fault type 2: Cylinder head cover leaking*

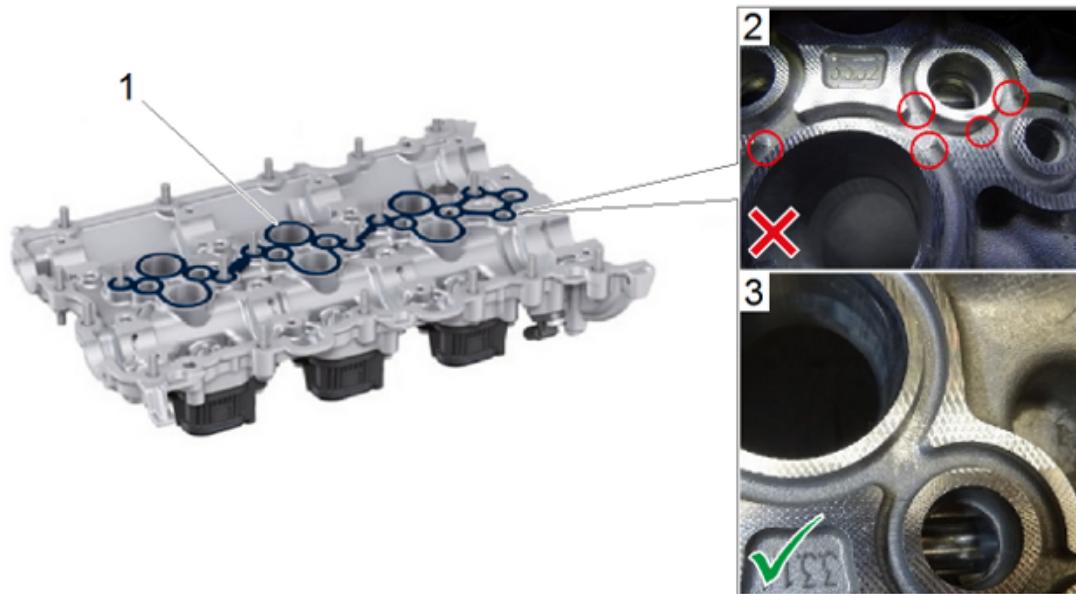
- Due to a batch error in the casting procedure there may be cast residue in the cylinder head cover sealing groove.
- This cast residue may cause the injector holes to leak.

2.6 Check the sealing groove (⇒ *Cylinder head cover sealing groove -1-*) of the cylinder head cover visually. Be particularly meticulous when doing this especially in the vicinity of the affected cylinder.

*Cylinder head cover sealing groove*

2.7 Carefully remove any cast residue (⇒ *Cylinder head cover sealing groove -2-*) using a **small flat screwdriver, ensuring that the sealing groove is not damaged**. There must be no more cast residue in the sealing groove after machining (⇒ *Cylinder head cover sealing groove -3-*).

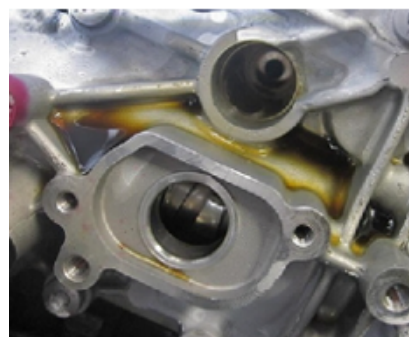
2.3.1 Oil must have collected in the vicinity of the injector of the affected cylinder and the insulation on the bottom of the cylinder head cover should be fully soaked.

*Fault type 2: Cylinder head cover leaking*

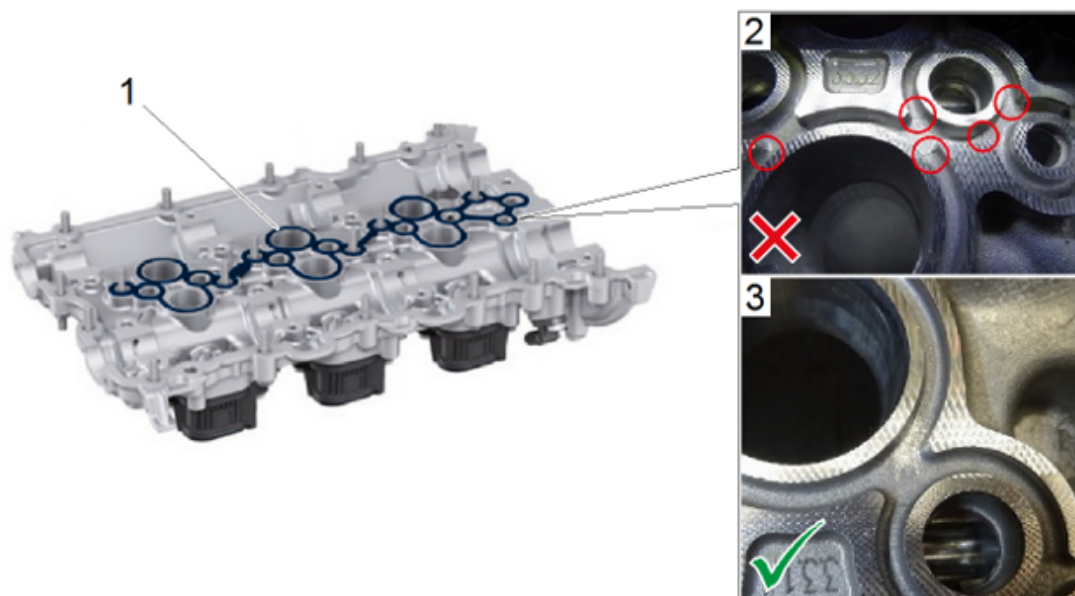
- Due to a batch error in the casting procedure there may be cast residue in the cylinder head cover sealing groove.
- This cast residue may cause the injector holes to leak.

2.6 Check the sealing groove (⇒ *Cylinder head cover sealing groove -1-*) of the cylinder head cover visually. Be particularly meticulous when doing this especially in the vicinity of the affected cylinder.

*Cylinder head cover sealing groove*

2.7 Carefully remove any cast residue (⇒ *Cylinder head cover sealing groove -2-*) using a small flat screwdriver, ensuring that the sealing groove is not damaged. There must be no more cast residue in the sealing groove after machining (⇒ *Cylinder head cover sealing groove -3-*).

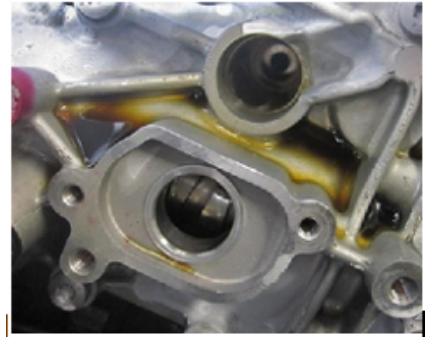
2.3.1 Oil must have collected in the vicinity of the injector of the affected cylinder and the insulation on the bottom of the cylinder head cover should be fully soaked.

*Fault type 2: Cylinder head cover leaking*

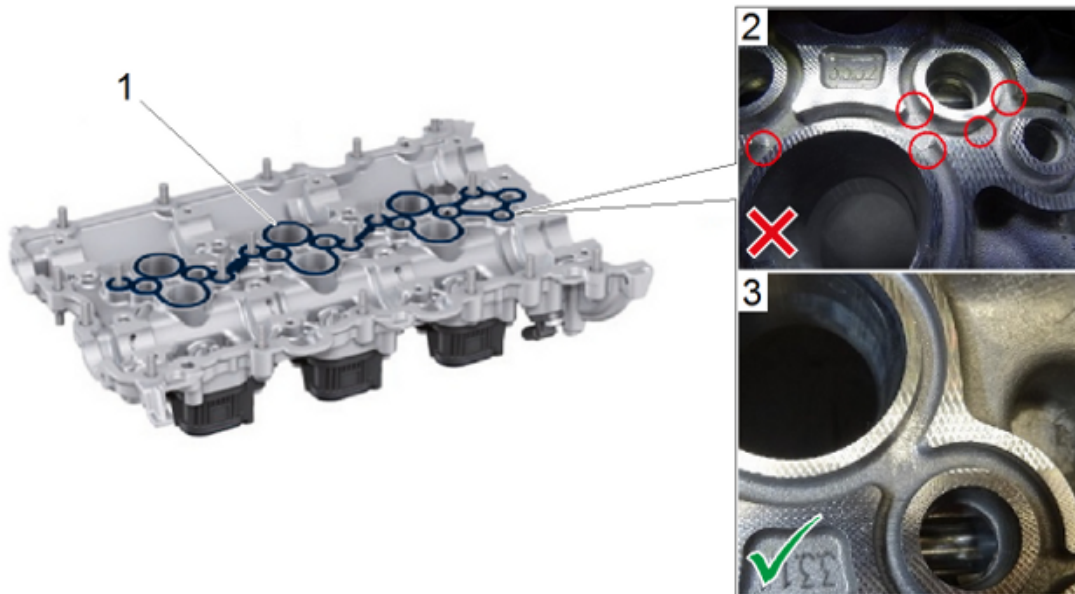
- Due to a batch error in the casting procedure there may be cast residue in the cylinder head cover sealing groove.
- This cast residue may cause the injector holes to leak.

2.6 Check the sealing groove (⇒ *Cylinder head cover sealing groove -1-*) of the cylinder head cover visually. Be particularly meticulous when doing this especially in the vicinity of the affected cylinder.

*Cylinder head cover sealing groove*

2.7 Carefully remove any cast residue (⇒ *Cylinder head cover sealing groove -2-*) using a small flat screwdriver, ensuring that the sealing groove is not damaged. There must be no more cast residue in the sealing groove after machining (⇒ *Cylinder head cover sealing groove -3-*).
