WKL3 - Replacing Ball Pins on Rear Lid (Workshop Campaign)

Revision: This bulletin replaces bulletin Group 5 100/20 WKL3, dated August 14, 2020.

Model Line: **Cayenne (9YB)**

Subject: **Replace ball pin on rear lid**

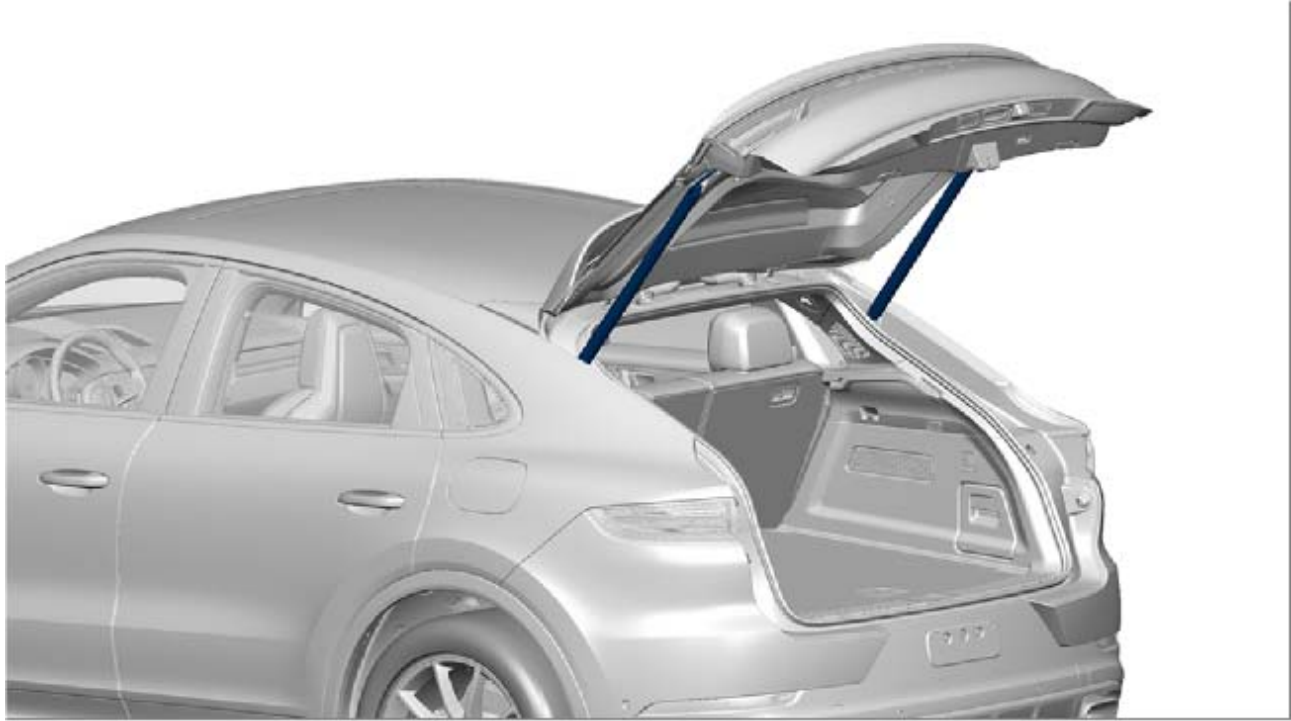
Information: **There is a possibility that the ball pins for securing the actuating cylinders for the rear lid will loosen from the body over the service life of the vehicle due to a manufacturing error.**

The resultant increased notch effect can cause the ball pins to break, resulting in unintentional lowering of the lid.

Installation position of ball pins for actuating cylinder

Remedial Action: Replace ball pins on the rear lid at the left and right.
