Complaint - Cylinder Head Cover Near the Injector holes Leaking: Subsequent Work on Cylinder Head (180/18)

Subject: **Cylinder head cover**

Information: **Complaint about injector hole leaks**

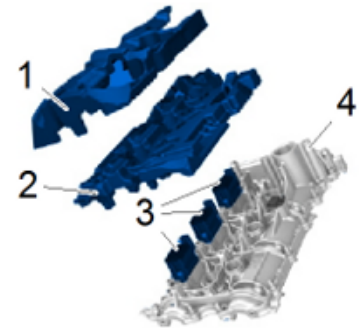
Component overview of cylinder head cover

- 1 – Insulation on top of cylinder head cover
- 2 – Insulation on bottom of cylinder head cover
- 3 – Solenoid hydraulic valve for valve lift adjustment
- 4 – Cylinder head cover

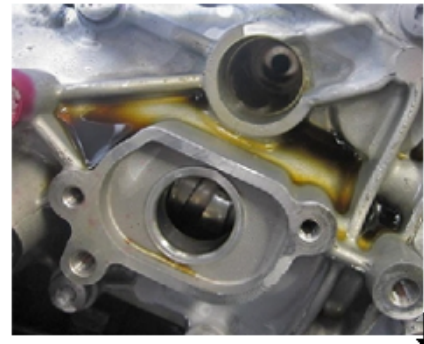
2.3.1 Oil must have collected in the vicinity of the injector of the affected cylinder and the insulation on the bottom of the cylinder head cover should be fully soaked.

⇒ *Fault type 2: Cylinder head cover leaking*

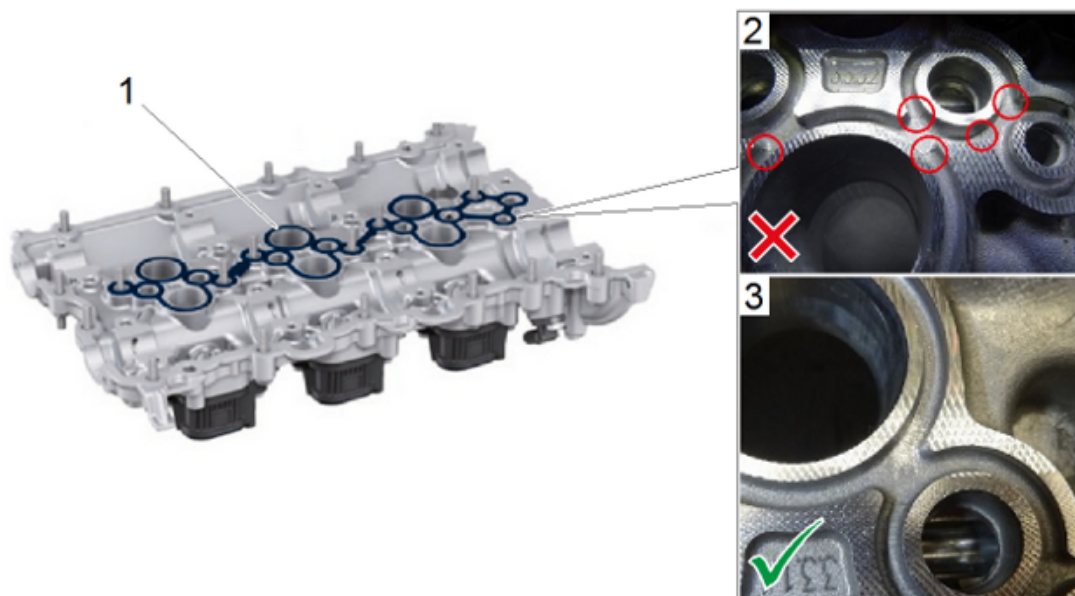
Cylinder head cover sealing groove

- The casting procedure may have caused cast residue in the cylinder head cover sealing groove.
- This cast residue may cause the injector holes to leak.

2.6 Check the sealing groove (⇒ *Cylinder head cover sealing groove -1-*) of the cylinder head cover visually. Be particularly meticulous when doing this especially in the vicinity of the affected cylinder. *Fault type 2: Cylinder head cover leaking*

2.7 Carefully remove any cast residue (⇒ *Cylinder head cover sealing groove -2-*) using a **small flat screwdriver, ensuring that the sealing groove is not damaged**. There must be no more cast residue in the sealing groove after machining (⇒ *Cylinder head cover sealing groove -3-*).

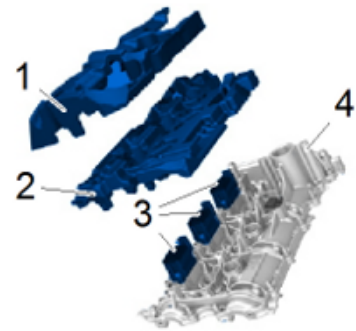
Component overview of cylinder head cover

- 1 – Insulation on top of cylinder head cover
- 2 – Insulation on bottom of cylinder head cover
- 3 – Solenoid hydraulic valve for valve lift adjustment
- 4 – Cylinder head cover

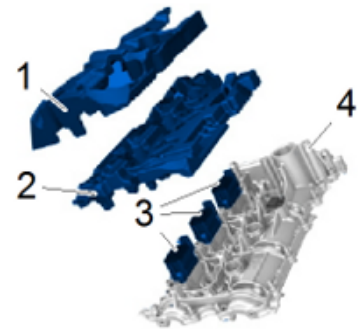
Component overview of cylinder head cover

- 1 – Insulation on top of cylinder head cover
- 2 – Insulation on bottom of cylinder head cover
- 3 – Hydraulic valve for valve lift switchover
- 4 – Cylinder head cover

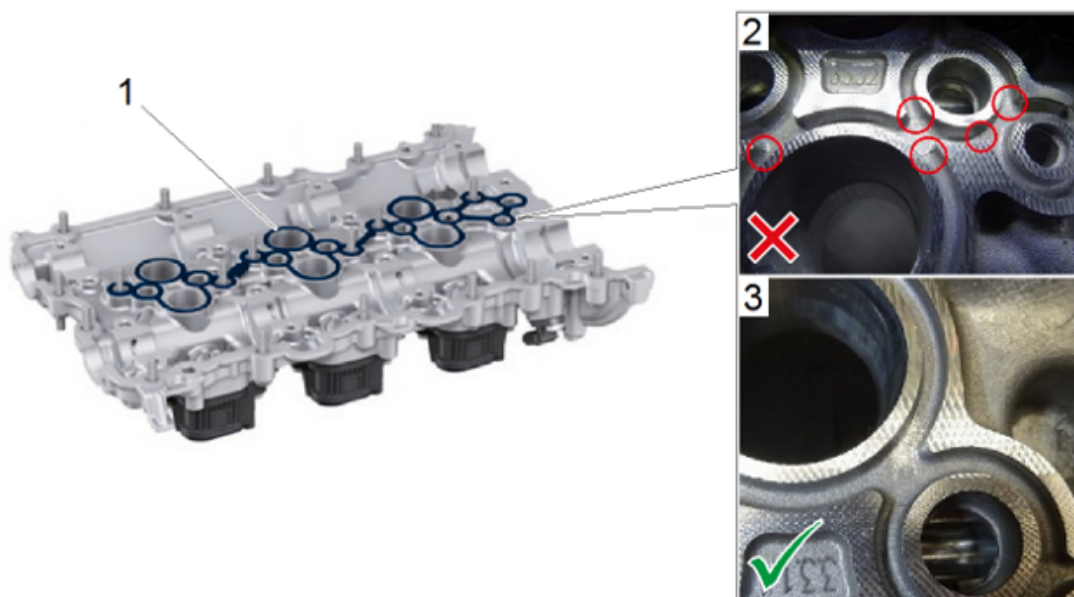
Cylinder head cover sealing groove

- Due to a batch error in the casting procedure there may be cast residue in the cylinder head cover sealing groove.
- This cast residue may cause the injector holes to leak.

2.6 Check the sealing groove (⇒ *Cylinder head cover sealing groove -1-*) of the cylinder head cover visually. Be particularly meticulous when doing this especially in the vicinity of the affected cylinder.

2.7 Carefully remove any cast residue (⇒ *Cylinder head cover sealing groove -2-*) using a small flat screwdriver, ensuring that the sealing groove is not damaged. There must be no more cast residue in the sealing groove after machining (⇒ *Cylinder head cover sealing groove -3-*).
