**FT4949 Fault Code 1242 CEL No Accelerator Pedal Response NYCT**

## MQR 7621-2121

Accelerator Pedal Not Responding (1242 Fault Codes)

➤ FT4949 Field Instruction – Splice Connectors Modification (Rev03)

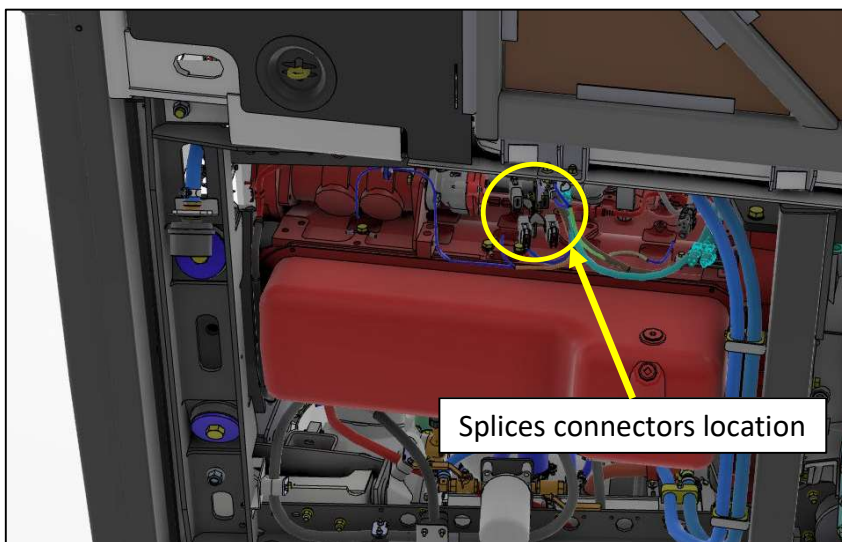
Figure 2 – Splice Connectors Cluster Location

1. Lift and secure the vehicle onto the safety stands.
2. Locate the splice connectors cluster (see figure 2).
3. Remove the bolt that retains all splice connectors and then remove the upper splice connectors (see figure 3).

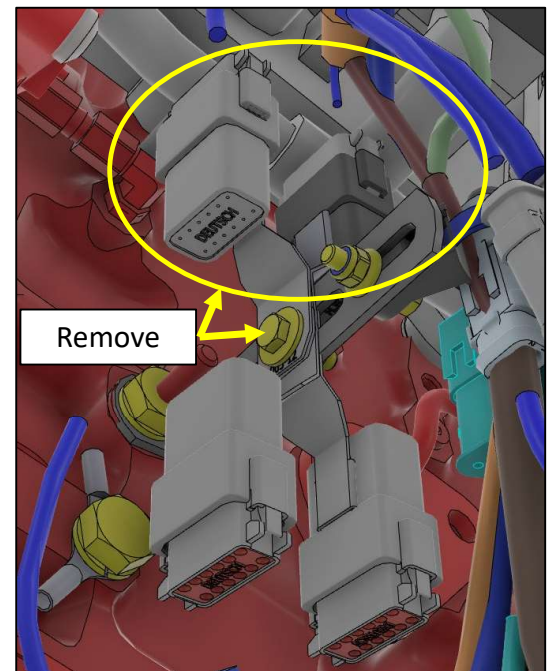
Figure 3 – Splice Connectors Location

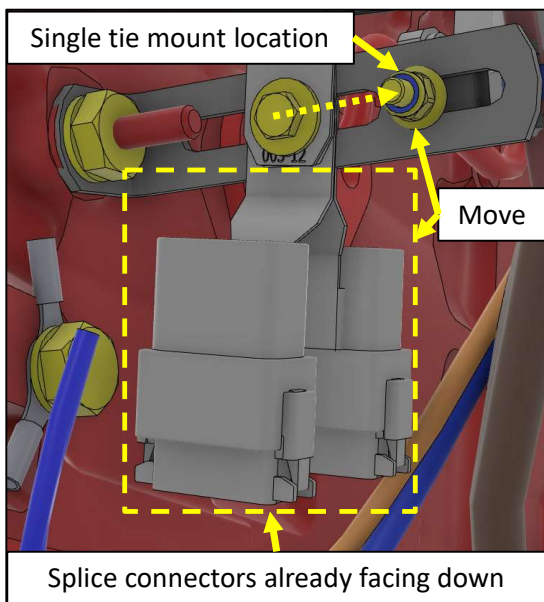
Figure 4 – Splice Connectors with Wire Entry Already Facing Down

4. Move the 2 lower splice connectors with wire entry already facing down so that they are positioned and reassembled at the single tie mount location (see figures 4, 5 & 6). Before fastening, ensure that the mounting hardware parts stacking is the same as on figures 5 & 6.

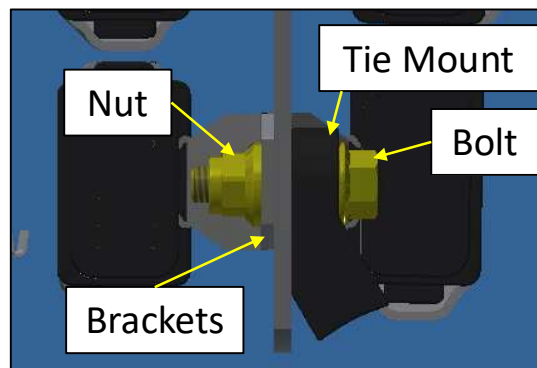
Figure 5 – Brackets Installation (Top View)

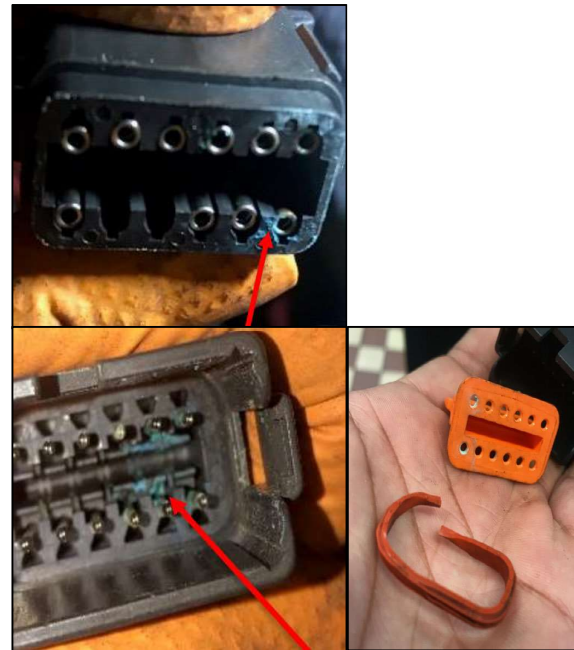
5. Move the upper splice connectors and inspect the terminals, seals and wedge locks for signs of corrosion (see figure 7).
  - a) Move away the grey boot.
  - b) Remove the connector cap and the connector wedge lock.
  - c) Inspect the connector cap jumper, the terminals and the seals.
6. If no sign of corrosion is found, then go to step 8.
7. Else if there are some signs of corrosion, go to step 11 and/or step 12 (depending on affected splice connectors).
8. Clean all parts thoroughly with contact cleaner.
9. If the connector mating seal is worn, damaged or missing, replace it with a new seal (Deutsch P/N 1010-020-1206).
10. Extract the drain wire terminals of splice connector SC95N (see figure 8 for the terminal positions) and add 25mm of heat shrink tubing P/N N82227-02 over the extended terminal crimp area (see figure 9 on next slide).

Figure 7 – Examples of Corrosion and Damaged Mating Seal

#### 11. Replacement of the corroded / damaged parts of the +MT-SC95N splice connector:

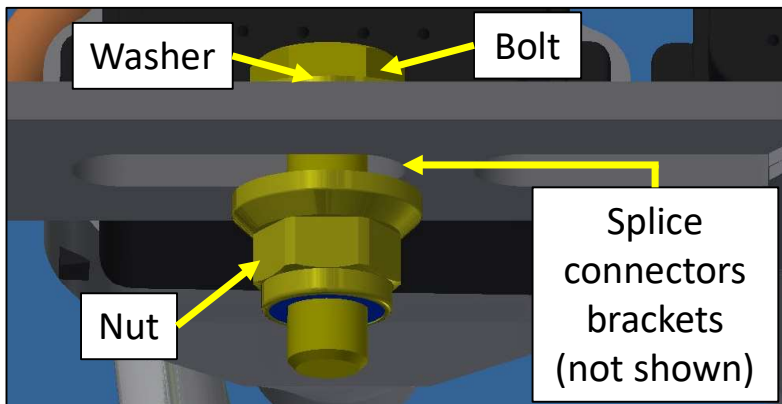
Figure 10 – Hardware Modification

13. Install the remaining splice connectors with the previously removed hardware inside the left slot of the main mounting bracket (first slot starting from motor side). See figures 10 & 11 for the parts stacking order. Splice connectors support brackets must be placed between the nut and the main mounting bracket.

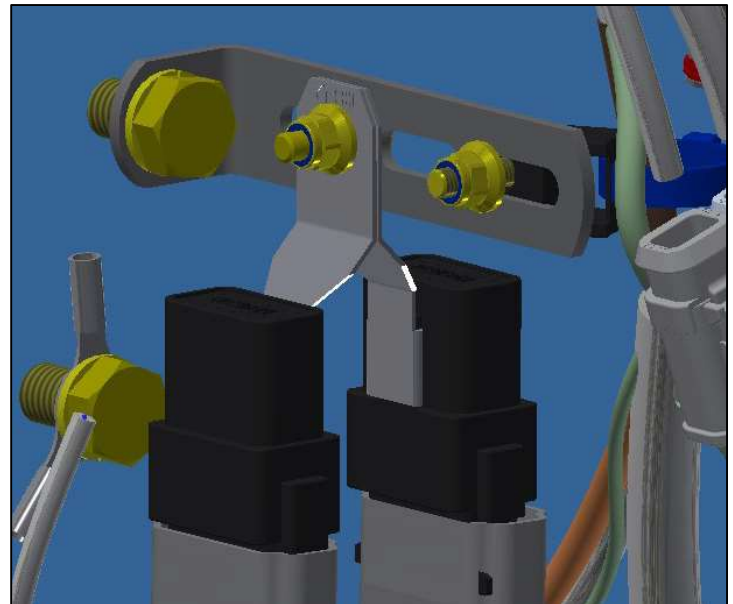
Figure 11 – Left Splice Connectors Securement

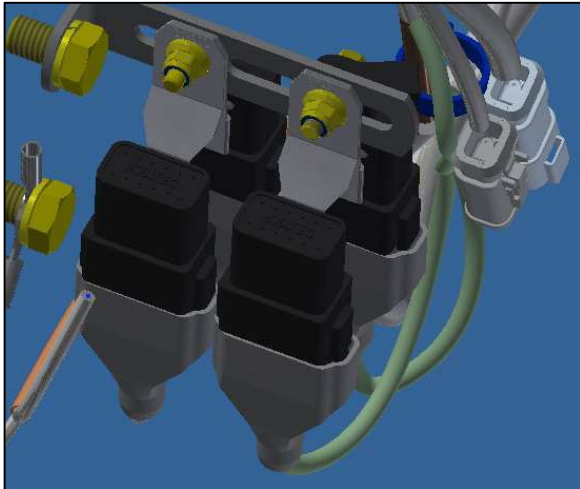
Figure 12 – Final Installation – View 1

14. Using blue cable ties P/N N56339, secure the splice connectors wiring to the main harness bundle.
15. Confirm that the grey boots cannot slip or easily move down in order to protect the connector wire entries from water, dust or dirt projections.
16. Confirm that the throttle pedal is working and then return bus to service.

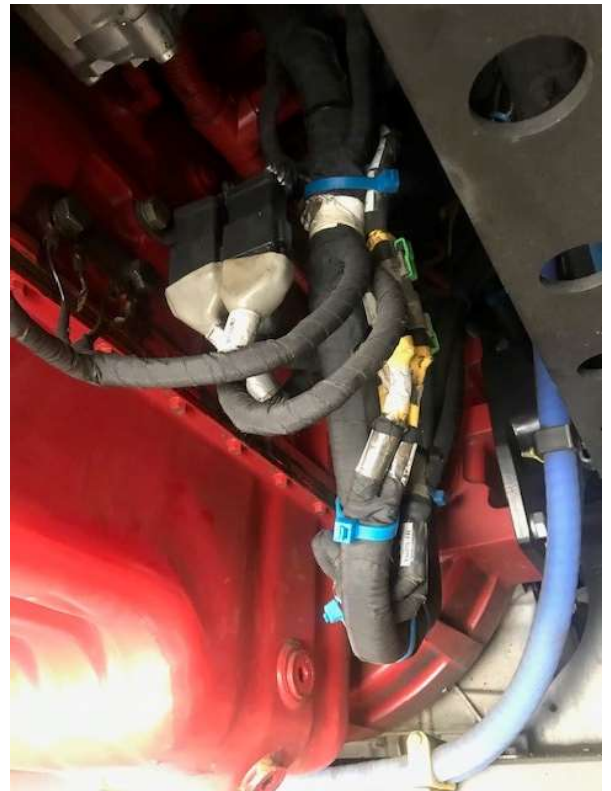
Figure 13 – Final Installation – View 2
