Technical Service Bulletin

90 Drive select menu is greyed out in the MMI, DTC U111000 is stored in the information electronics control module

90 21 86 2061989/1 January 28, 2021.

Model(s)	Year	VIN Range	Vehicle-Specific Equipment
Q5, SQ5	2021	All	Not Applicable

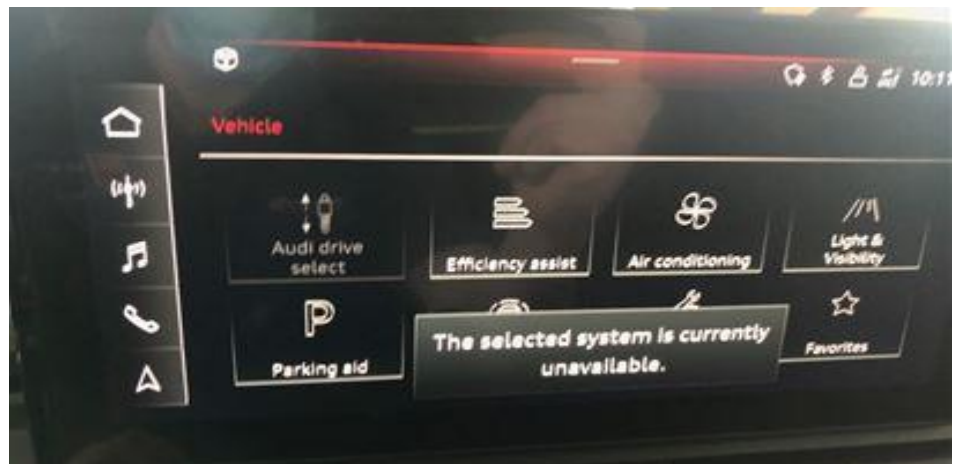
- The drive select menu is greyed out in the MMI and the message “The selected system is currently unavailable” appears (Figure 1).

Figure 1. Drive select is unavailable.

The following DTC is stored as static in the information electronics 1, J794 (address word 005F)

- DTC U111000** (Function restriction due to communication interruption) with symptom code 7191.

If the above condition and DTC are present, perform the replacement test plan for the Gateway, J533 (address word 0019) as follows:

- Follow the on screen prompts.
- Once complete allow a 10 minute sleep cycle and re-check the operation. Drive select functions are now restored and the DTC can be cleared.
