JLRTB02065NAS1

**TECHNICAL BULLETIN**

501-02

Rattle Noise From Under The Vehicle

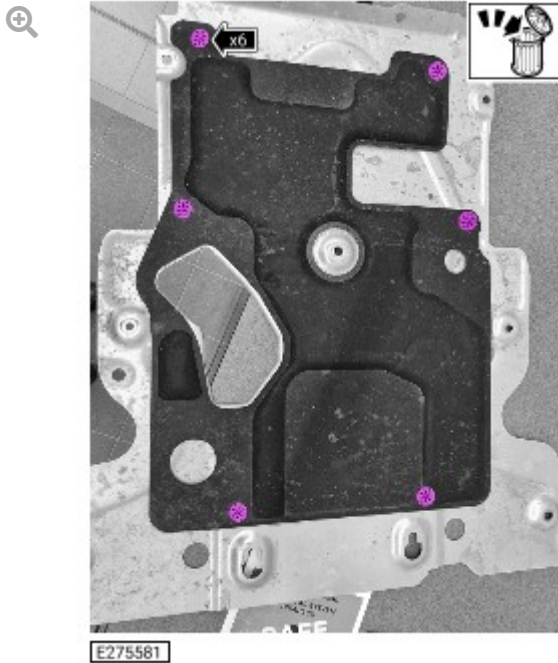
2.

A rattling noise can be heard coming from under the vehicle. Investigation has determined that the rattle is coming from the engine undershield.

Star washer relaxation.

Remove and discard the 6 star washers.
