CAMPAIGN BULLETIN

Left Front Combination Lamp Dealer Inventory

Reference: PC778
Date: January 12, 2021

PC778 – 2021 - ROGUE LEFT FRONT COMBINATION LAMP INSPECTION

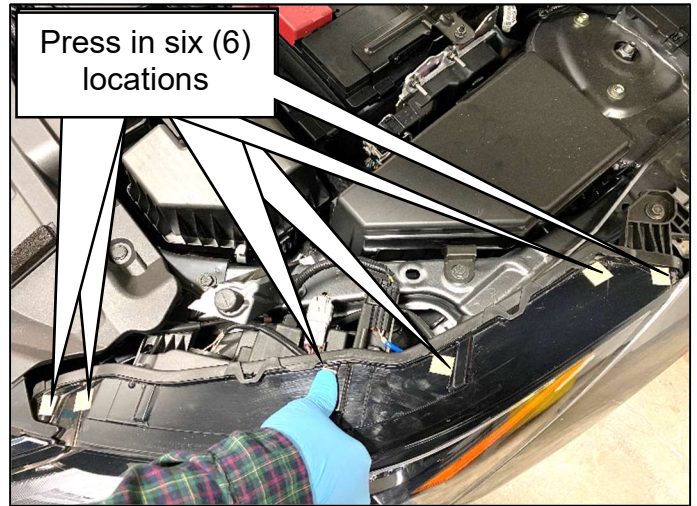
Figure 5

5. Using thumb, press down on the left front combination lamp.(Figure 5)

- With a microfiber towel, wipe the top black portion of the combination lamp assembly
- Using a new **"clean"** disposable glove to prevent cross contaminant of chemicals
- Apply moderate thumb pressure in six (6) locations along the top of the combination lamp shown in figure 5.

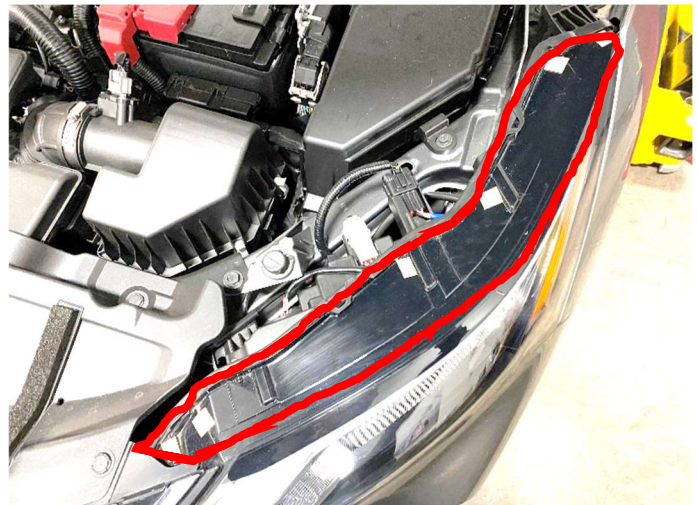
Figure 6

6. Inspect top black portion on left (only) combination lamp for cracks. (Figure 6)

NOTE: Be aware there are molding lines in this area, the molding lines are not cracks.

- If **"NO"** cracks are present, no further action is needed. Submit a claim with PC7780 operation code
- If cracks **"Are"** present, continue to Step seven (7) for combination lamp replacement

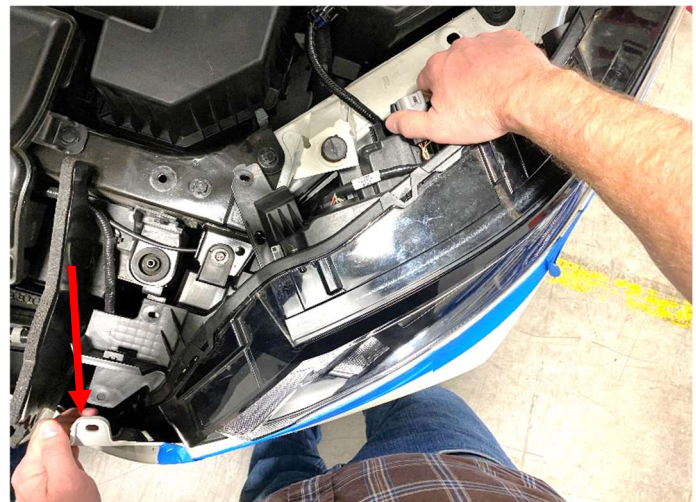
Figure 15

15. Carefully pull the fascia back and remove the cracked combination lamp assembly. (Figure 15)

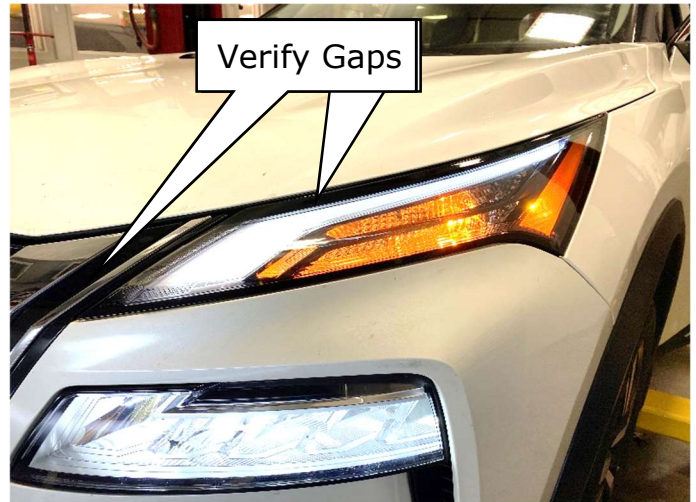
Figure 28

28. Verify combination lamp does **NOT** come in contact with the grill or hood.

- If contact is found, ensure combination lamp installation is correct. (Figure 28)

NOTE: Verify left side fit is similar to right side fit.
