SIB 64 06 17

AIR CONDITIONING COOLING IS INSUFFICIENT

This Service Information Bulletin (Revision 1) replaces SI B64 06 17 **dated November 2017**.

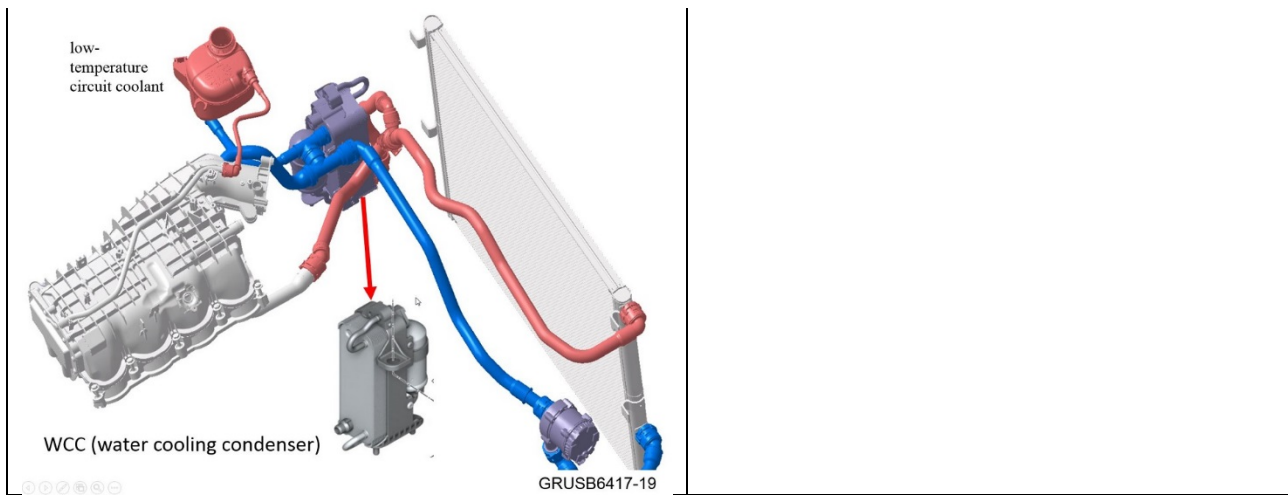
<p>If low-temperature circuit coolant is not low or leaking and refrigeration system is not low or leaking, continue below to step 1.</p>
--	---

1. Completely drain **all** coolant from the low-temperature circuit and dispose properly based on your local regulations.

2. Evacuate the refrigeration circuit.

3. Replace the AC Condenser WCC with the new part specified below. Refer to ISTA 64 53 550 "Removing and installing or replacing capacitor for heating and air conditioning system".

4. Replace the low-temperature radiator with new part specified below. Refer to ISTA REP 17 11 006 "Remove and install/ replace low temperature cooler".

5. Replace the intake system with charge air cooler with new part listed below. Refer to ISTA REP 11 61 050 "Removing and installing the intake plenum". These parts are different based on which engine is installed.

6. Refill coolant circuit with new coolant refer to Operating Fluids in TIS Group 17; refer to ISTA REP 17 00 011/580 (Inclusive labor operation) "Draining and topping up coolant circuit for low temperature".
