BULLETIN NUMBER: **SB20-N-001**

Starter Clicks When Cranking - E-98 Ground Relocation

2018-2020MY Isuzu NPR/NPRHD equipped with 6.0L Gasoline Engine.

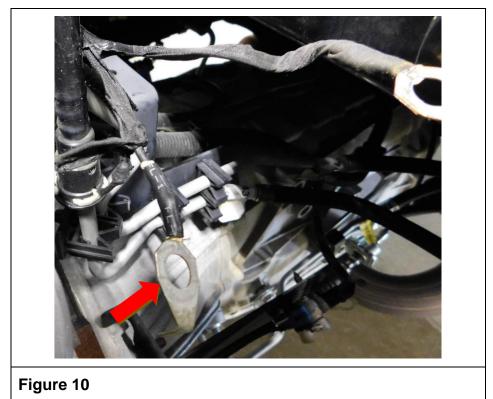
NOTE: E-98 has a single wire going to the ring terminal.

15. Remove tape from the end of the engine harness and pull back on the convoluted tubing as necessary to expose the ground wires. Find the E-98 ground, the largest gauge wire in the tubing, and separate it from other wires. (See Figure 10.)
