48-20-01 - Electromechanical Power Steering - Creaking Noise when Turning

Release date: 2/9/2021

Noise resulting from tension between the servo motor unit and the steering gear housing.

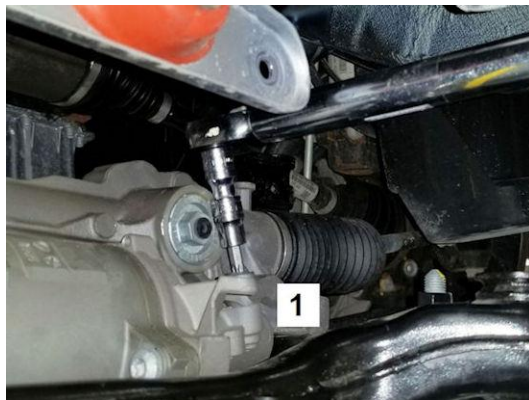
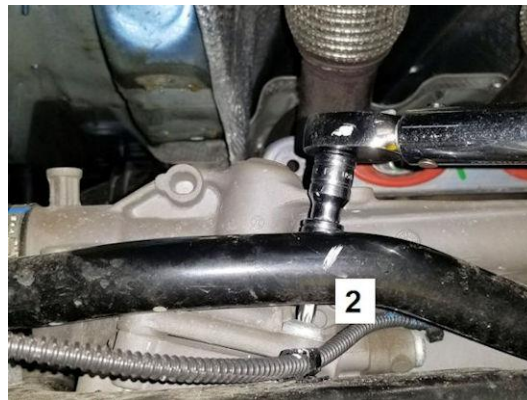
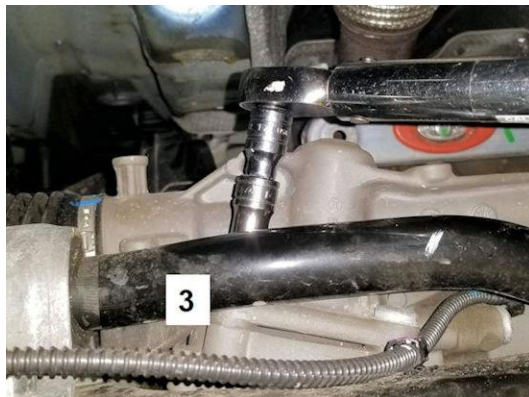
If a torque of **25 Nm** is not reached with no more than **10°** of additional turn (max. total turn **75°**), then the steering gear must be replaced! Worn or damaged threads are non-repairable.

- Return the servo motor unit to its starting position.
- Tighten the three T40 Torx screws in sequence 1, 2 and 3 (Figures 2, 4, 5 and 6) with a torque of **10 Nm**.

- Retighten the three T40 Torx screws in sequence 1, 2 and 3 (Figures 2, 4, 5 and 6) with a turning angle of **65°**.
- Verify the final torque of the three T40 Torx screws in sequence 1, 2, and 3 (Figures 2, 4, 5 and 6) using a torque value of **25 Nm** while checking that no more than **10°** of additional turn is applied.
