Technical Service Bulletin

72 Rear backrest release in the luggage compartment is inoperative

72 21 32 2062113/1 February 3, 2021.

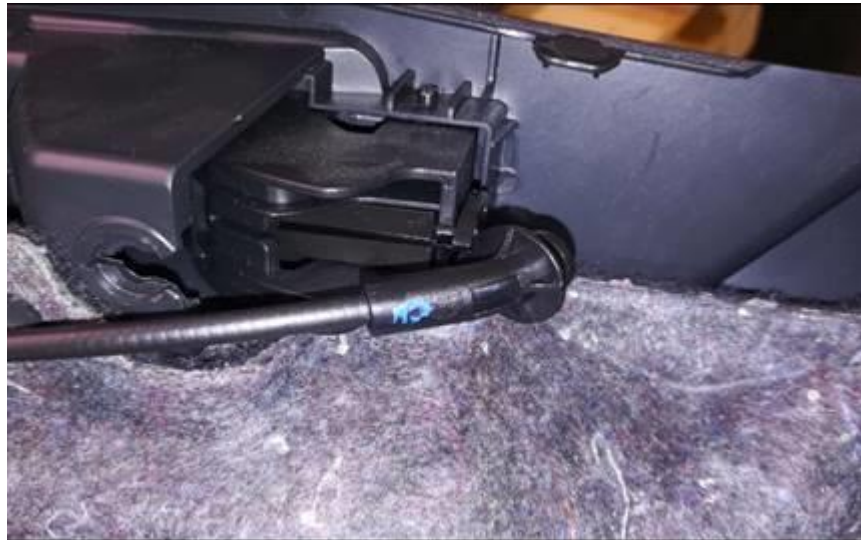
The Bowden cable disengages from its attachment point and does not release the backrest latch.

In some cases, this results in damage to the Bowden cable or to its attachment point in the luggage compartment side trim.

1. If the second row backrest release lever is without resistance or feels loose, the Bowden cable in the luggage compartment side trim has become disengaged (Figure 1).

Figure 1. Bowden cable is disengaged from the attachment point.

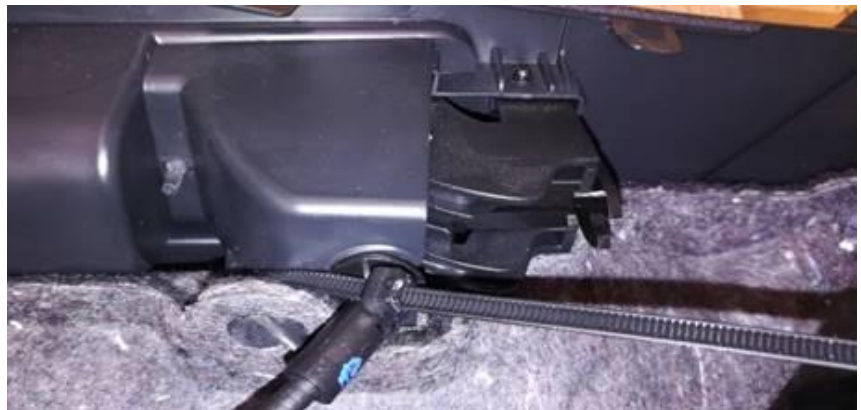
Figure 2. The Bowden cable reinstalled and secured with tie wrap.

2. Remove the luggage compartment side trim of the affected side according to the repair manual in Elsa.
3. Inspect the Bowden cable and the backrest release mechanism for any damage.
4. Reinstall the Bowden cable in the backrest release mechanism and secure it with a tie wrap (Figure 2).
