February 11, 2021

Version 2

Warranty Extension: MIL Comes On with DTC P0420/P0430, P030x, and/or P219A/B (With Software Update)

Supersedes 20-100, dated November 24, 2020, to revise the information highlighted in yellow.

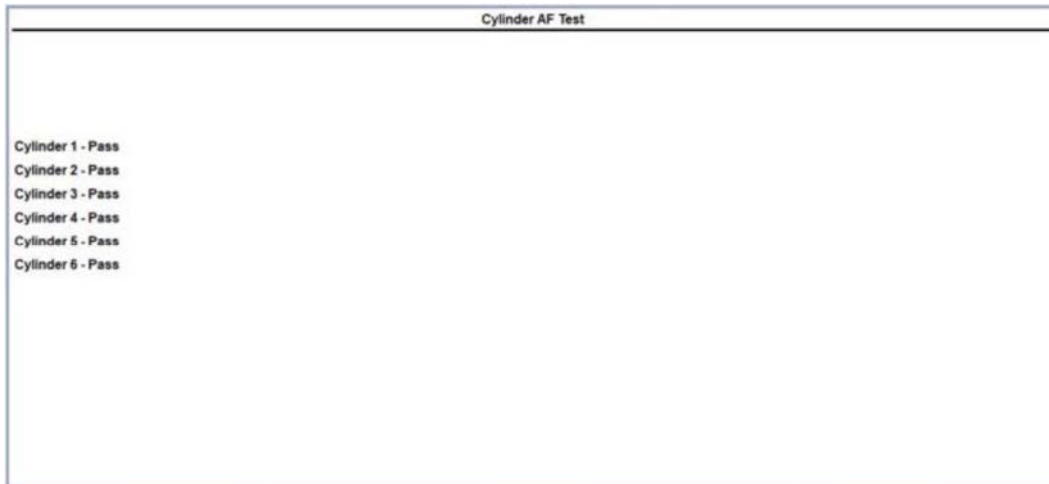
8. Make sure all cylinders pass.

No - Go to REPAIR PROCEDURE.

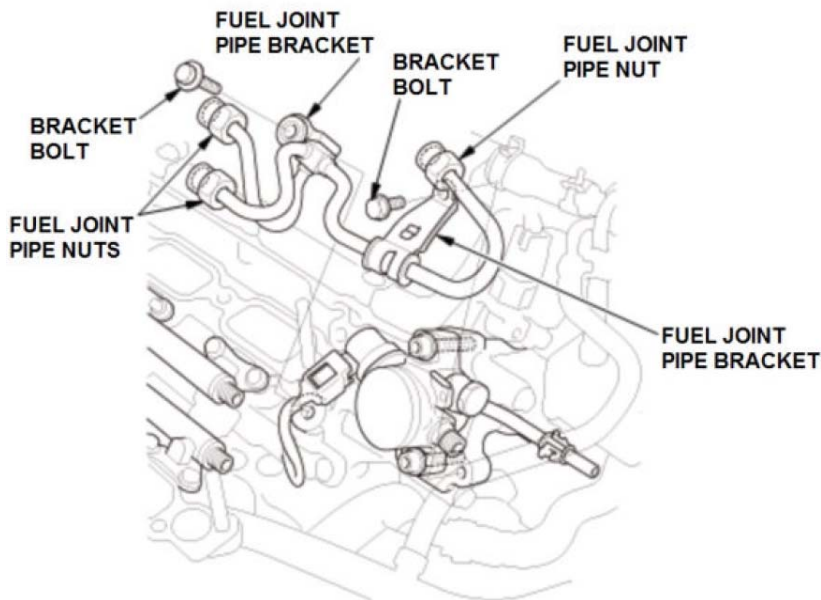
NOTE: Do not reuse the fuel joint pipe. Failure to install a new fuel joint pipe will cause fuel leaks.

12. Loosen the fuel pump mounting bolts.
13. Install the new fuel joint pipe.

14. Tighten the fuel joint pipe nuts by hand until the tips of the fuel joint pipe are seated on the fuel rails and the high pressure fuel pump.

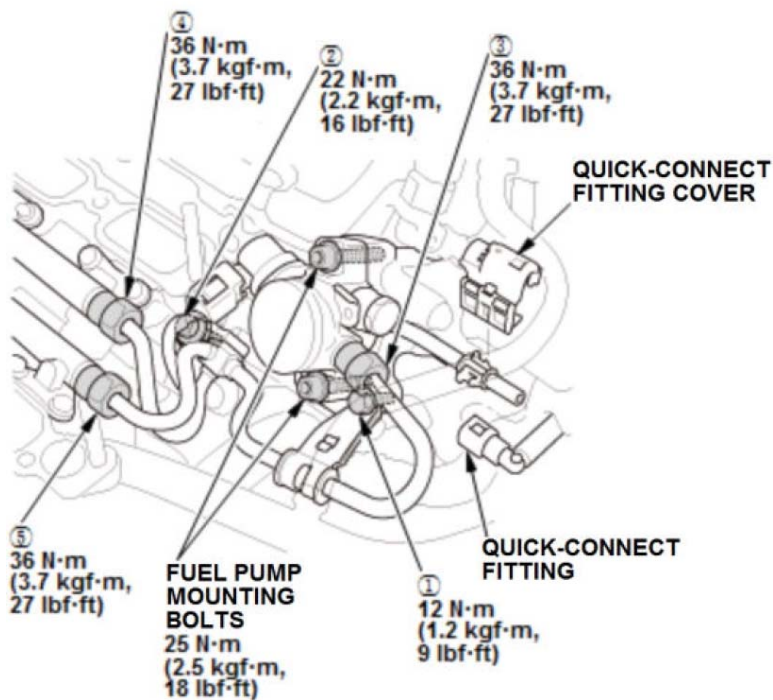
- A crowfoot-type special tool increases the torque applied by the torque wrench. Refer to Torque Specifications on SIS for details on how to recalculate the torque wrench setting.
- Failure to tighten the fuel joint pipe nuts to the proper torque will cause a fuel leak.

15. Loosely install the bracket bolts to secure the new fuel joint pipe to the cylinder head.
16. Tighten the fuel pump mounting bolts to **25 N·m (18 lb-ft)**.

17. Tighten the fuel joint pipe bracket bolts to **12 N·m (9 lb-ft)** and **22 N·m (16 lb-ft)** in the order shown.
18. Tighten the fuel joint pipe nuts to **36 N·m (27 lb-ft)** in the order shown.
