Technical Service Bulletin: TSB210013	Released Date: 22-Jan-2021
C500 D6RE Fault Code 5866 Harness Fix

C500 D6RE Fault Code 5866 Harness Fix

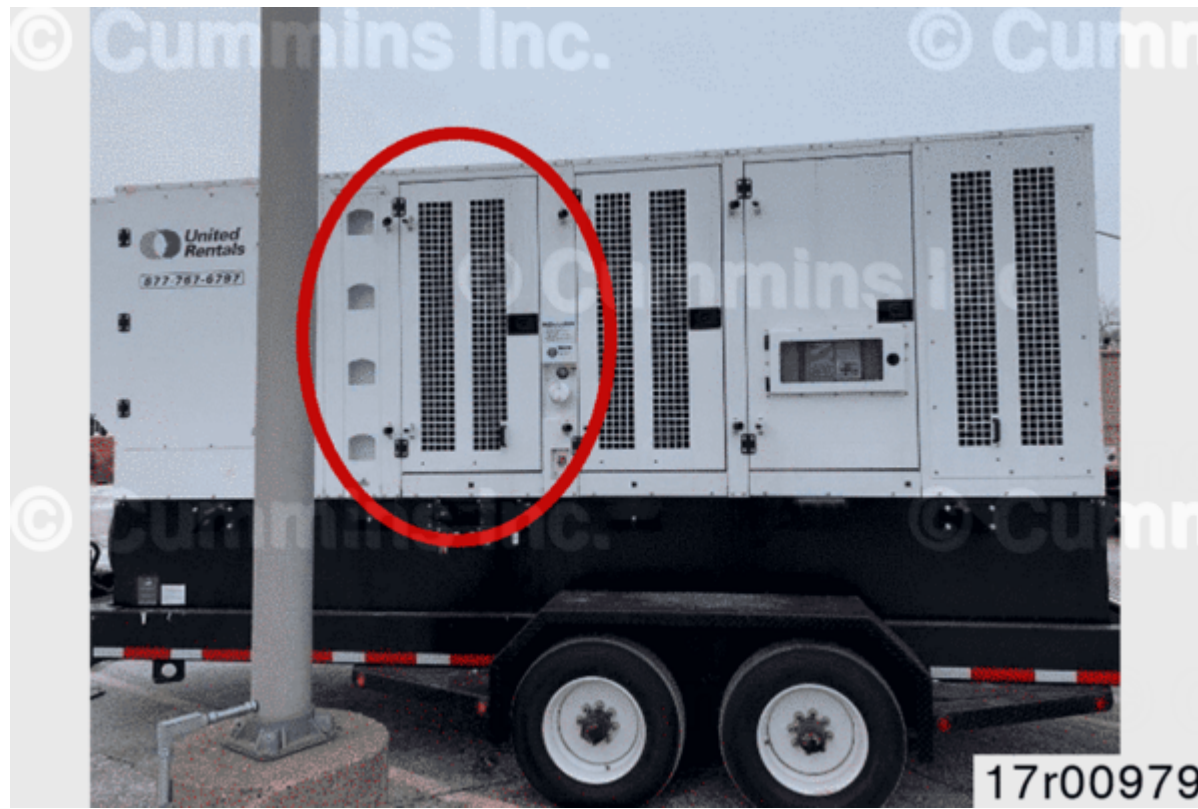
Figure 1, Service Door access

1. Identify Relay 5. Figures 1, 2, 3 show the location of the harness.

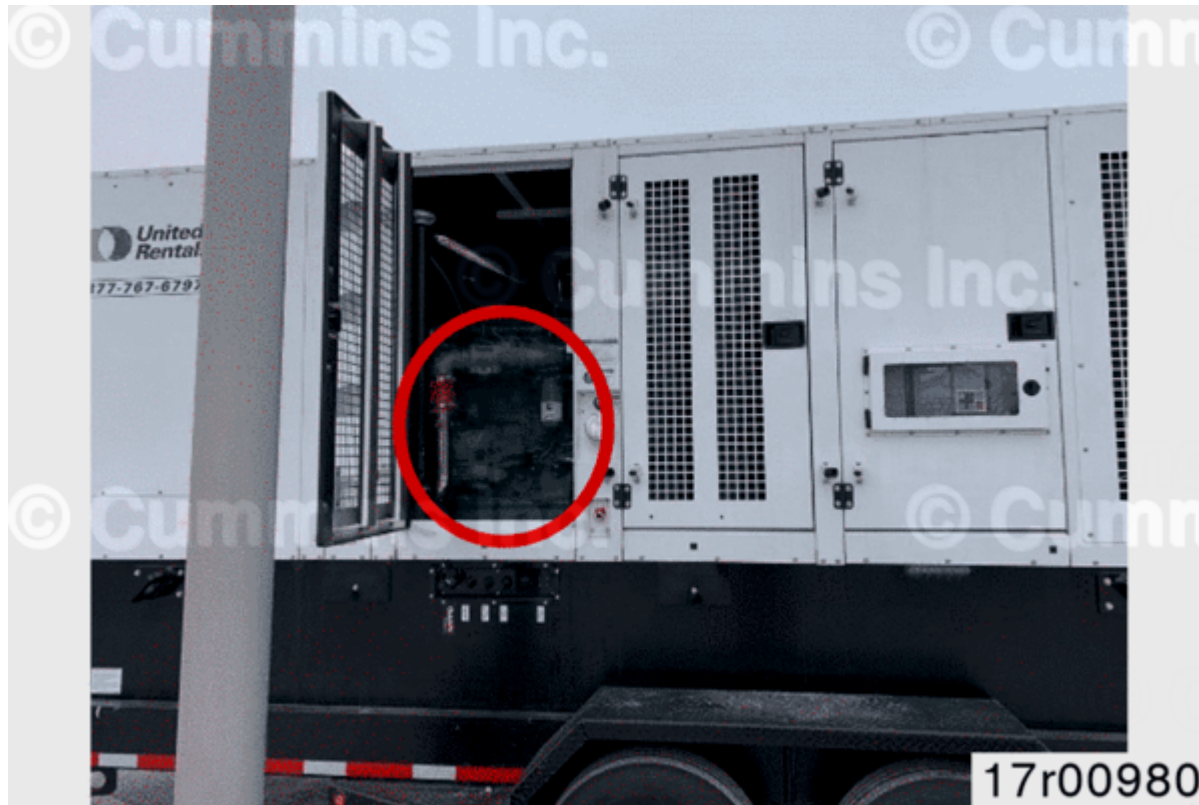
Figure 2, Location of harness

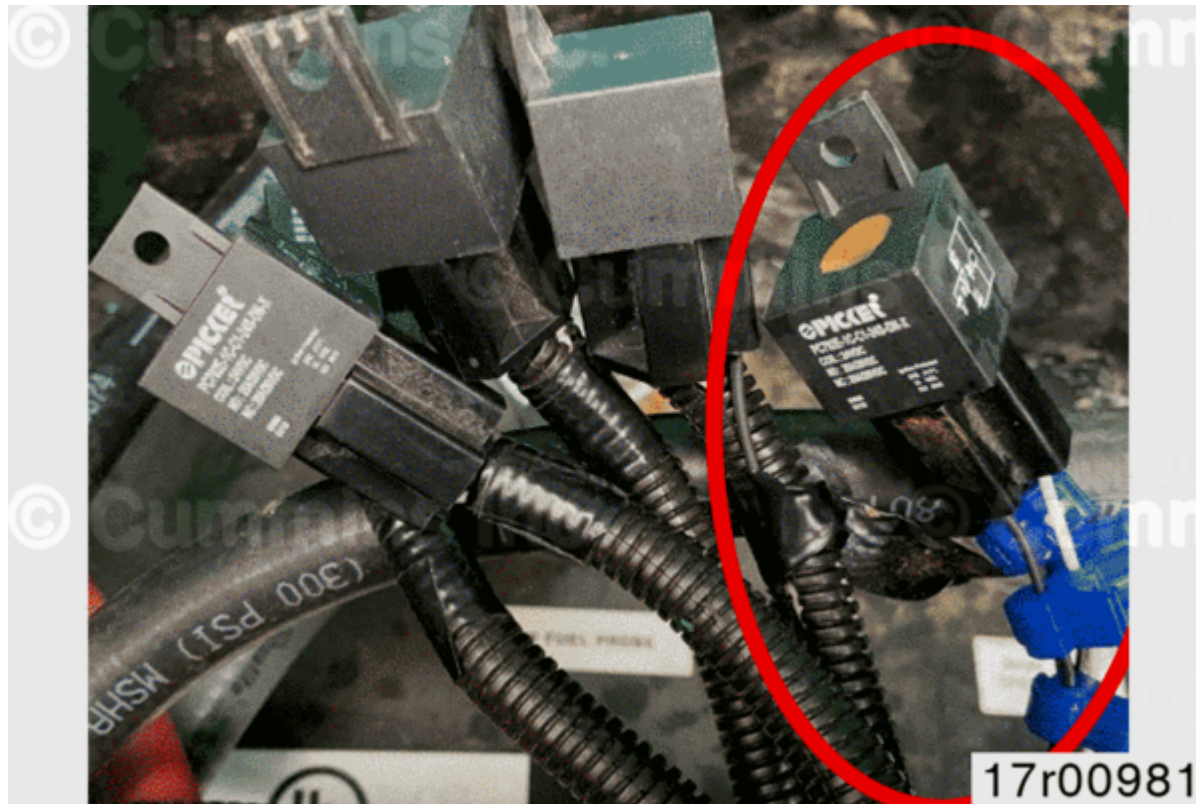
Figure 3, Harness relay circled in red

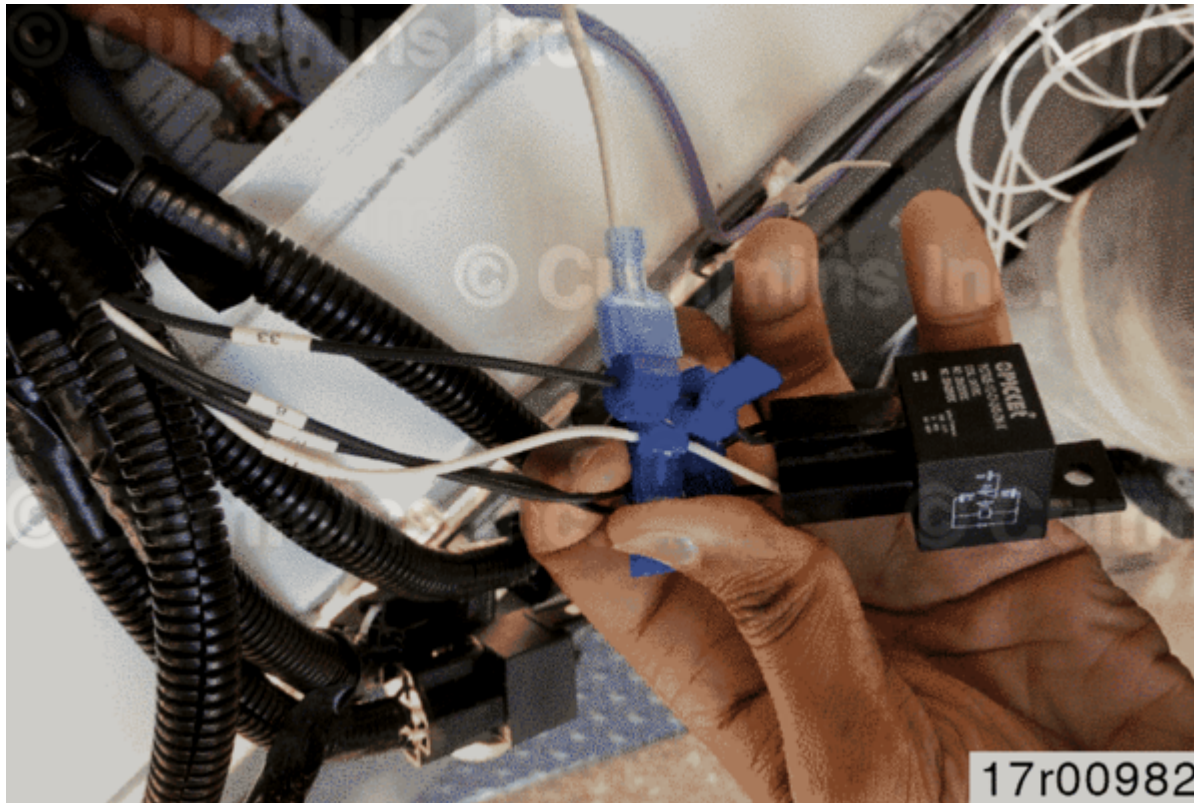
Figure 4, Splice into wire 33 that connects to R5-87 pin

2. Using quick Splice for wire gauge, splice into wire 33 that connects to R5-87 pin.

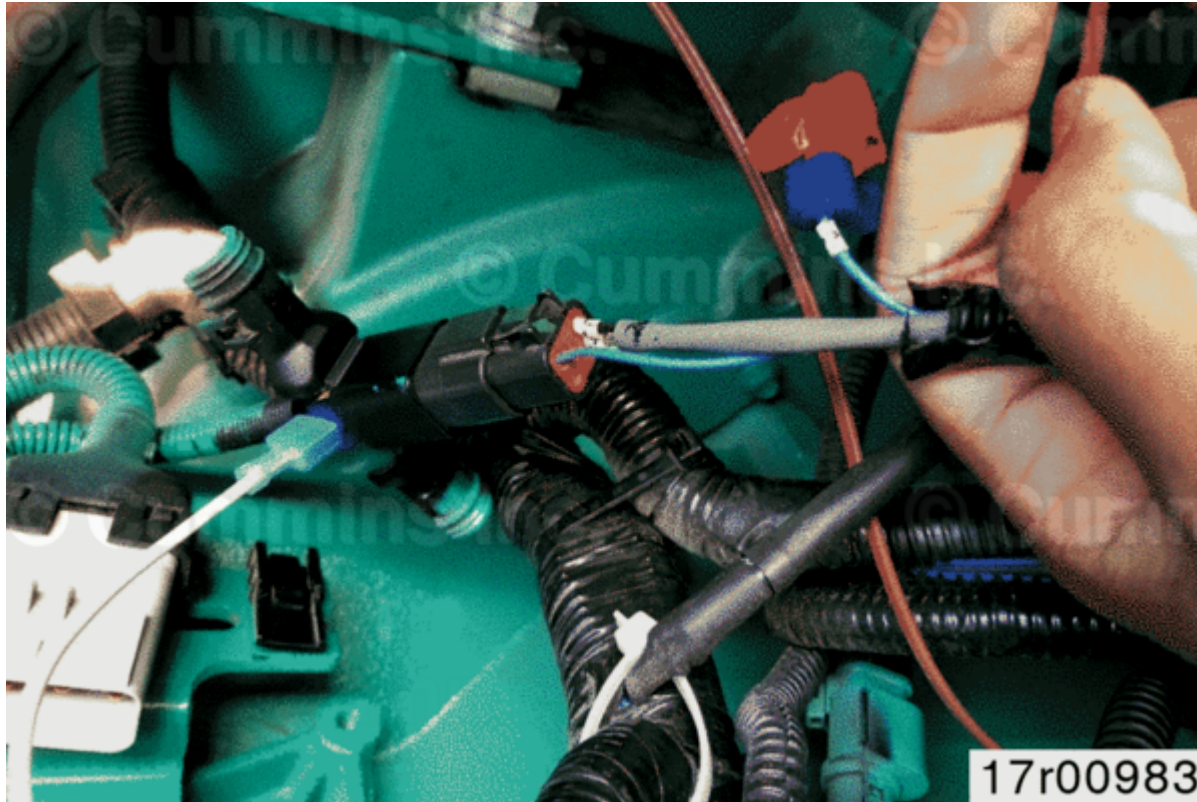
Figure 5, Removed wire - taped to avoid short circuit

3. Remove wire going into pin 3 on CC4D.

3 a. Tape to avoid short circuit to metal parts.
