Preliminary Information

PIT5751C SES MIL / Reduced Engine Power / Misfire / IPC Gauges Sweep / IPC Warning Message / Loss Communication / Various DTCs / Blown Fuse (Inspect Engine Harness 3.0L Diesel)

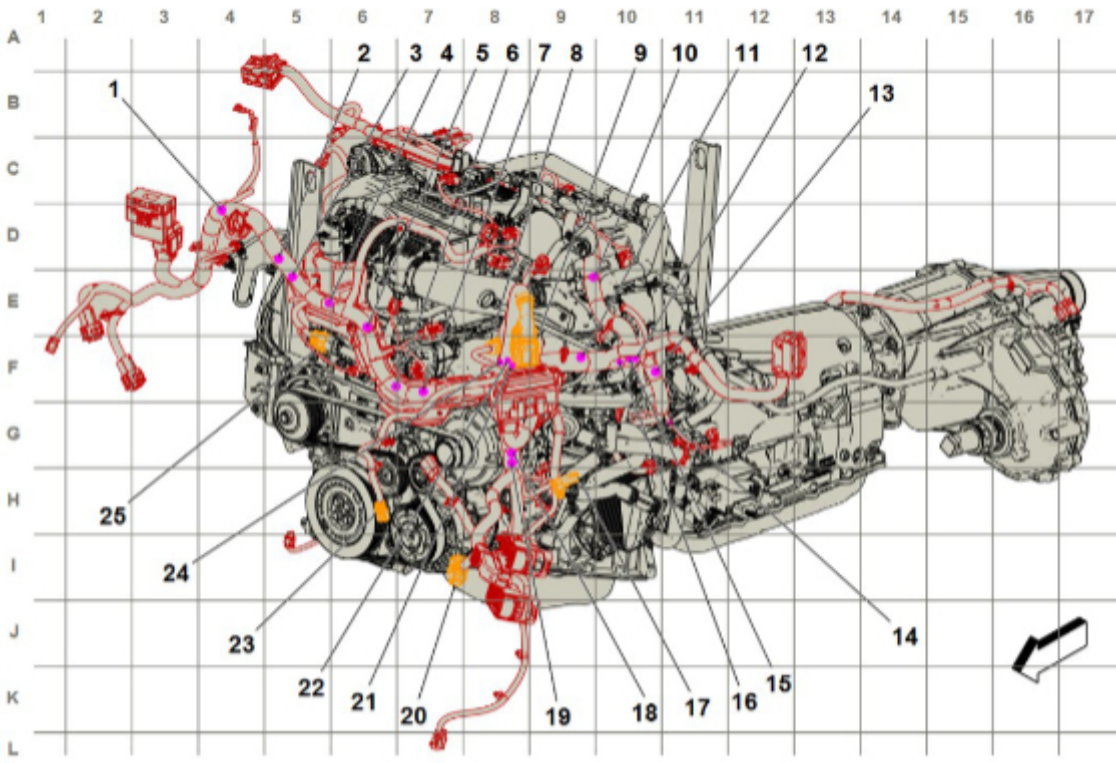
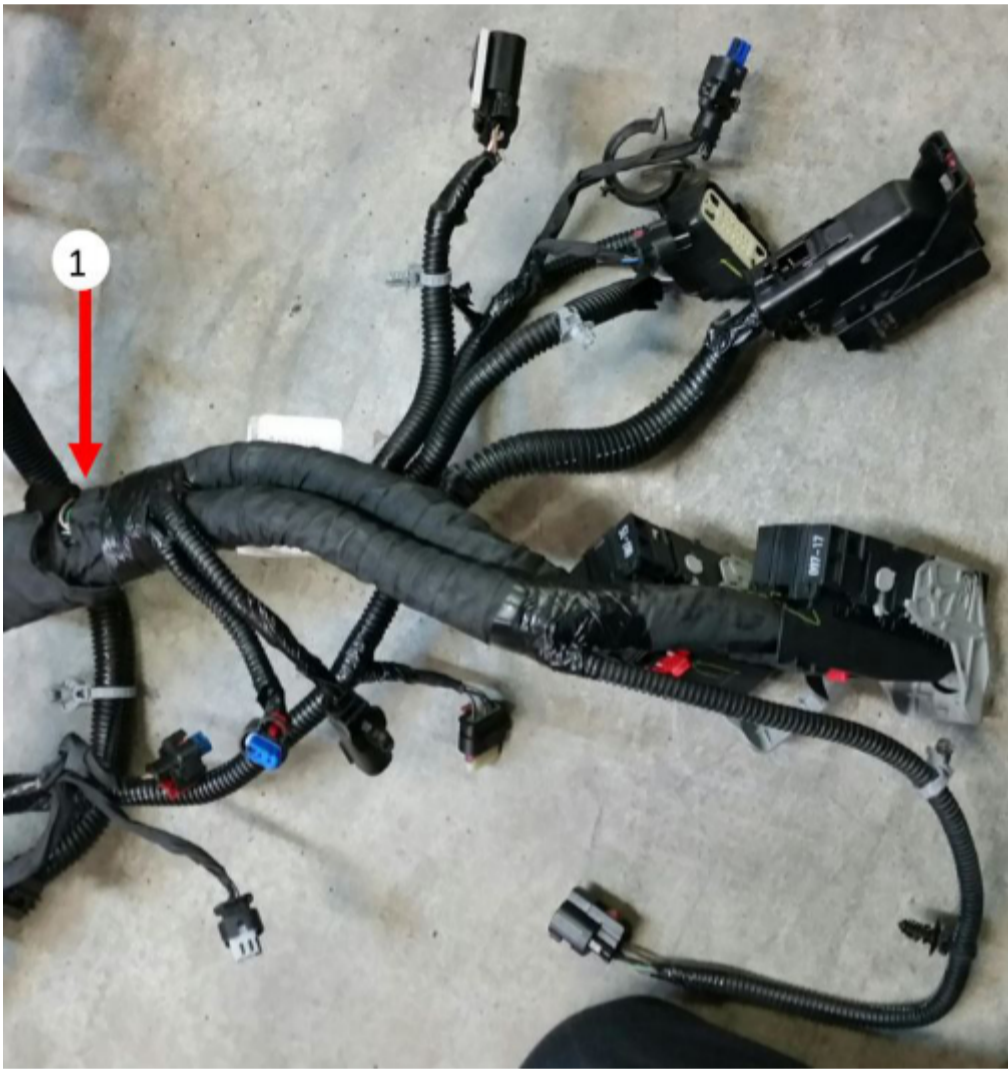
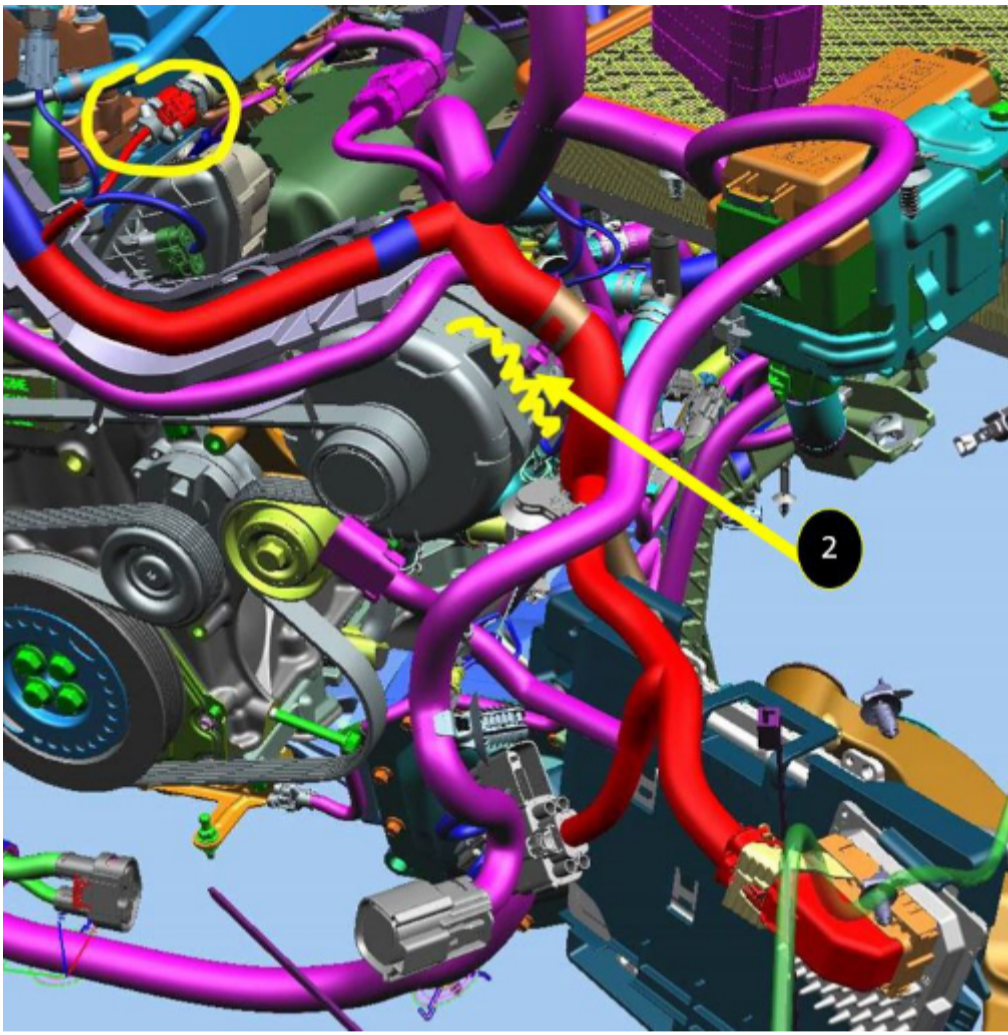
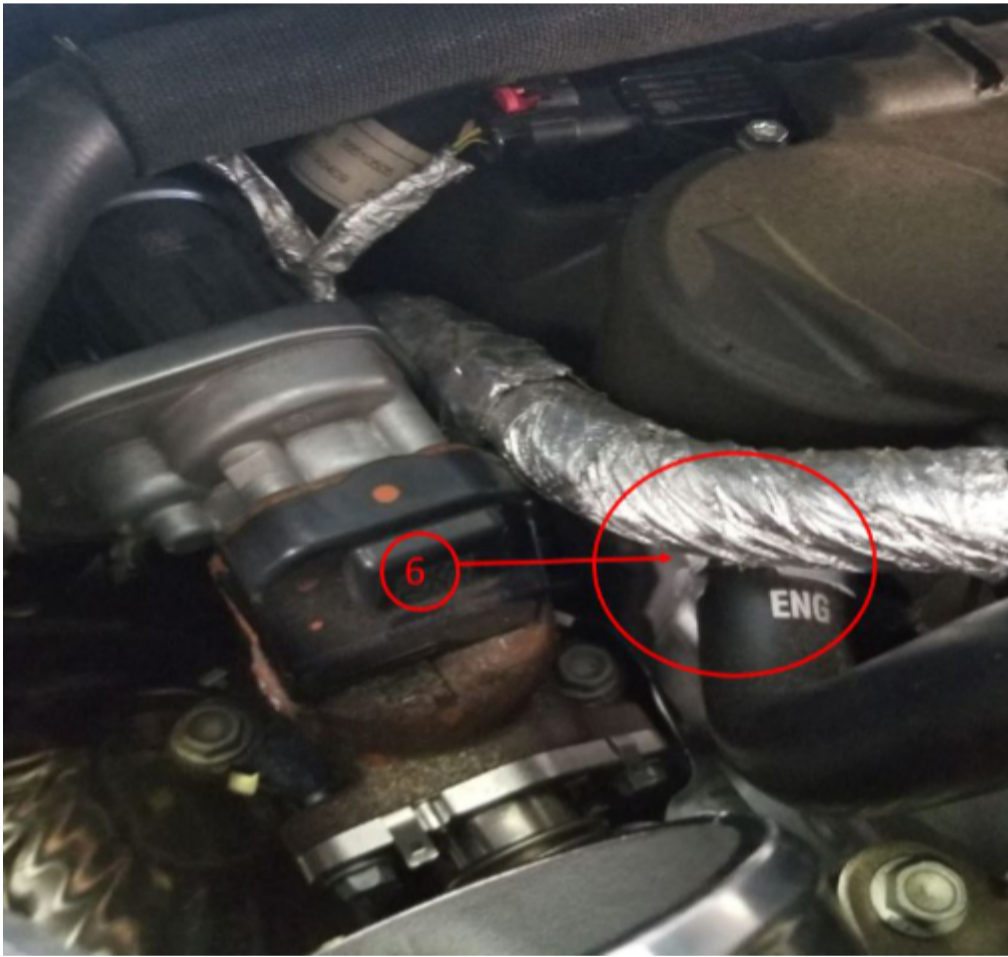
1. The engine harness pinched/shorted/chaffed at grid coordinates G-8, as shown below. This location is approximately 18 inches from the ECM connectors (1) and on top of the generator (2), as shown below. Due to the number of circuits in the harness, there is a wide variety of different symptoms that could occur, depending on which circuit(s) are damaged.
2. The engine harness shorted/chaffed at grid coordinates C-9, as shown below. The engine harness could be shorted out on the PVC hose clamp at the crankcase pressure regulator, as shown below (6). This is located approximately 4 inches from the crankcase sensor connector pigtail harness breakout.

In many cases, the ECM has been unnecessarily replaced for these concerns. Please thoroughly inspect the areas shown above and follow published SI diagnostics before any parts are replaced. If any concerns are found, then follow SI Wiring and Connector repair instructions to correct the concern.

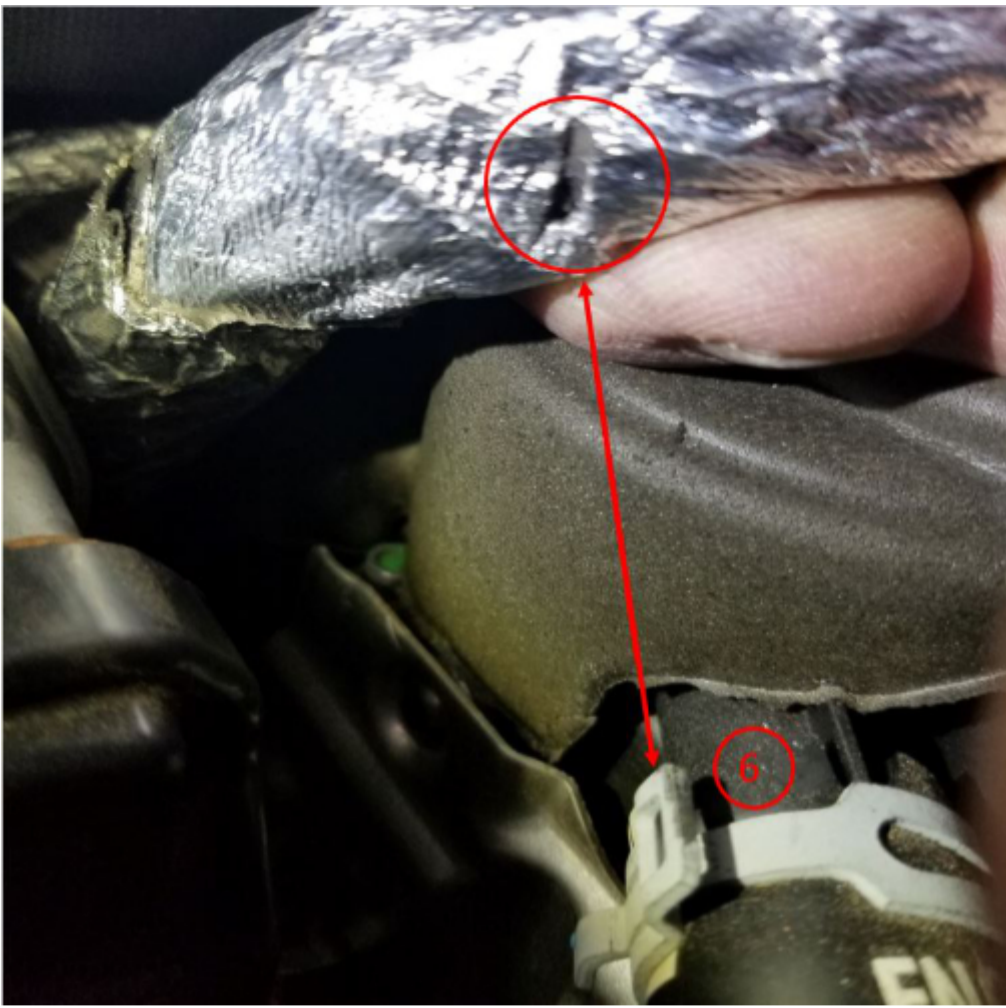
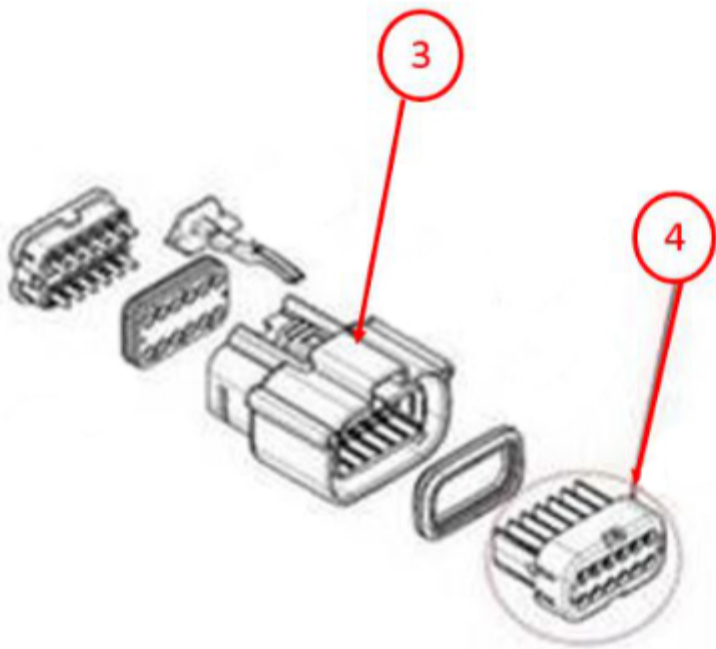
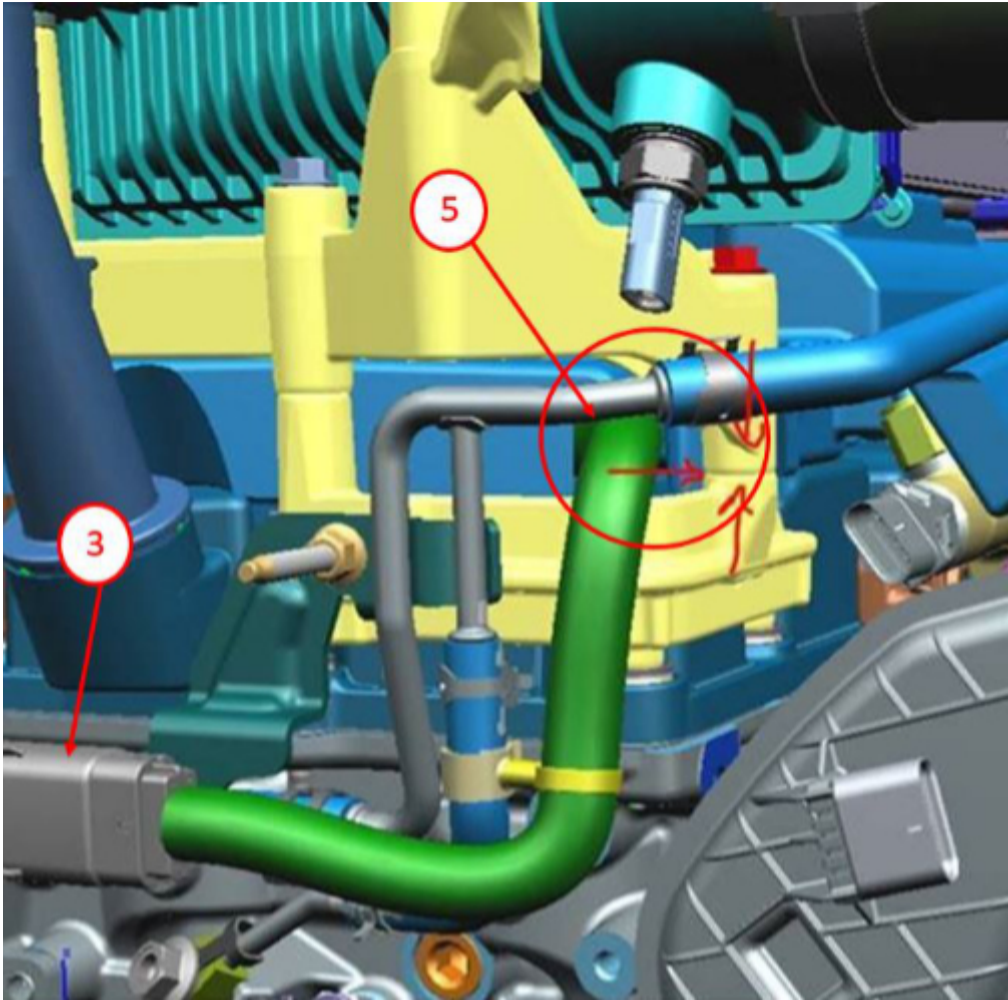
1. Inspect for poor terminal tension at connector X160, shown below as callout 25. While inspecting X160 make sure the terminal locking feature (4) is not missing.
2. Inspect the fuel injector connectors to make sure they are fully connected/seated.
3. Inspect the fuel injector wiring harness near the X160 connector (3) for being pinched/shorted/chaffed, as shown below (5).
