# Technical Service Bulletin

## 15 Oil leak from the cylinder head - 2.9 and 3.0TFSI only

15 21 37 2053278/6 February 16, 2021. Supersedes Technical Service Bulletin Group 15 number 21-36 dated January 29, 2021 for reasons listed below.

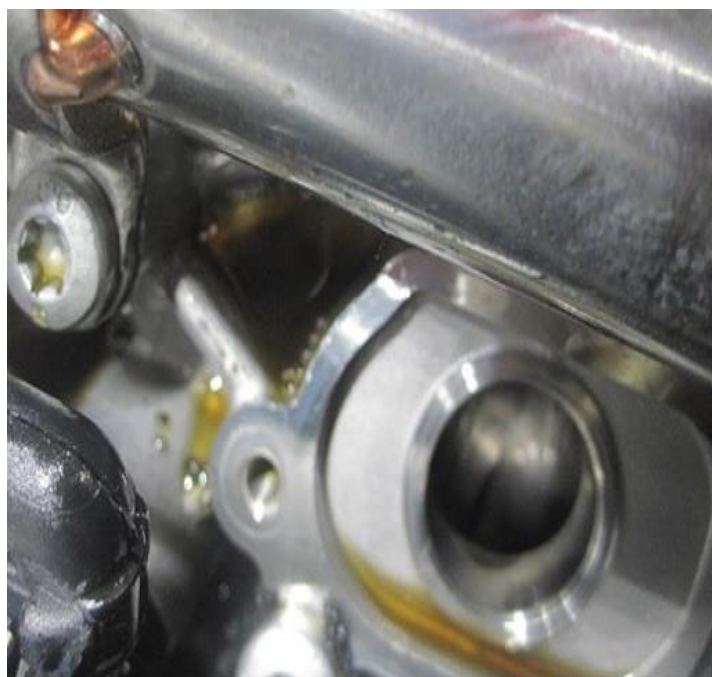
**A.** If there is a substantial quantity of oil below the Audi valvelift system actuator (illustration), the cause of the leak is the O ring of the Audi valvelift system actuator.

**Figure 2.** Oil in the Audi valve lift system.

Replace the Audi valvelift system actuator with an O ring, clean the engine compartment, and if necessary replace the noise insulation (if it is soaked in oil) (Figure 2).

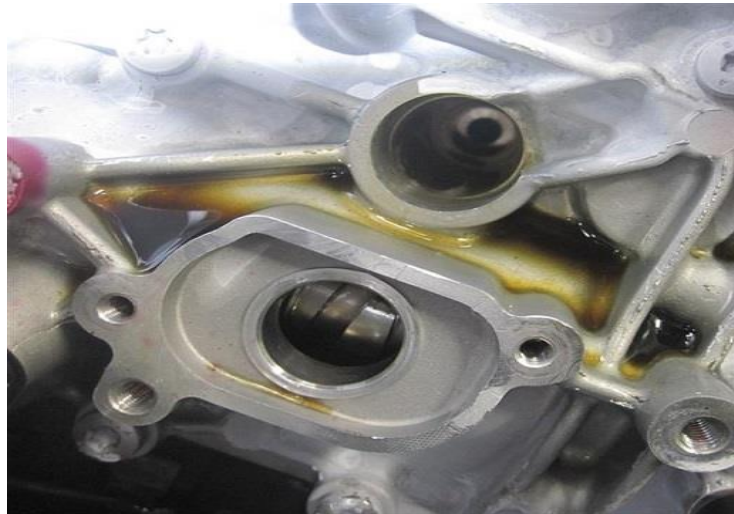
4. Remove the lower noise insulation.
5. Locate the affected cylinder. Oil should have gathered in the area of the injector (Figure 3) and the noise insulation should also be soaked in oil.

**Figure 3.** Locating the affected cylinder.

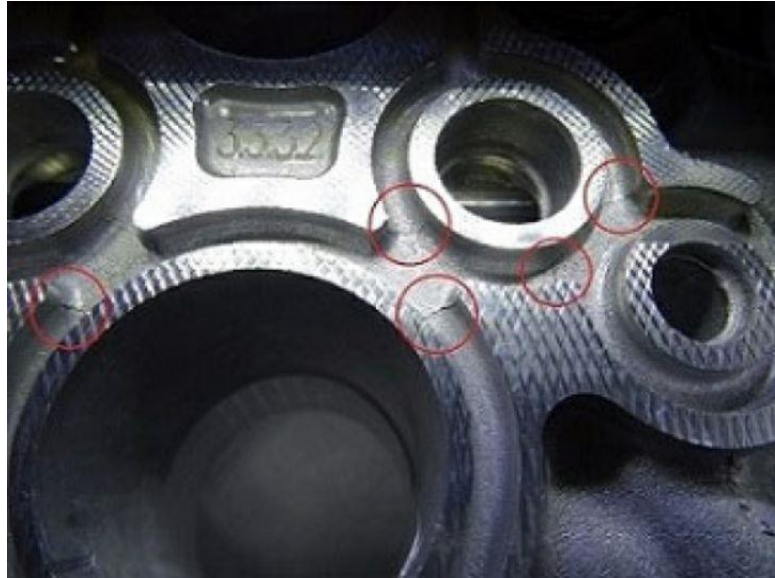
Metal shavings produced during manufacture in sealing groove between cylinder head cover and the cylinder head.

7. Inspect the gasket groove in the cylinder head cover and remove any casting residues with a suitable tool. (Figure 5). The residues can be removed with a small flat screwdriver (Figure 6).

*Figure 5. Before the repair.*

8. Install a new seal, re-assemble the camshaft cover, clean the engine compartment, and if necessary replace the noise insulation (if it is full of oil).

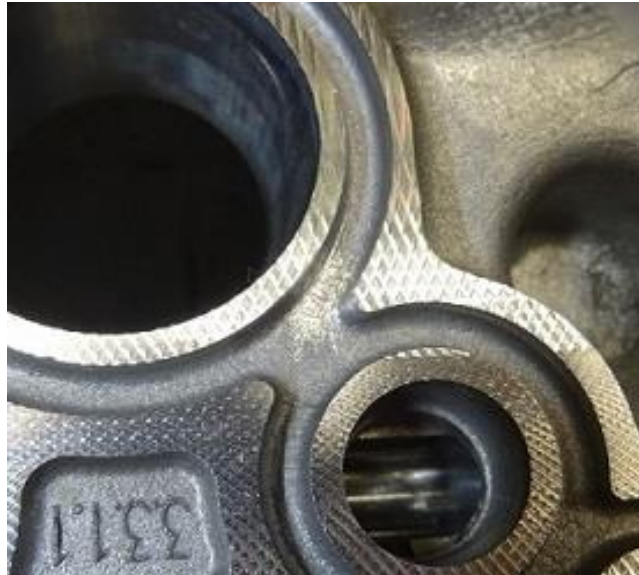
*Figure 6. After the repair.*
