Service Bulletin

Bulletin No.: 20-NA-199

Subject: Radio Software Version U150 Update

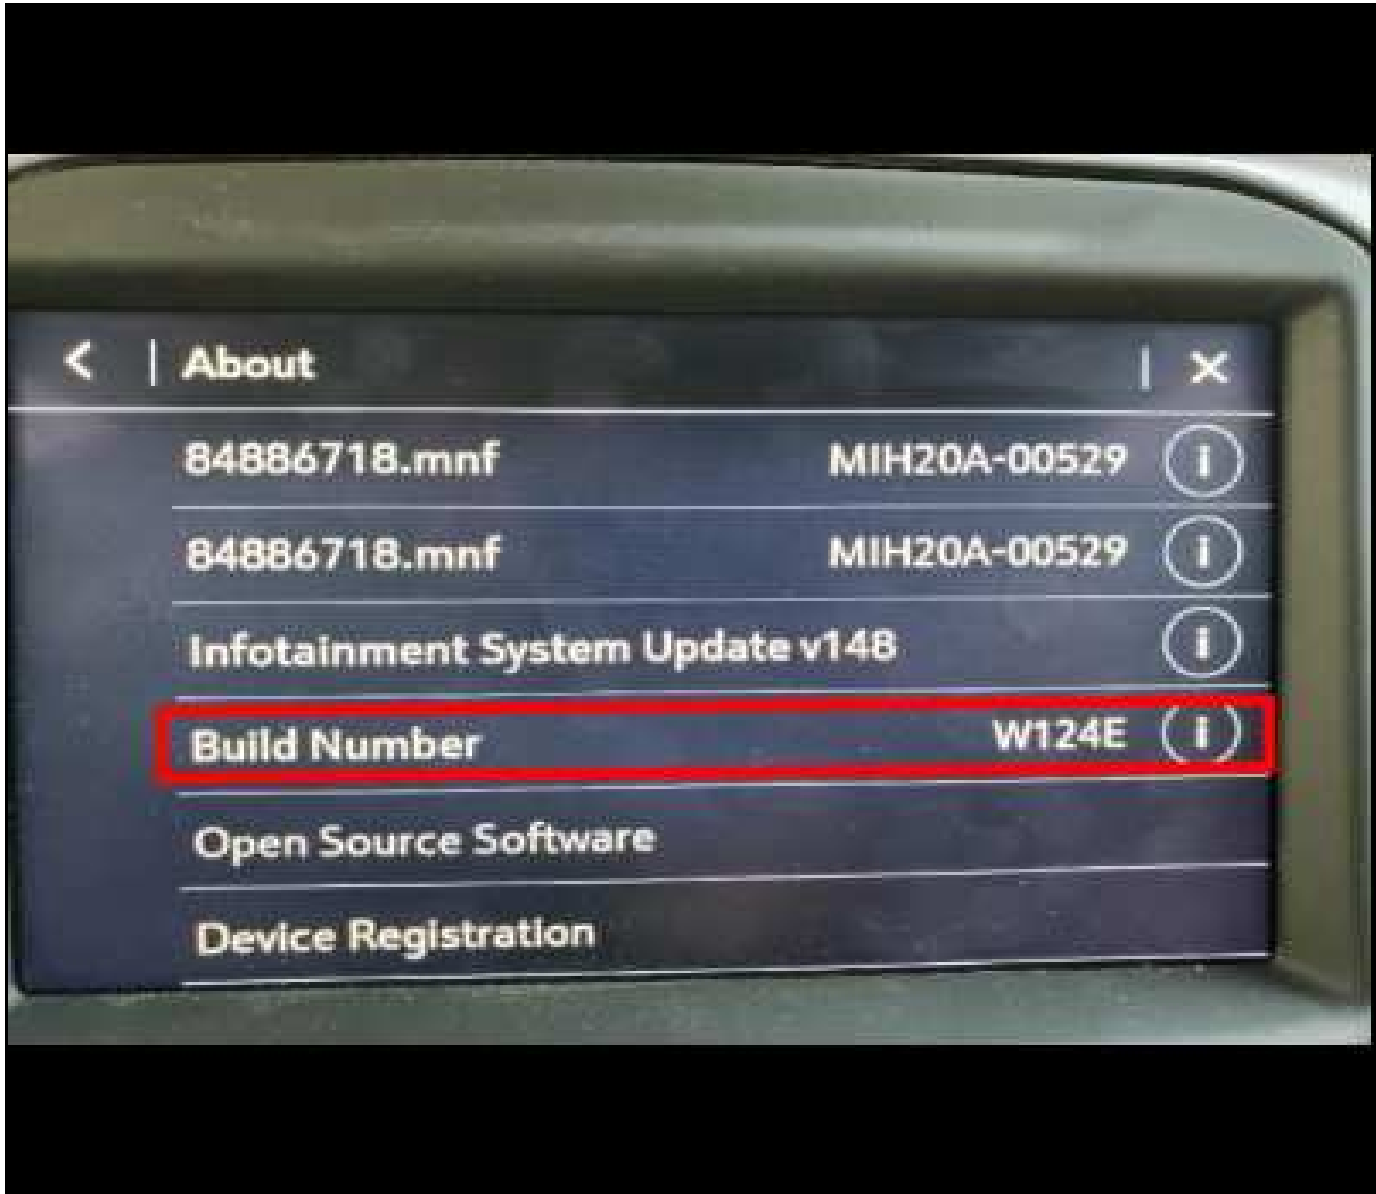
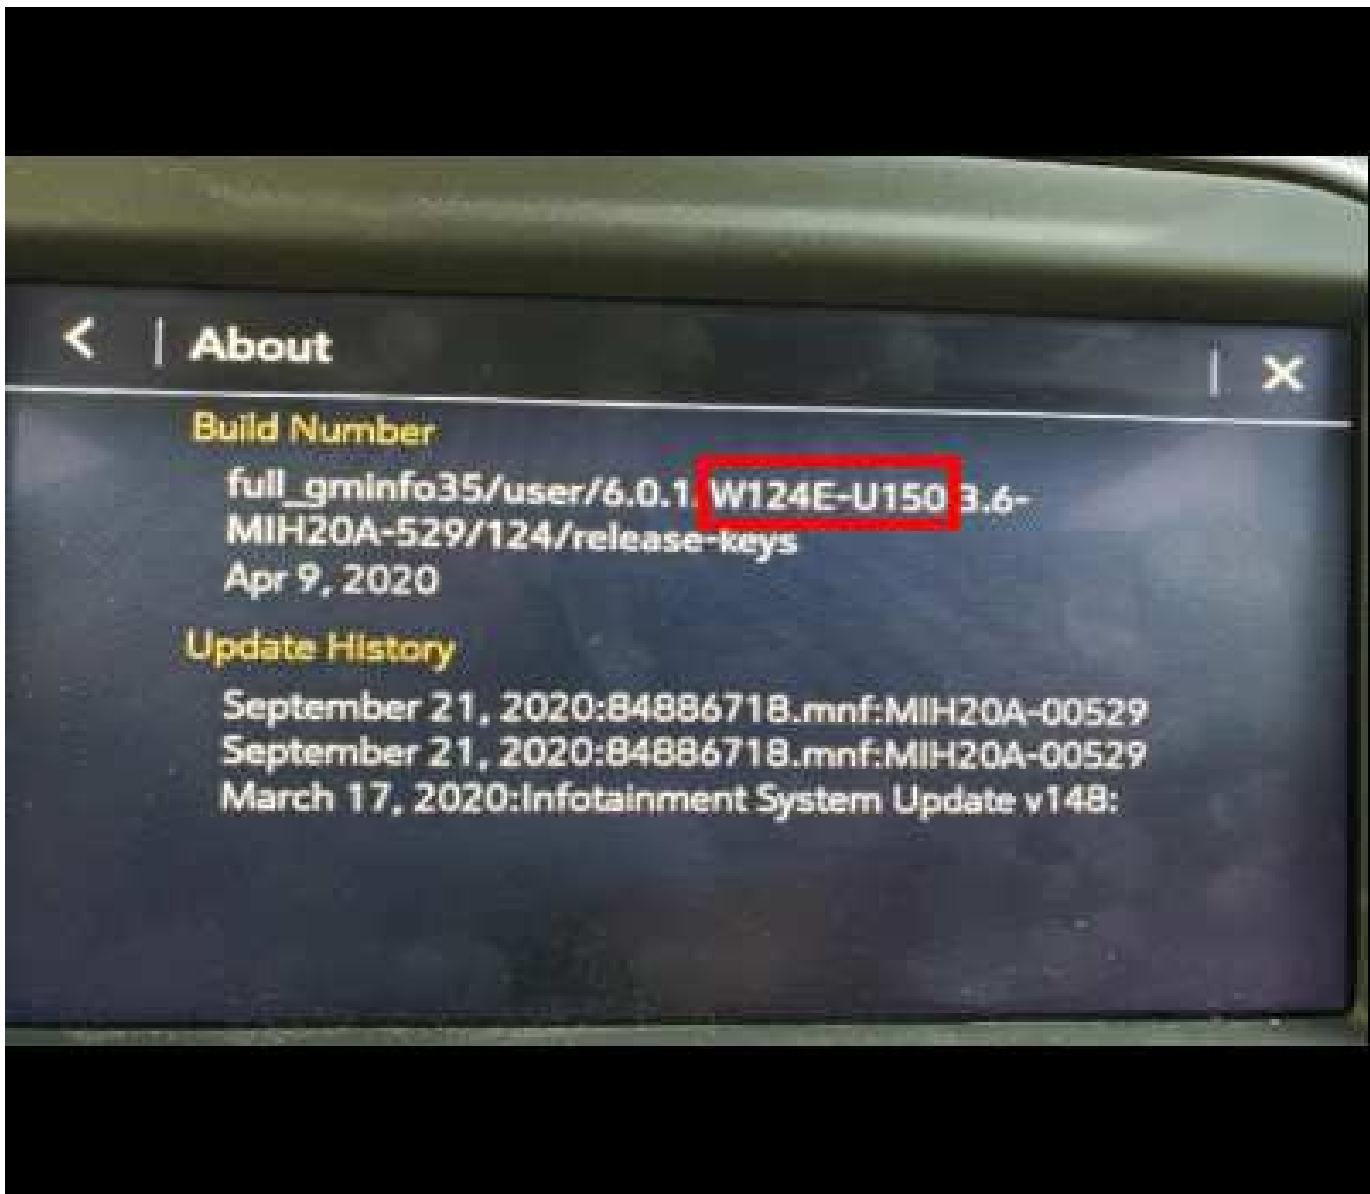
5662665

Important: Some technicians are reporting that the radio remains on v148 after the radio displays the software update completed successfully. It is important to ensure that the technician is inspecting the **Build Number** and not other rows of information on the same screen. This requires the user to locate the Build Number, and then select the Information icon (circled

lower-case i) to see the full software version file name. In these radios, the build number could be W124E after installing U150. This W124E is NOT the software version and is not unique to the U150 software release.

Important: After pressing the information icon, review the full software version file name. In the middle of this long file name you see the U150.3.

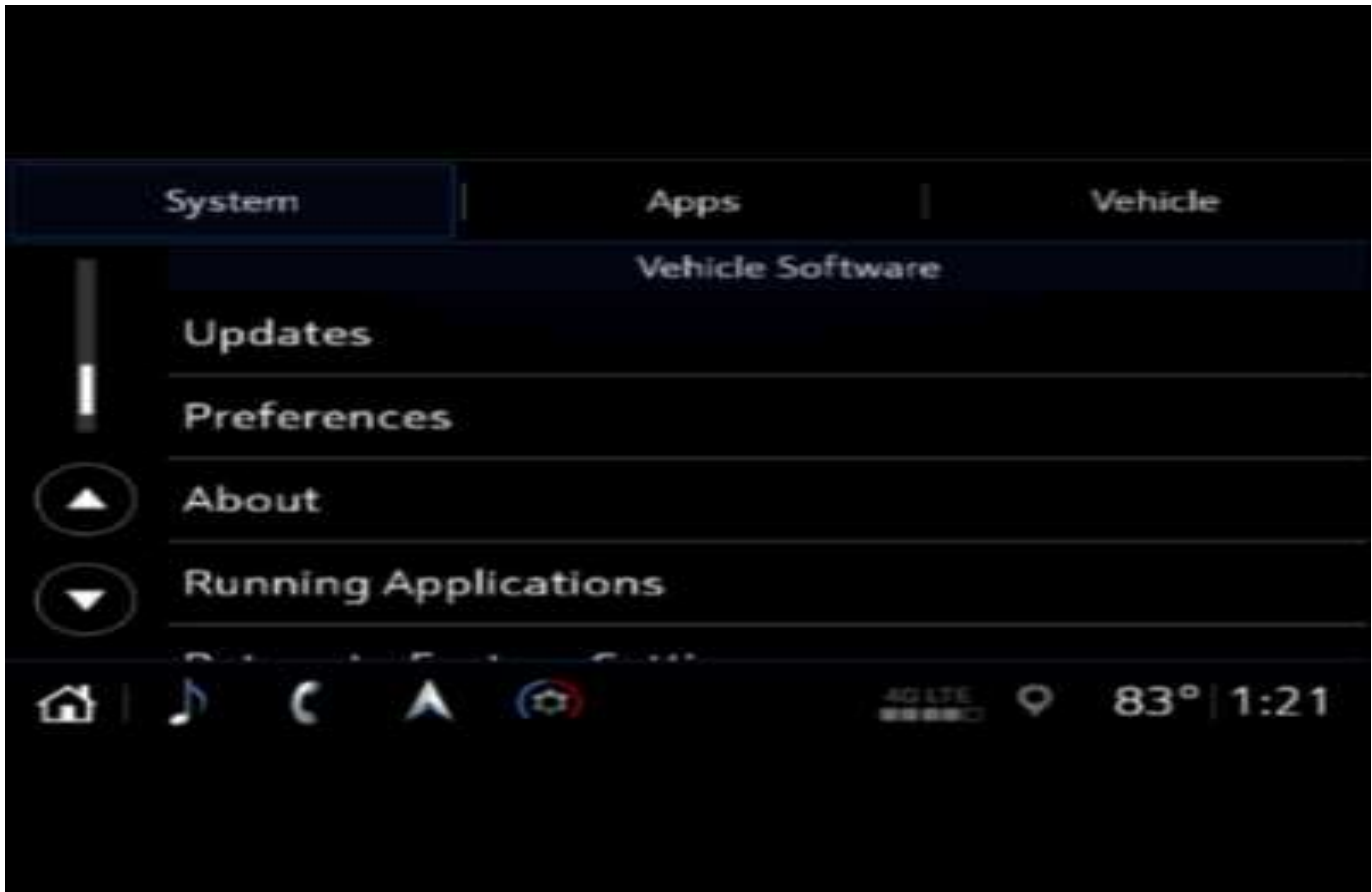
5651942

- If an update is shown under the “Updates” screen, proceed to the **Update Procedure Using Remote Vehicle Update** section of this document.

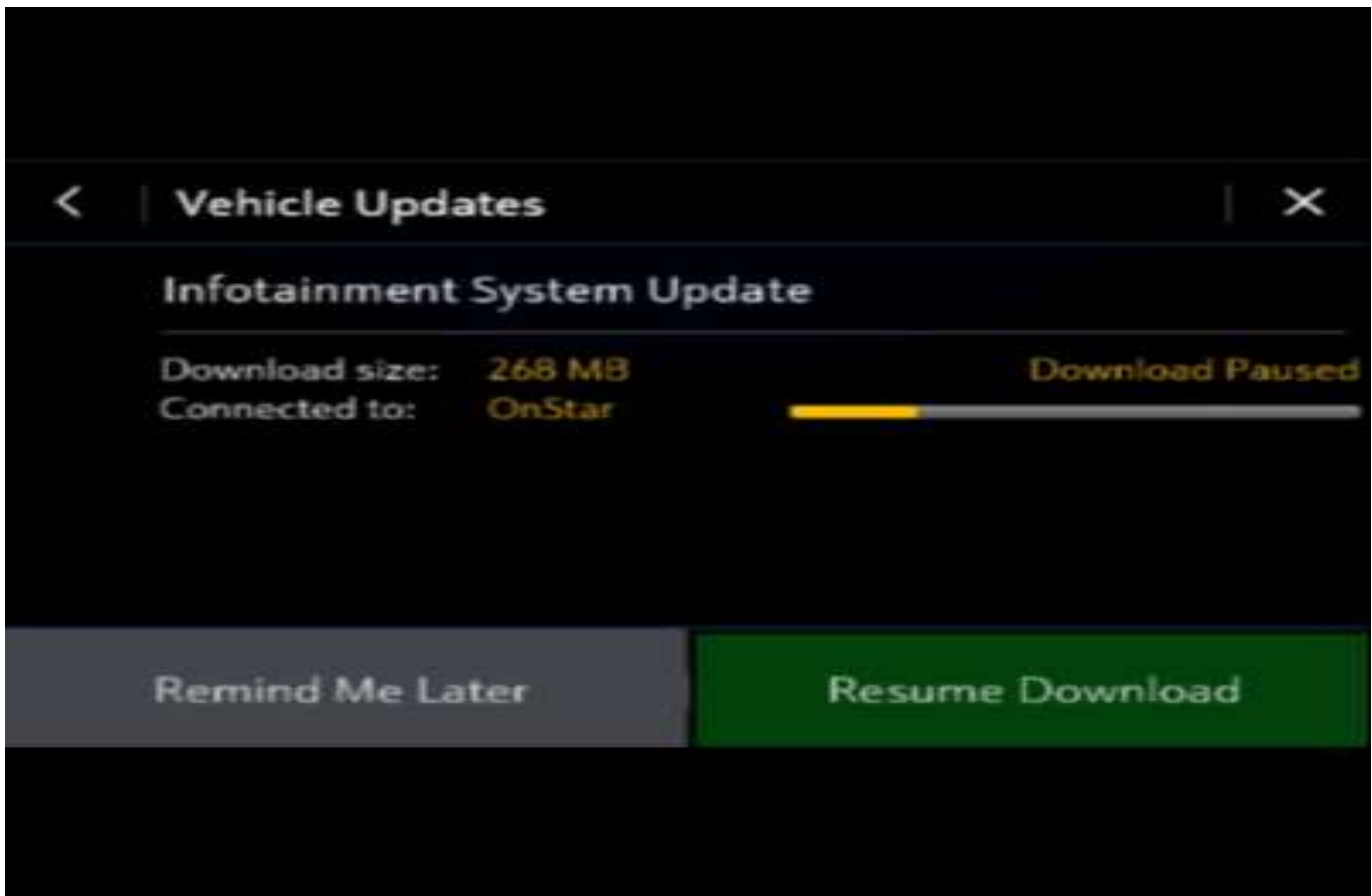
5651943

Caution: If Vehicle Update screen shows “Infotainment System Update” (such as the screen above), do not use TIS2WEB or insert a USB stick. Use of the USB stick when the Remote Update has already been downloaded, installed, or paused during installation could result in program failures or module lockup condition. The update should be completed using the Remote Vehicle Update procedure, following prompts on the infotainment screen. Refer to Update Procedure Using Remote Vehicle Update after reading the remaining information in this section if the Remote Update has already been downloaded to the radio.

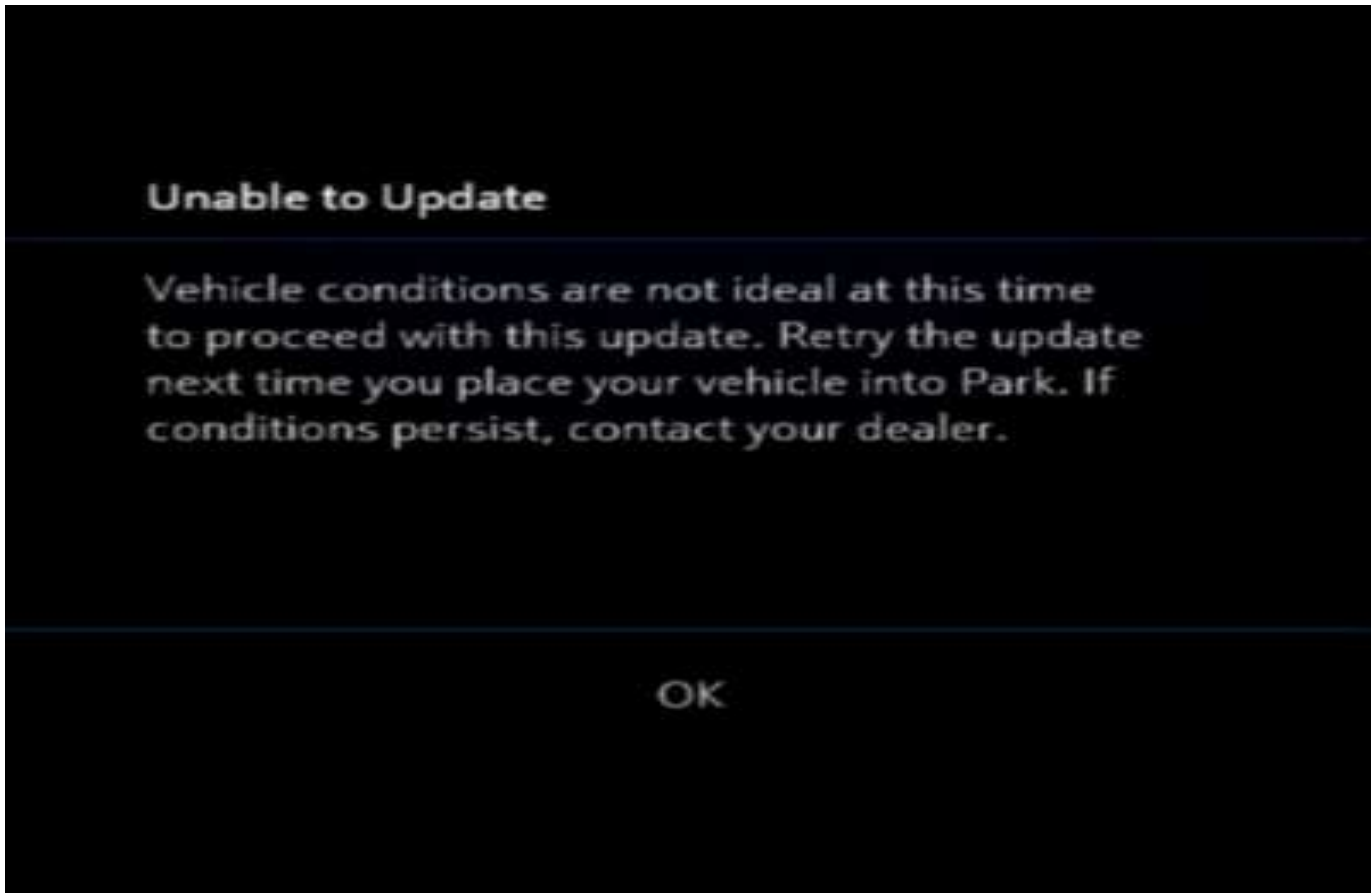
5651949

Scenario 1: Vehicle conditions are not ideal.

If the above screen is shown, download the update through TIS2Web and perform USB update. Upon USB insertion while vehicle is running, the "Install Now" pop up will be presented. Ensure the vehicle battery is being maintained (using EL-49642 or battery maintainer) while performing this update.

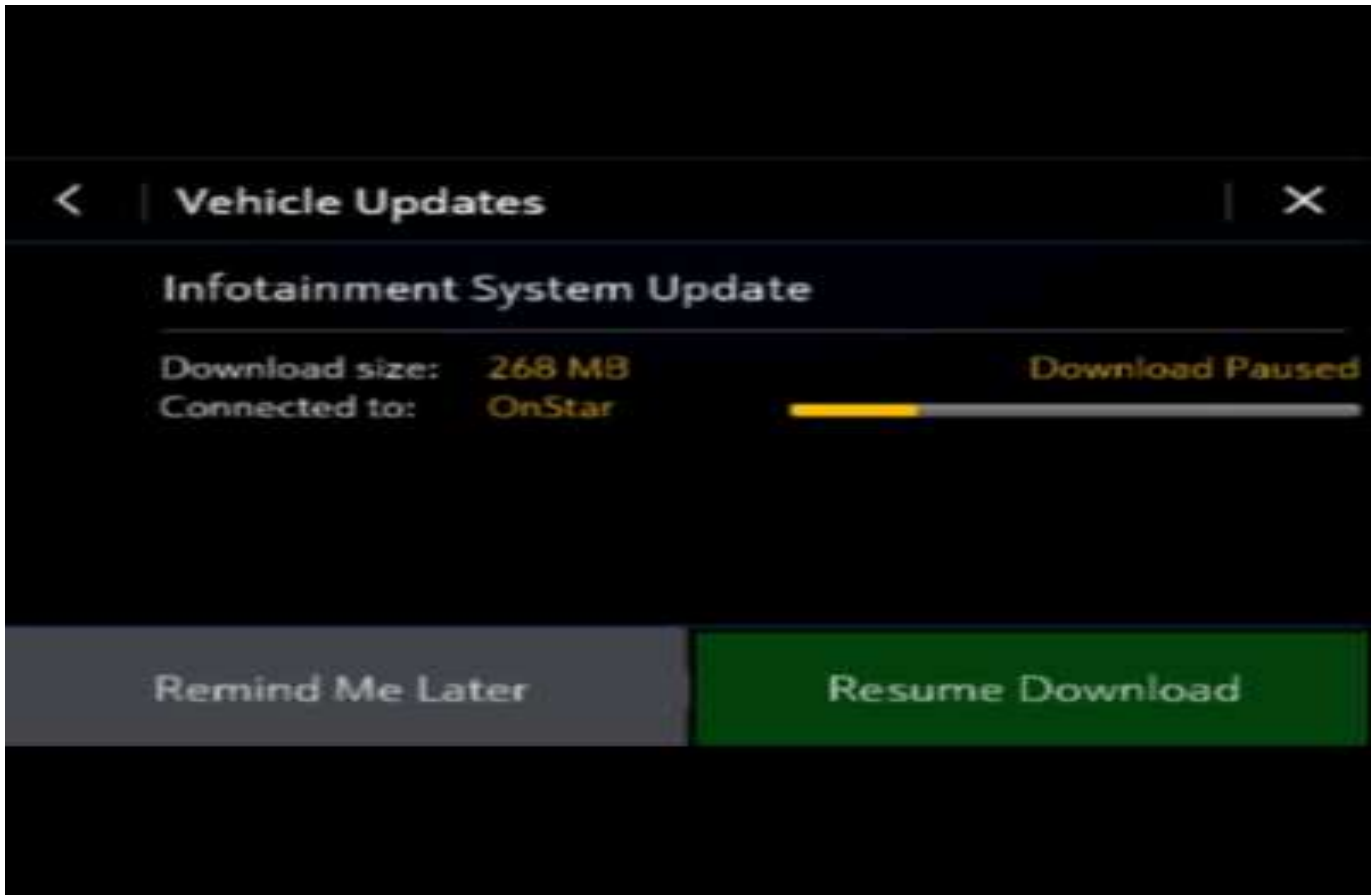
5651943

Scenario 2: Consistently Paused Download

If the above screen is shown and resuming the download repeatedly fails, a USB update will need to be performed. Turn the vehicle on, return to the home screen, and insert USB stick (see previous section). A pop up should be shown to "Install Now." Click "Install Now", verify the part number is correct and follow on screen prompts.

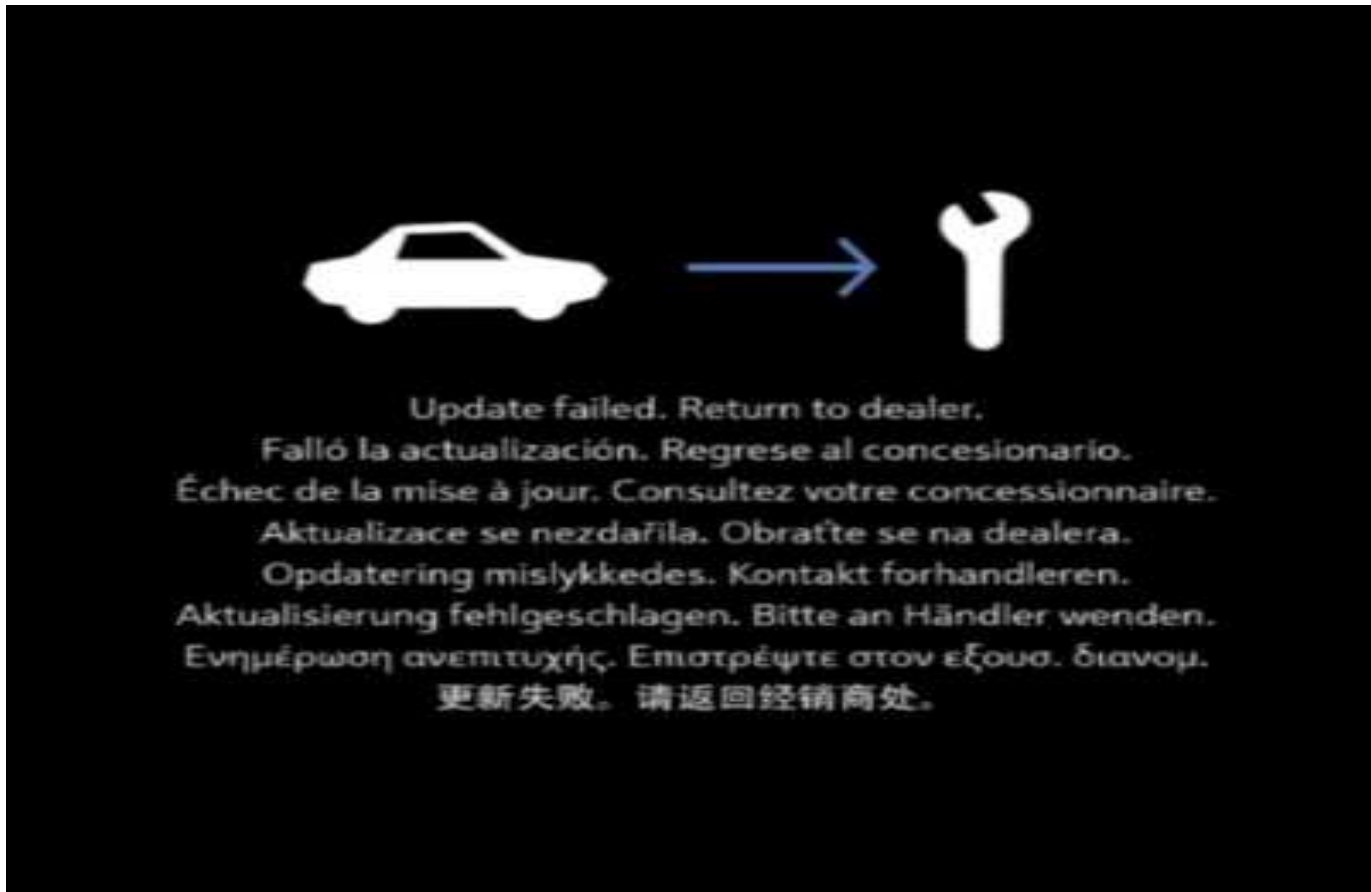
5651950

Scenario 3: Update failed. Return to dealer screen.

1. If the above screen is shown, download the update through TIS2Web and insert USB stick into the radio *twice* (USB stick is not recognized on first insertion). A blue progress bar should come on the screen and update will proceed. If this screen above is shown when trying to update the radio through USB, reformat to FAT32 on your PC, and then try to download the update through TIS2WEB again.

2. After selecting USB File Transfer, if you are prompted by TIS2Web to select a software P/N, then follow the on-screen instruction to attempt to gather the software P/N from the A11 Radio using GDS2 scan tool. If GDS2 indicates the radio is not communicating, go back to TIS2Web, select A11 Radio, and select when radio displays “*Update failed. Return to dealer.*” to complete the USB File Transfer programming event.

3. If the screen above is shown again, contact Technical Assistance (TAC) for further assistance.
