# Service Bulletin

Bulletin No.: 20-NA-237

**Subject: Radio Software Version V152 Update**

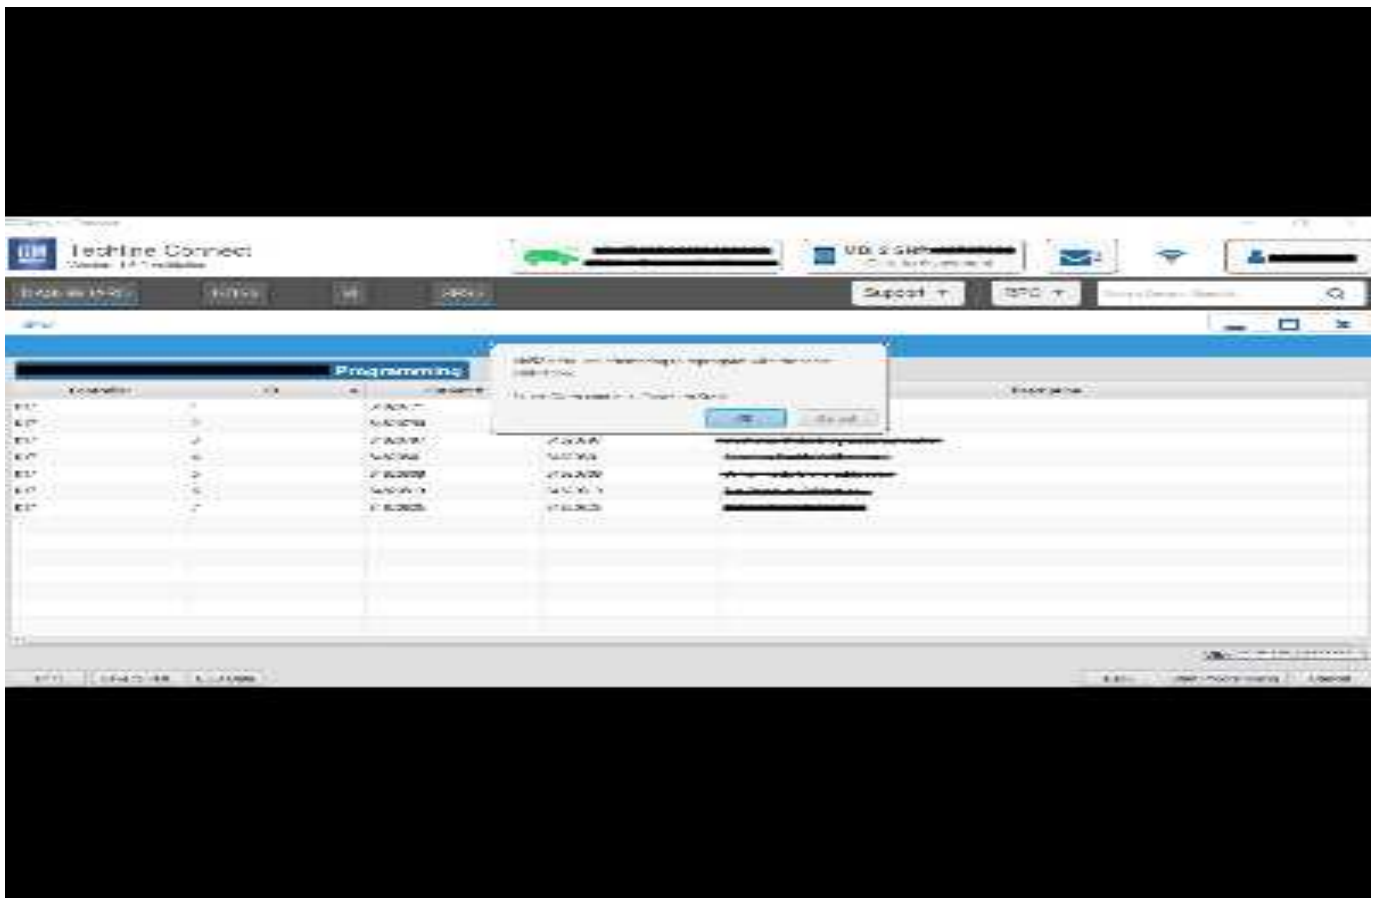
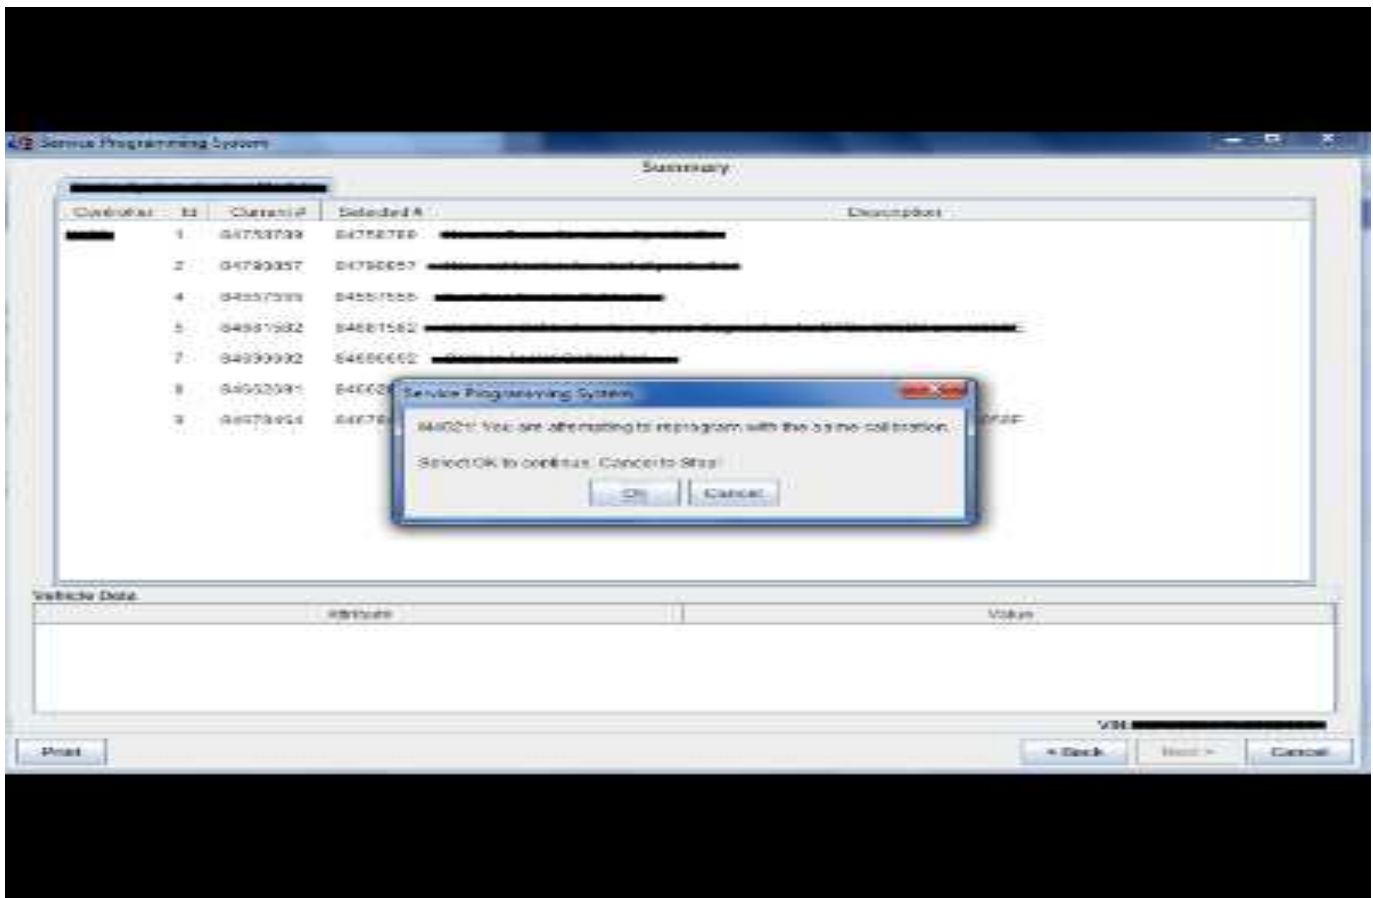
**Important:** Techline Connect and TIS2WEB screens shown above.

**Important:** If the Same Calibration/Software Warning is noted on the TLC or SPS Summary screen, select OK and follow on-screen instructions. The system will generate a warranty claim code (WCC) for documentation purposes only. Perform service information (SI) diagnostics to determine the cause of the condition. Use the applicable labor operation code when submitting a warranty claim. Do NOT use the WCC with the warranty claim submission.

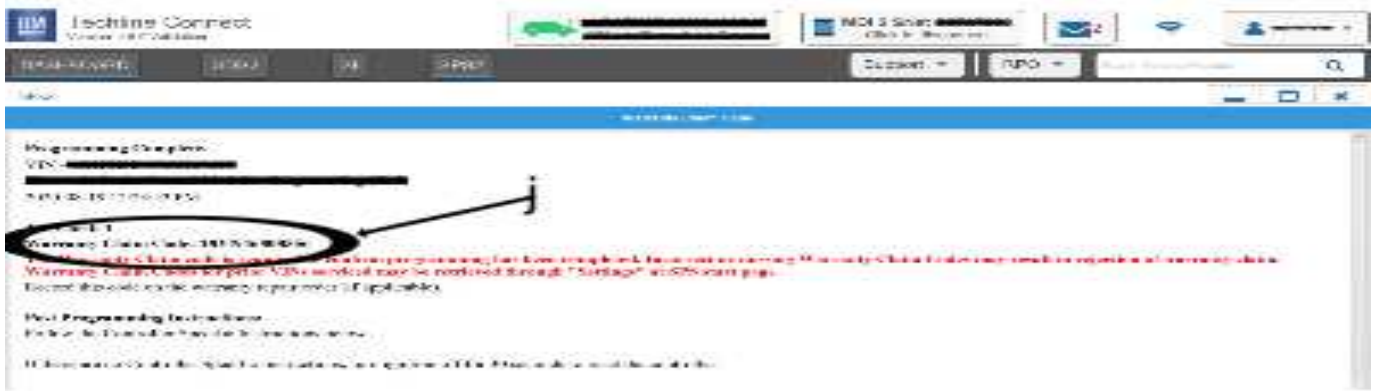
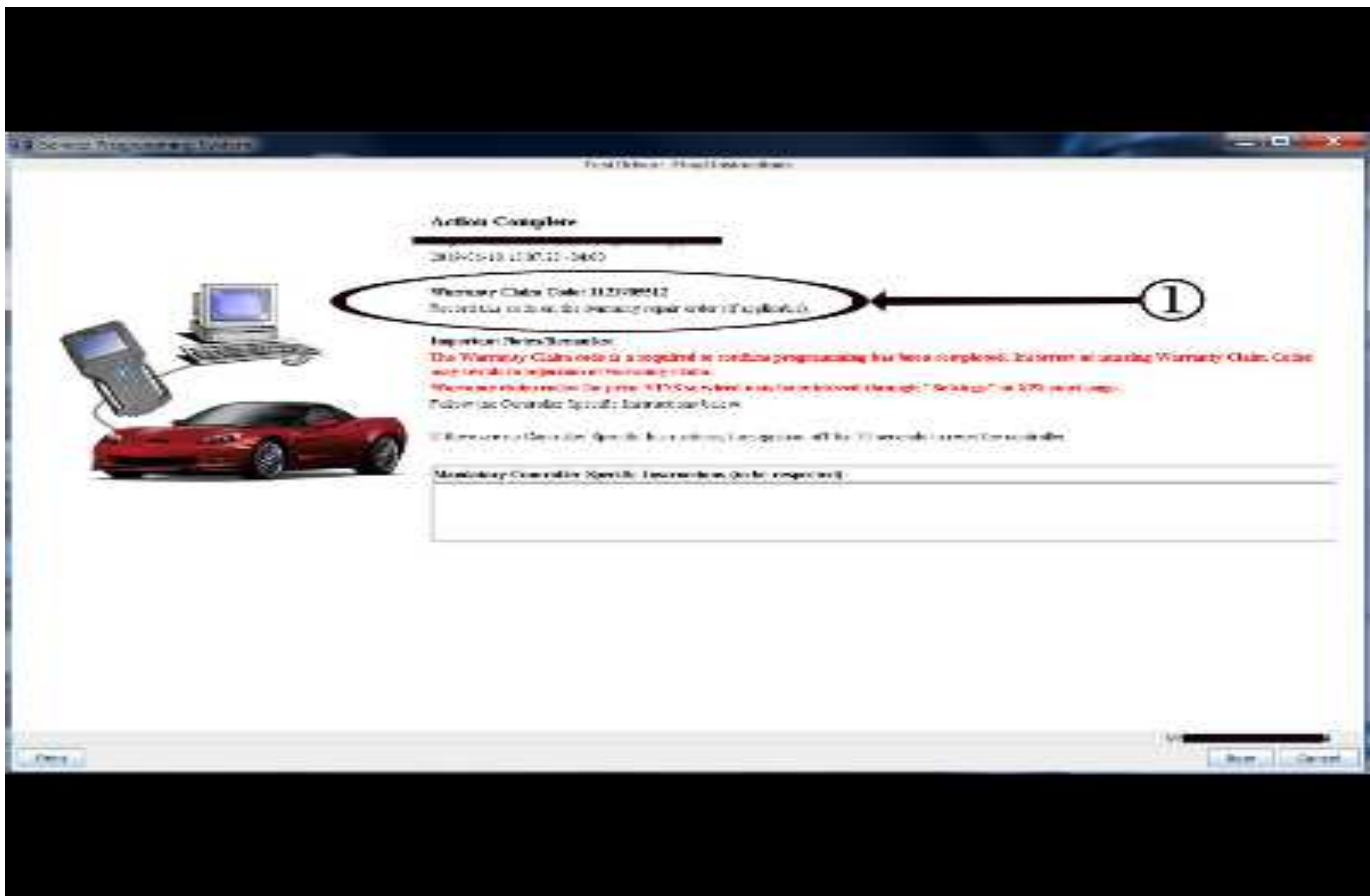
**Note:** The screenshots above are an example of module programming and may not be indicative of the specific module that is being programmed. Module selection and VIN information have been blacked out.

**Important:** To avoid warranty transaction rejections, you **MUST** record the warranty claim code provided on the SPS Warranty Claim Code (WCC) screen shown above on the job card. Refer to callout 1 above for the location of the WCC on the SPS screen.

- Record the SPS Warranty Claim Code on the job card for warranty transaction submission.
