# Aftersales TSO – Diagnostic Sheet

## MAS002453 (BOL 21-01)

### Difficulty opening the doors

**Models:** M156, M57 and M161 from MY18 and later vehicles equipped with "Soft Door Close" (OPT 228, 228+)

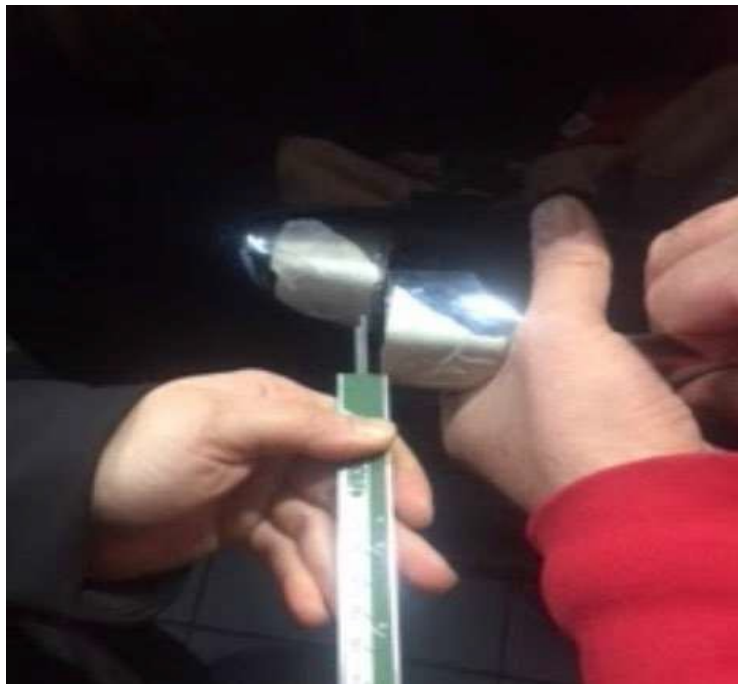
3) Perform the door handle stroke measurement following the below procedure:

- Slowly pull the handle until the door is unlocked
- Measure the stroke with a caliper, as shown in the following image
