Campaign No. 2021010005, January 2021

SUBJECT: **Model 907 (Sprinter), Model Year 2019**  
Engine Hood & Headlamp Adjusters

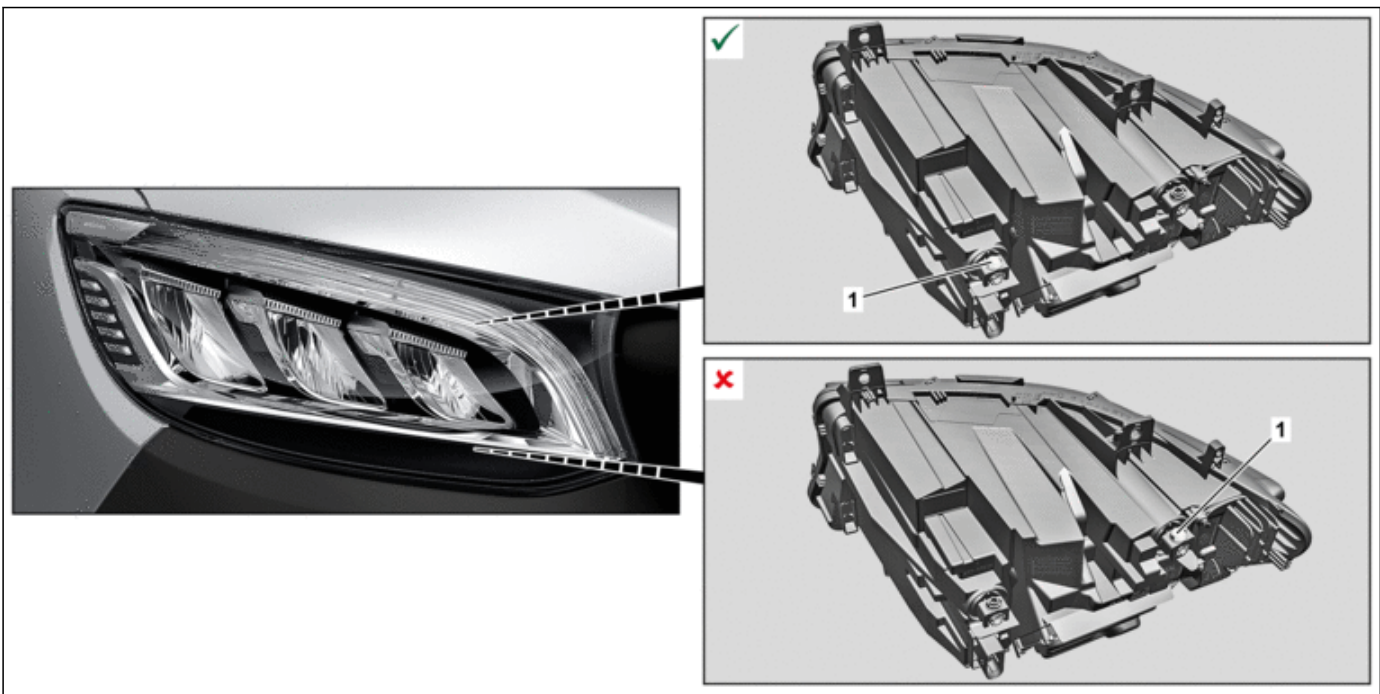
D88.40-A003-79

**Shown on right LED high-performance headlamp**

1 Cover cap

For authorized Mercedes-Benz service partners, only the entry in the Extended VEGA Application (EVA) system, in the "Current" tab, is decisive. An additional test of the affected vehicles in the workshop information system (WIS) or vehicle list is thereby not necessary.	
2	Check installation position of cover cap (1) on headlamps at left and right.	If respective cover cap (1) is correctly installed on headlamps, ↓ continue with operation step 4. If respective cover cap (1) is not correctly installed on headlamps, ↓ remove affected cover cap (1) from adjustment screw for vertical adjustment of headlamp and attach to adjustment screw for horizontal headlamp adjustment (see picture for correct installation position). If the respective cover cap (1) on the headlamps is missing, ↓ attach new cover cap (1) to adjustment screw for horizontal adjustment of headlamp (see picture for correct installation position).

Replace engine hood.		AR88.40-D-3000TS

Check/correct position of headlamps.		AR82.10-D-1131TS
