Technical Service Bulletin

97 Wire harness repairs and documentation

97 21 78 2061976/1 February 18, 2021.

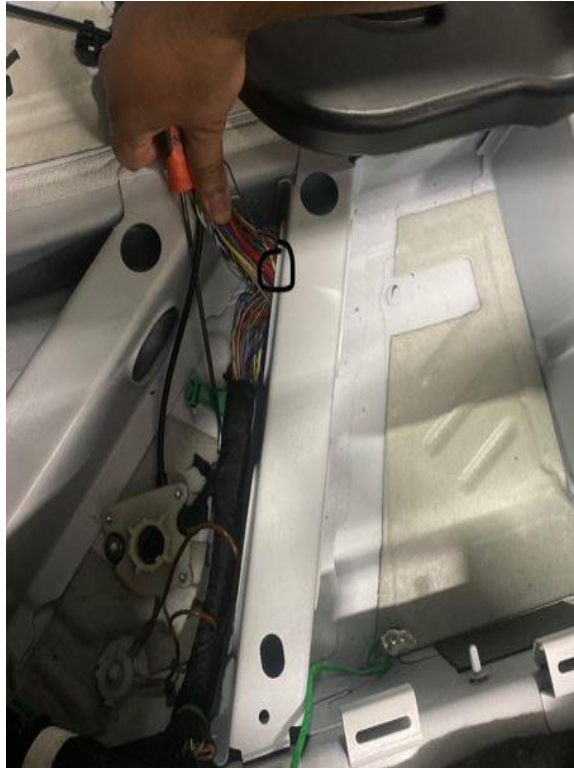
Example: Flexray circuit measured .6 ohm to ground with no components connected to the circuit. Short circuit to ground present on the green FlexRay wire between J743 Dual Clutch T23/1 and J533 Data Bus on Board Diagnostic Interface T54/27. Located damaged wire section underneath the driver seat along the frame rail.

Using the description in the example above, the root cause can be clearly identified in Figure 1.

Figure 1. A perspective view showing the area along the frame rail.

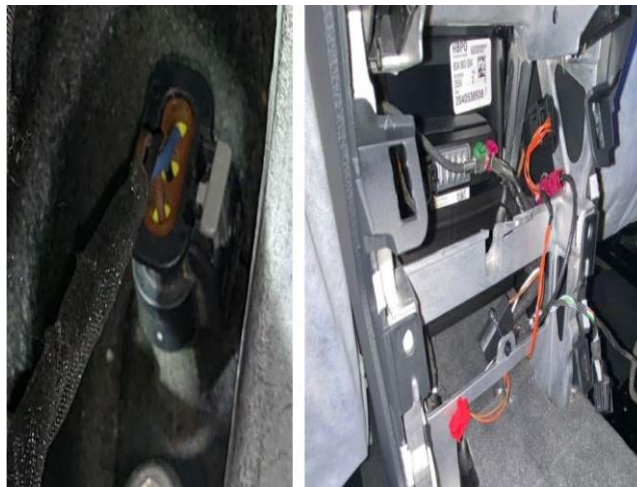
When a harness routing is determined to be the root cause, a photo should be taken to show how the harness was routed in its normal state (Figure 2).

Figure 2. G28 crank sensor harness tight (left), Q5 Wireless charging pad harness tight (right).

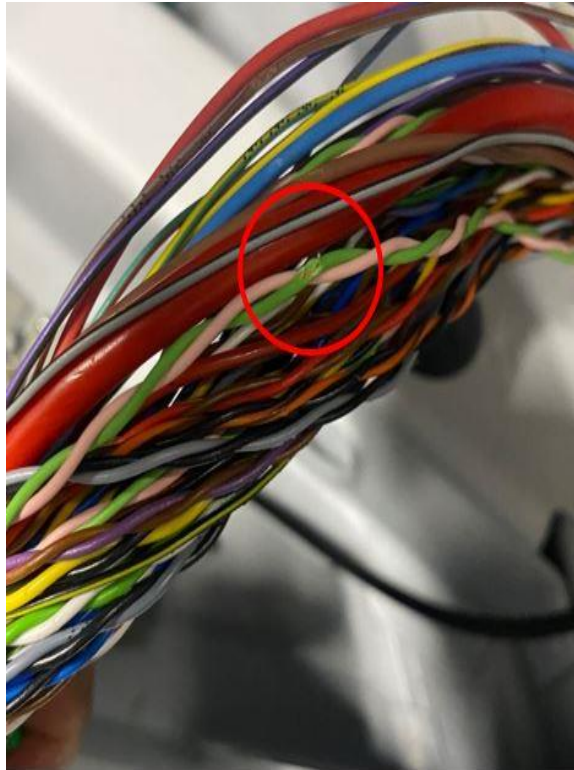
Using the description in the example above, the damage to the FlexRay wire is clearly visible in Figure 3.

Figure 3. Close-up of the damaged wire.

- Overlays may be used for diagnosis.
- Retain the affected section of wire that was removed/faulty.
- Repair faulty sections of the wire using VAS1978B.
