39-20-01 - Bevel Box Case Half Leak

Release date: 2/16/2021

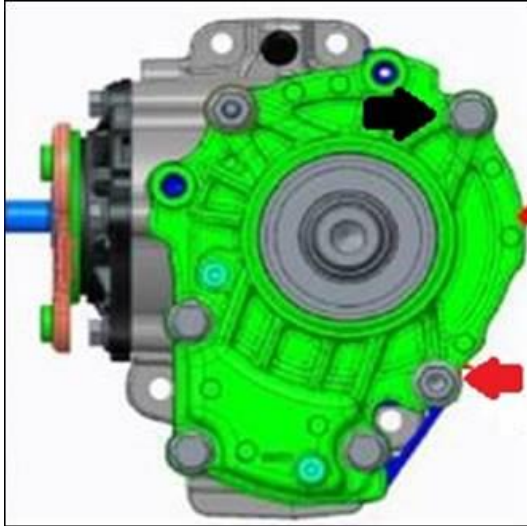
Figure 2.

Source of leak is between the case halves at the right side of the bevel box between the two bolts seen in Figure 2 (red and black arrows).

If the bevel box leak is confirmed to be from between the case halves, perform the following steps:
