Technical Service Bulletin

48 Electric steering column adjustment not working

48 21 93 2062288/1 February 25, 2021.

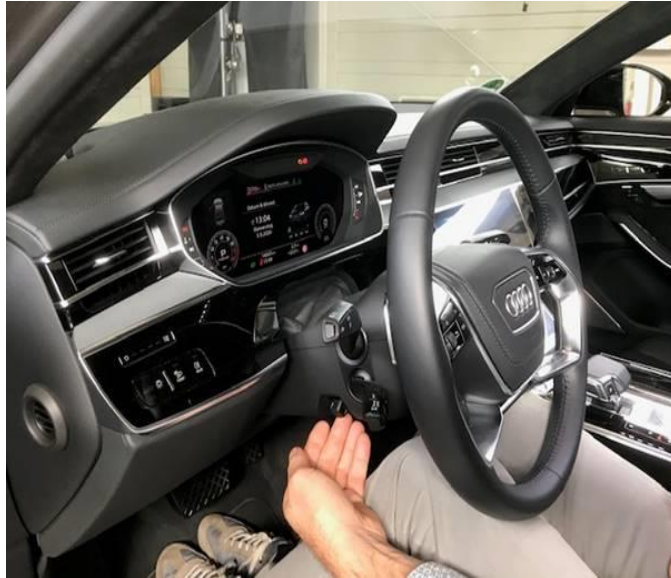
Figure 1. 40 kg force pushing steering wheel upward.

Get into the vehicle and use your knees to push the steering wheel upward (a force of approx. 40 kg or 88 lbs is required), at the same time press the steering column adjustment switch upwards in the vertical adjustment direction (Figure 1).

This will restore the function of the electric steering column adjustment.

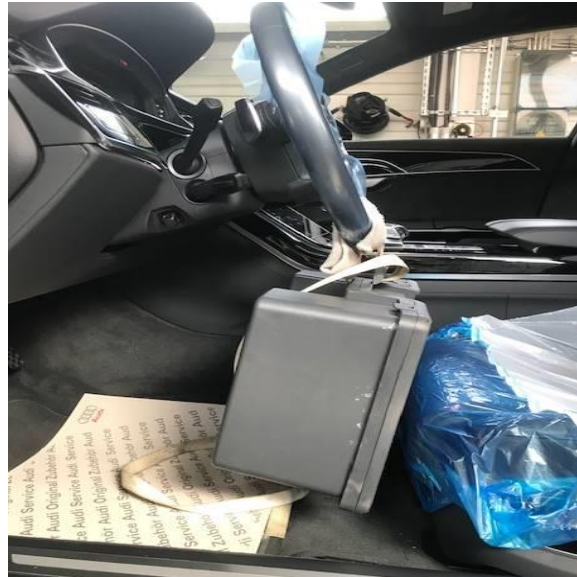
Figure 2. Weight necessary for steering adjustment.

6. Attach the tool kit to the steering wheel using a small securing strap (Figure 2). Take care not to damage the steering wheel.

We recommend placing a cleaning cloth underneath, as shown in Figure 2.

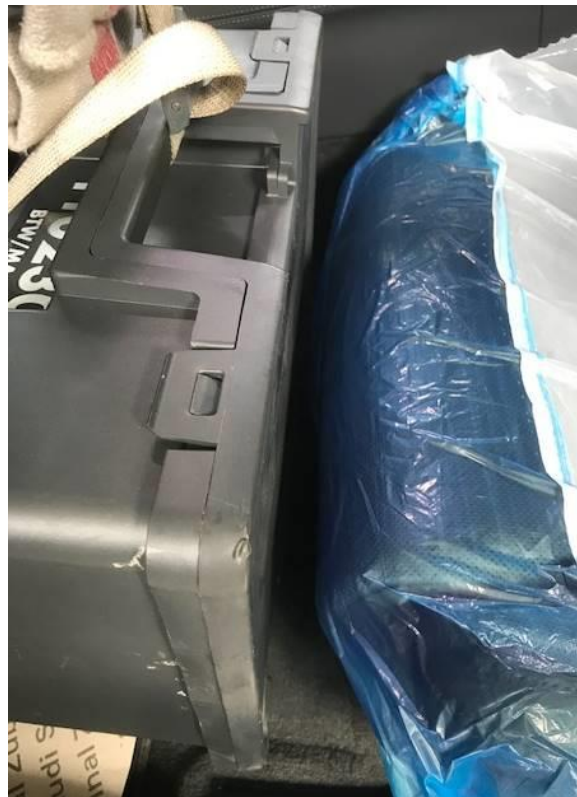
Figure 3. Plastic foil protection for the seat.

7. Apply plastic foil to make sure the tool kit cannot scrape against the seat (Figure 3).

- Then operate the steering column adjustment and move the steering column all the way up and down again up to 50 times. The weight of the tool kit will create a current in the adjustment motor and this will clear the adjustment unit.
