# Technical Service Bulletin

## 72 Rear backrest release in the luggage compartment is inoperative

72 21 33 2062113/2 February 25, 2021. Supersedes Technical Service Bulletin Group 72 number 21-32 dated February 3, 2021 for reasons listed below.

Model(s)	Year	VIN Range	Vehicle-Specific Equipment
A4 allroad	2017 - 2021	All	Not Applicable
A5	2018 - 2021	All	Not Applicable
RS 5	2019, 2021	All	Not Applicable

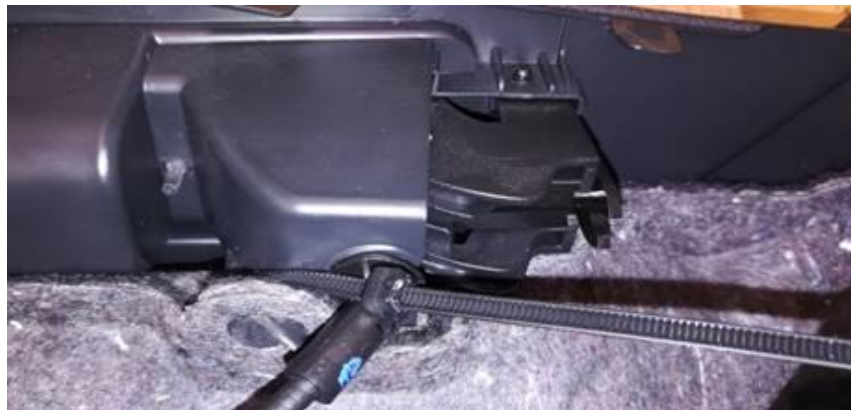
*Figure 2. The Bowden cable reinstalled and secured with tie wrap.*

2. Remove the luggage compartment side trim of the affected side according to the repair manual in Elsa.
3. Inspect the Bowden cable and the backrest release mechanism for any damage.
4. Reinstall the Bowden cable in the backrest release mechanism and secure it with a tie wrap (Figure 2).

5. Check the operation of both backrest release levers in the luggage compartment.
6. Reinstall the luggage compartment side trim.
