**NUMBER:** 23-038-20

Active Head Restraint (AHR) Inadvertent Deployment - X91 Warranty Extension

This bulletin involves inspecting the sled bracket striker pin and possibly replacing a front seat AHR that has inadvertently deployed.

2010	(JC)	Dodge Journey
2010	(JS)	Chrysler Sebring/Avenger/Sebring Convertible

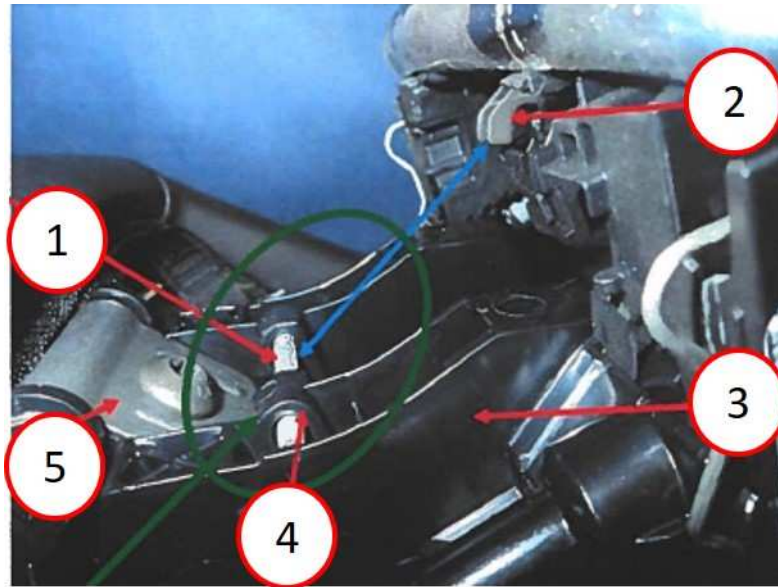
**Fig. 1**  
**Normal Deployed Position - AHR Can Be Reset**

1. Verify the sled bracket striker pin is attached to the sled bracket (Fig. 1) and (Fig. 2) .

- 1 - Striker Pin Correctly Attached To The Sled Bracket
- 2 - Latch Pawls
- 3 - Sled
- 4 - Sled Bracket With Pin Attached
- 5 - Tilt Clip

- YES >>> This bulletin has been completed, use inspection LOP (23-20-48-9H) to close the bulletin.
- NO >>> The striker pin is locked in the AHR latch (Fig. 2) . Proceed to [Step 1](#) of the Repair Procedure.

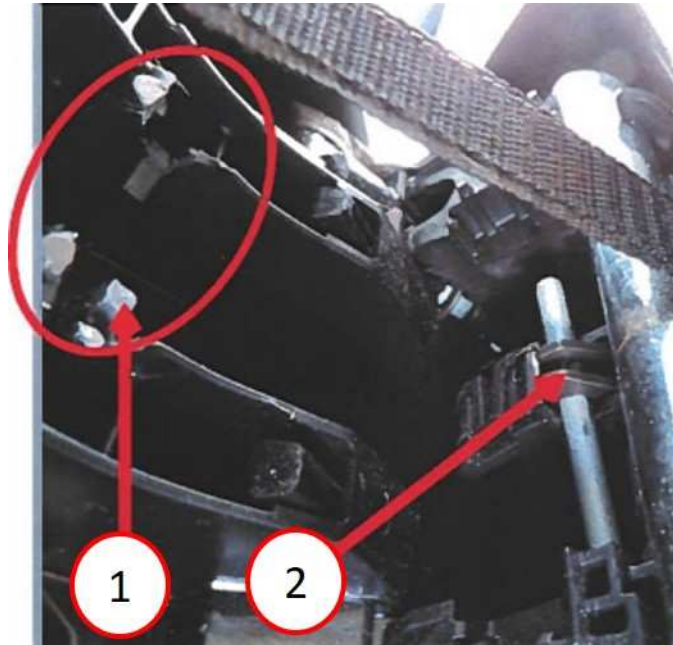
**Fig. 2**  
**Deployed AHR Has Failed And Will Not Reset**

- 1 - Sled Bracket Failed
- 2 - Striker Pin Fastened/Locked To Latch (**Will Not Reset**)

1. Replace the AHR. Refer to the detailed procedures available in DealerCONNECT > Service Library> under: 23 - Body/Seats/Headrest, Front/Removal/Installation.
2. Cycle the ignition 'OFF' then 'ON', after performing the AHR replacement to ensure there are no DTCs set.
