# Service Bulletin

Bulletin No.: 19-NA-037

**Subject: No Start, Hard Start with Belt Squeal, Belt Break, Loss of Power Steering and/or Power Brake Assist**

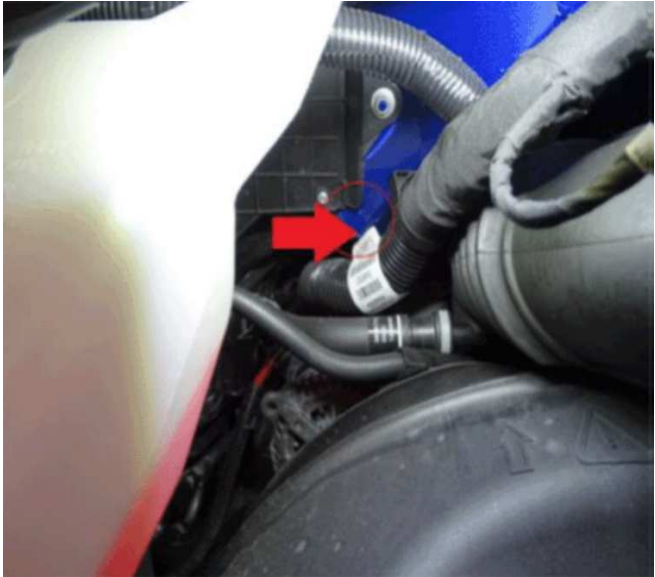
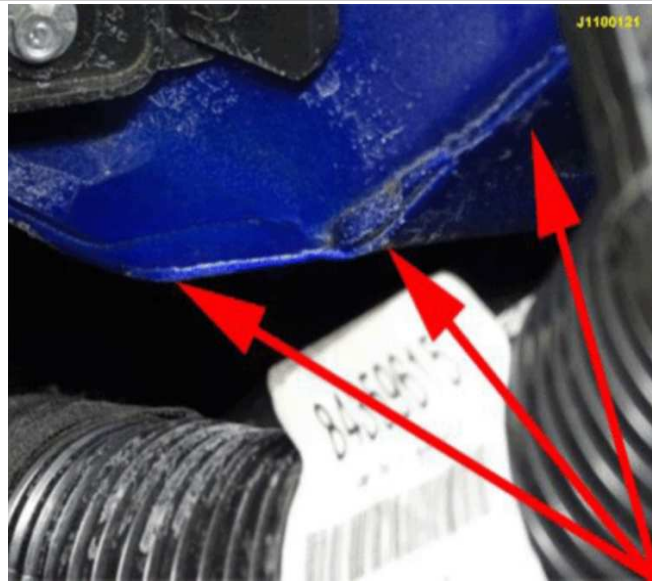
**Note:** The common location of the water leak path is shown in the graphics above.

- Seal water leak at cowl with Kent Automotive High-Tech™ Clear Seam Sealer, following the steps in the Service Procedure below.

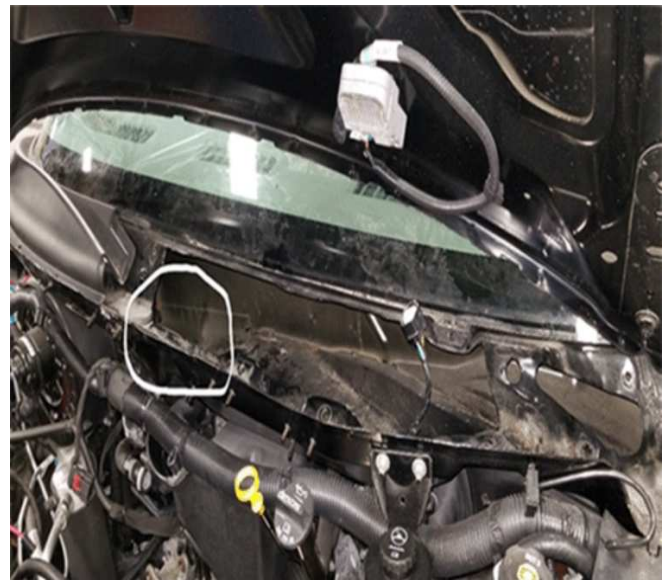
5246055

2. Note the location of the inner lower right side seam circled in the graphic above.
