Ferrari North America

Technical Information

Date: February 2021
Bulletin #: 2720
Campaign #: 461
Supersedes:
Section: 9

Subject: Replacing engine compartment lid Lexan screen

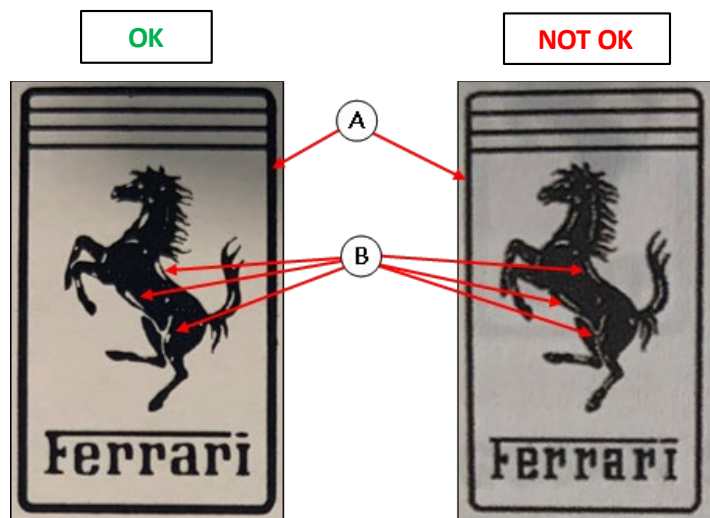
Checking Lexan rear screen

To determine if it is necessary to replace the Lexan screen of the engine compartment lid, inspect the **Ferrari** logo printed on the component carefully to check the following:

- A. That the border line around the logo is of the correct thickness and clearly defined;
- B. That the demarcation and difference in contrast between the printed black zones and the unprinted clear zones are clear and easily distinguishable.

If the logo meets is **OK**, it is not necessary to replace the Lexan screen.

If the logo is **NOT OK**, replace the component as described below.
