**WLG9 Workshop campaign - Replacing lower part of front lid lock**

Revision: This bulletin replaces bulletin Group 5 185/20 WLG9, dated January 25, 2021.

Model Line: **718 Boxster (982)/Cayman (982)  
911 (991)  
911 (992)**

Concerns: **Lower part of front lid lock**

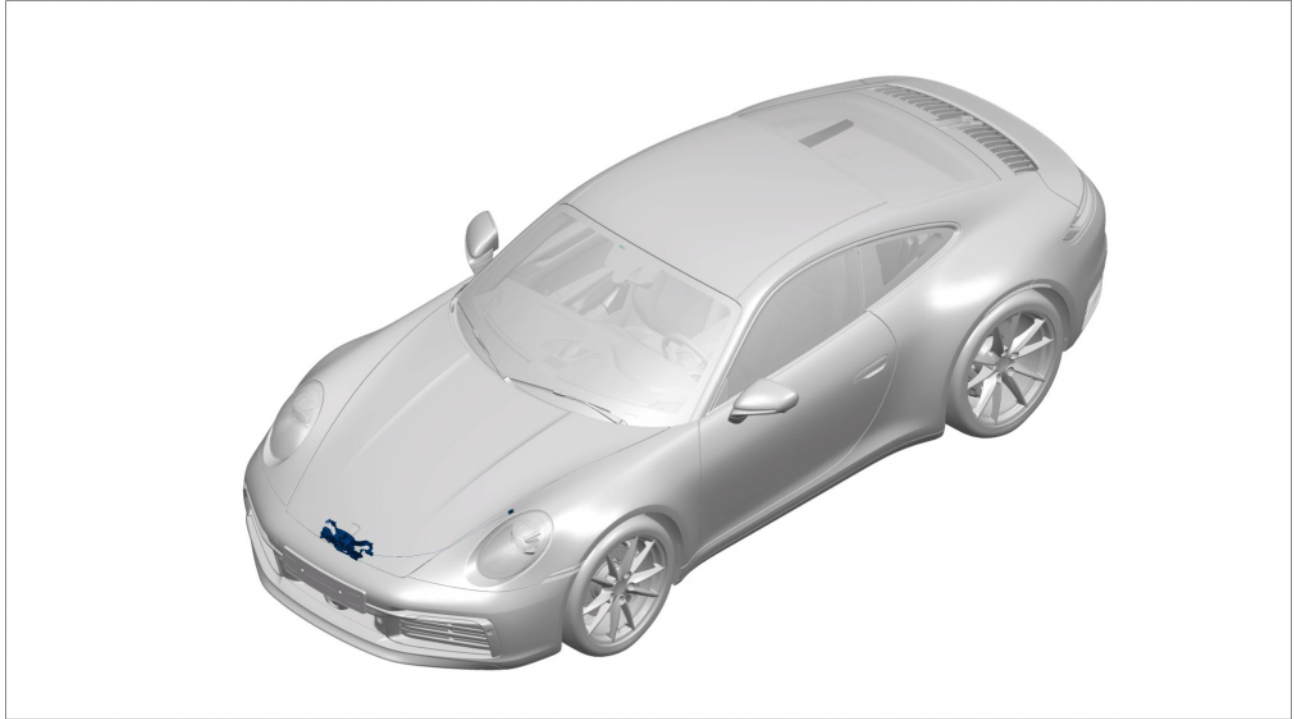
Installation  
Position

Information: **A bowden cable that does not meet the required specifications was installed on lower part of the front lid lock on the affected vehicles and this can crack over the service life of the vehicle.**  
If this happens, the front lid cannot be unlocked and must then be opened using the emergency release.

*Installation position of lower part of front lid lock*

Remedial Action: Replace lower part of front lid lock.
