Subject: Engine Door Debonding Inspection			
Field change Program: Service Bulletin	Bulletin Number: 3149	Revision: A	Date: 02/10/2021
Coach Section: 03-Body	P/N: 03-31-4155		Type: Service Information

This bulletin outlines steps to inspect engine compartment door de-bonding.

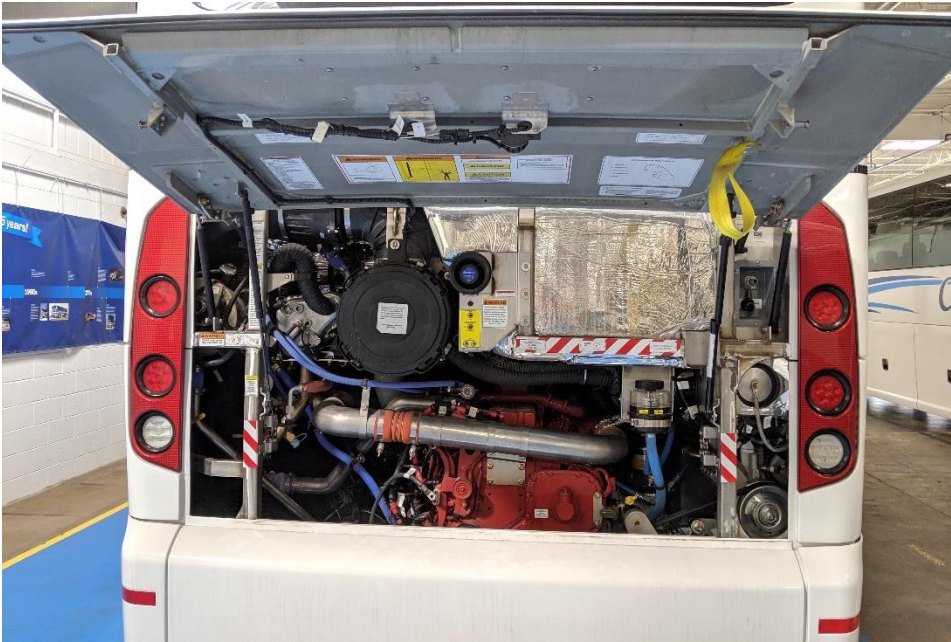
Inspect to see if the fiberglass section of the door is intact to the metal frame.

If the fiberglass section of the door is intact to the metal frame, continue to Section 5.0. Otherwise, contact your MCI representative or nearest MCI service center to rework the door using internal procedure P03-267.

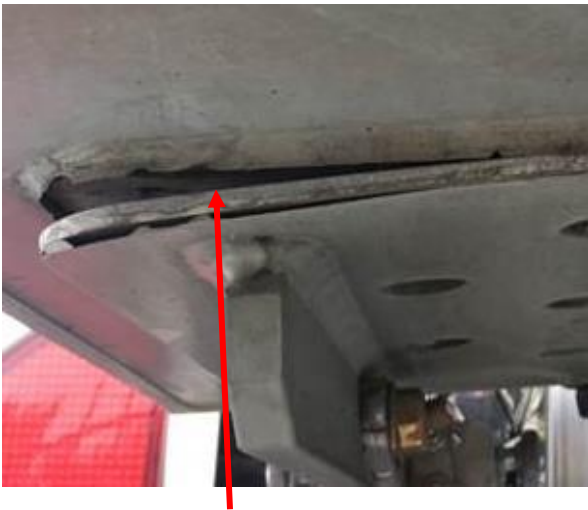
Bad

Fiberglass section is separated from metal frame. Contact MCI representative or nearest MCI service center for rework

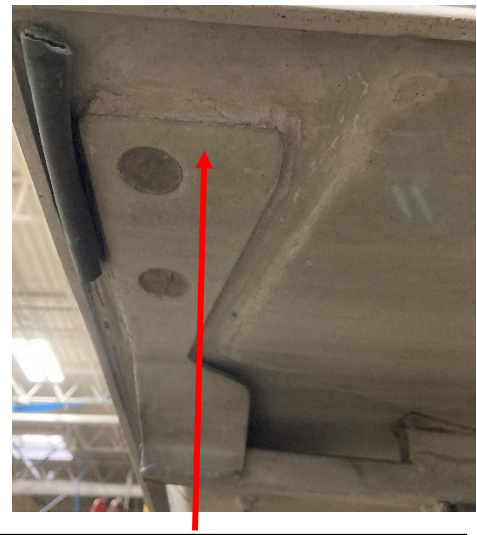
Good

Fiberglass section is intact to the metal frame. Continue to Section 5.0
