Field campaign

Topic	Bentayga Hybrid - Software update to 008C Hybrid battery management and 06D0 Battery interrupt switch (SC20/11)
Market area	Germany E02 Bentley rest Europe (6E02),United Kingdom E01 Bentley UK (6E01),United States E05 Bentley USA and rest America (6E05)
Brand	Bentley
Transaction No.	2059286/3
Campaign number	EB53
Note	
Type	
US code

Software update required to address 008C - Hybrid battery management control module and address 06D0 - Battery interrupt switch control module

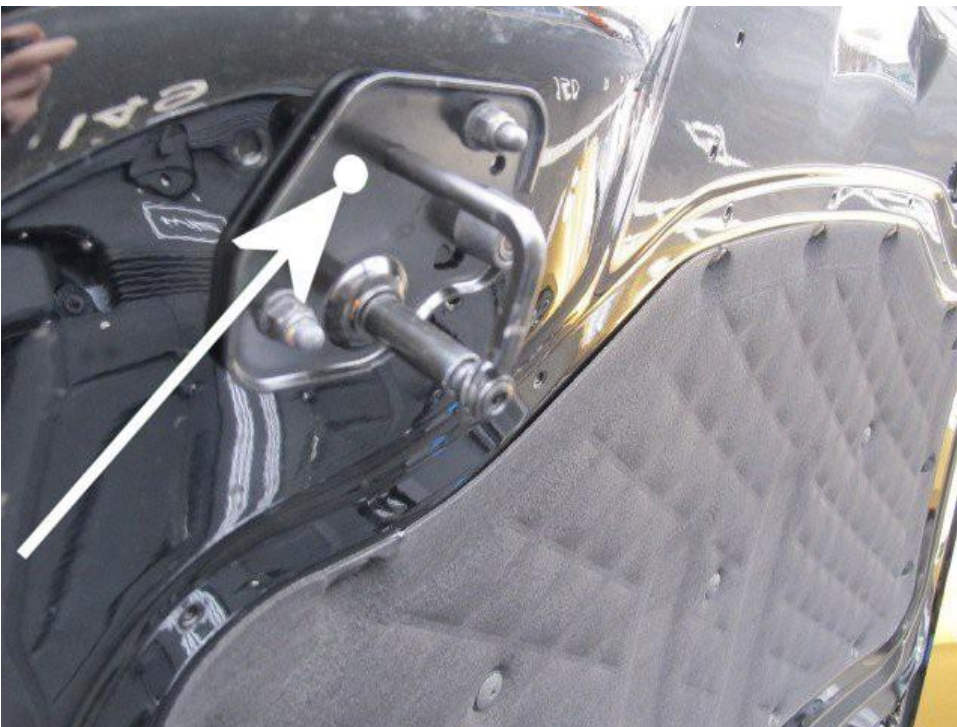
Figure 8

White paint completion mark on the right hand bonnet latch striker (Figure 8)

9) Place a white completion mark on the right hand bonnet latch striker (Figure 8)
