Technical product information

Topic	TPMS - Warning within the Drivers Information Panel (DIP) - DTC C1239F0 - Tyre pressure display Positioning not possible
Market area	Bentley: worldwide (2WBE)
Brand	Bentley
Transaction No.	2061739/3
Level	EH
Status	Approval
Release date

Bentayga - New Flying Spur - New Continental GT and GTC

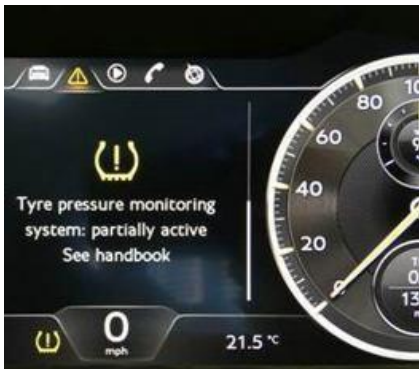
- After a 4 minute drive cycle, The (TPMS) will enter into a partially active mode and outputs a warning within the (DIP) as shown in Figure 1

NOTE: This is a pre-warning to the customer about a potential issue with the TPMS

1) Check the part numbers of all four TPMS transmitters

In the event that 5Q0907275B are fitted - Replace all four transmitters with 5Q0907275F – Refer to Rep.Gr 44 (See parts information section)

In the event that 5Q0907275C are fitted - Replace all four transmitters with 5Q0907275G – Refer to Rep.Gr 44 (See parts information section)

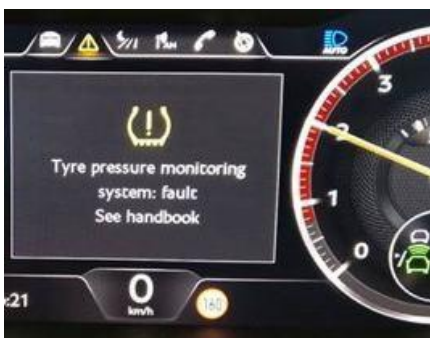
- Should the TPMS control unit not receive any information after a further 5 minutes, the TPMS warning will be as shown in Figure 2
