SERVICE BULLETIN

APPLICABILITY: 2015-16MY Legacy and Outback Models

NUMBER: 12-192-15R

SUBJECT: Windshield Cracking Concerns

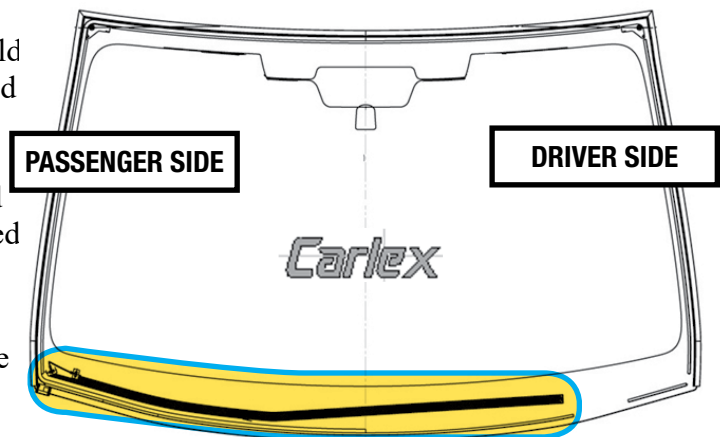
IMPORTANT: The information in this bulletin is only applicable to certain windshield glass manufactured by CARLEX and equipped with the windshield wiper deicer feature (part of the All-Weather Package) on vehicles within the specified VIN ranges. The affected windshields can develop cracks when impacted in the printed black area of the highlighted below.

IMPORTANT NOTE: The illustration to the right shows the windshield as viewed from **OUTSIDE** the vehicle.

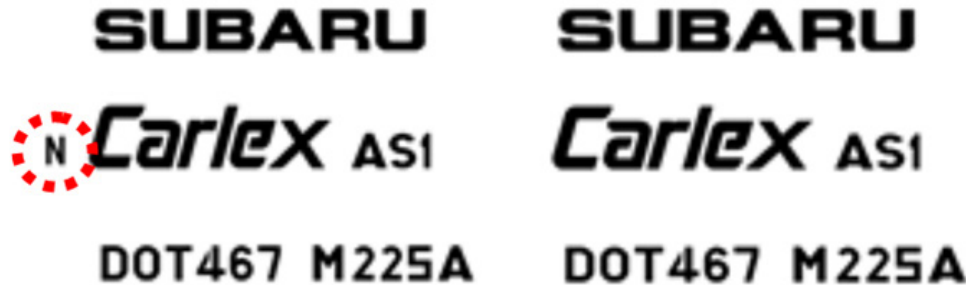
Fig. 1

The original windshields (before production change) can be easily identified by the identification markings found in the lower left, driver’s side corner shown in Figure 1 below.

If the marking contains SUBARU and Carlex and matches one of the illustrations shown in Figure 1 above, proceed with the inspection as the windshield was manufactured prior to the production change. Visually inspect the crack to determine if it passes through the affected deicer area. Visually examine the entire length of the crack for evidence of impact.

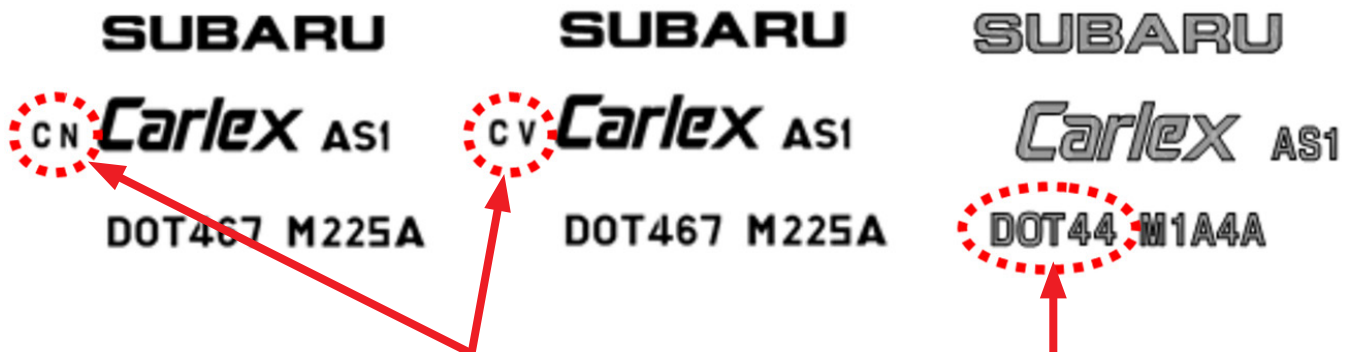
Fig. 2	These 2 production markings can be found on production or replacement part windshields.	This marking is found on replacement part windshields only.
---------------	---	---

The enhanced production parts and replacement part windshields are identified by the additional identification markings (CN, CV, DOT44) as shown in Figure 2 below. Windshields with these markings are NOT eligible for replacement under the warranty extension.

STOP: After confirming the presence of a crack, inspect the manufacturer identification marking in the lower left driver's side corner of the windshield. If the marking is the same as shown in the enhanced production part and replacement part illustrations in Figure 2, this warranty extension DOES NOT apply. These identification markings indicate an enhanced replacement windshield has already been installed.

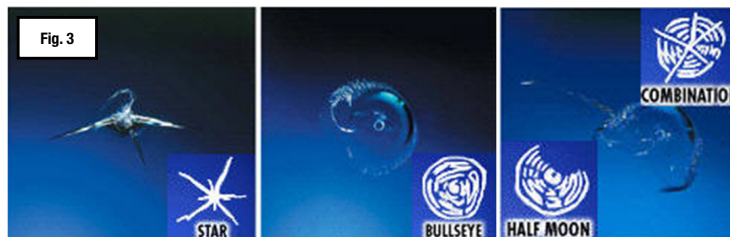
Confirm the windshield is actually cracked and the crack does not originate from a bulls eye, star, or combination impact that appears outside of the deicer region of the windshield (refer to the images in Figure 3 below). Windshields with such impact evidence appearing outside of the deicer region do not qualify for repair under warranty. Bulls eye, star, or combination impacts that appear inside the deicer region of the windshield qualify for the one-time repair under warranty. If there is no evidence of impact, then the crack must pass through the deicer section of the windshield to qualify for the one-time repair under warranty. **DO NOT submit an Authorization Request for a windshield replacement which will be covered by the warranty extension outlined in this Service Bulletin.**

IMPORTANT: Evidence of impact damage must be visible to the naked eye and should be assessed by visual inspection only. No ballpoint pen, fingernail, or other object should be used to assess whether the damage originated from an impact.

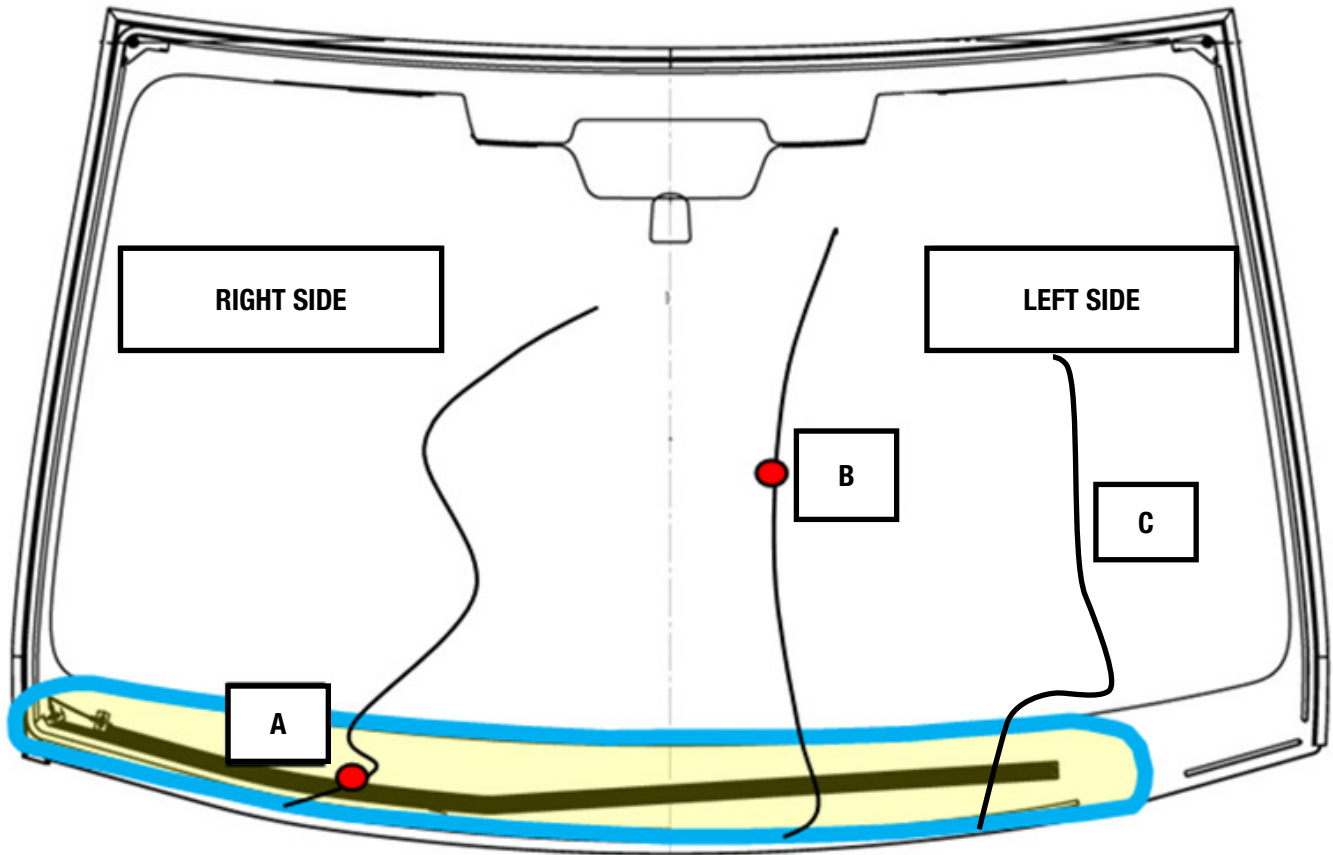
- If an impact point is found within the affected deicer area (as shown by "A" in the illustration below), proceed with windshield replacement under the terms of this warranty extension.
- If the impact point is found outside of the affected deicer area (as shown by "B" in the illustration below), this bulletin and warranty coverage do not apply.
- If an impact point cannot be identified, and the crack passes through the affected deicer area, the windshield replacement would fall under this warranty extension.

As noted above, use visual inspection only to identify evidence of impact (i.e., no fingernail or pen test).
