Diagnostic Trouble Codes (DTC) P20EE And P103C, Diagnostic Procedure; - US17+OBD16 and US17+OBD2018 Emissions, Model Year 2018,2019

Selective Catalytic Reduction (SCR) Efficiency And NOx Sensor Diagnostic Trouble Codes (DTC) P225C, P225E, P221A and P2201: NOx Sensor Diagnostic Information TO BE USED BEFORE SENSOR REPLACEMENT - OBD13 And Newer Emissions (Commonly Model Year 20

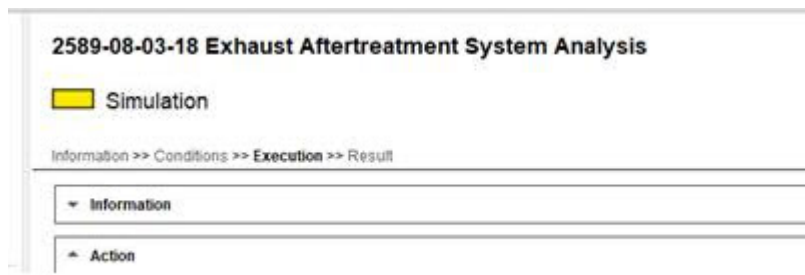
7. If vehicle has a VGT System run Exhaust After-treatment System Analysis, Operation 2589-08-03-18.

Make sure to select only SCR efficiency(priority) and NOx sensors (2nd priority), during selection phase of the test.

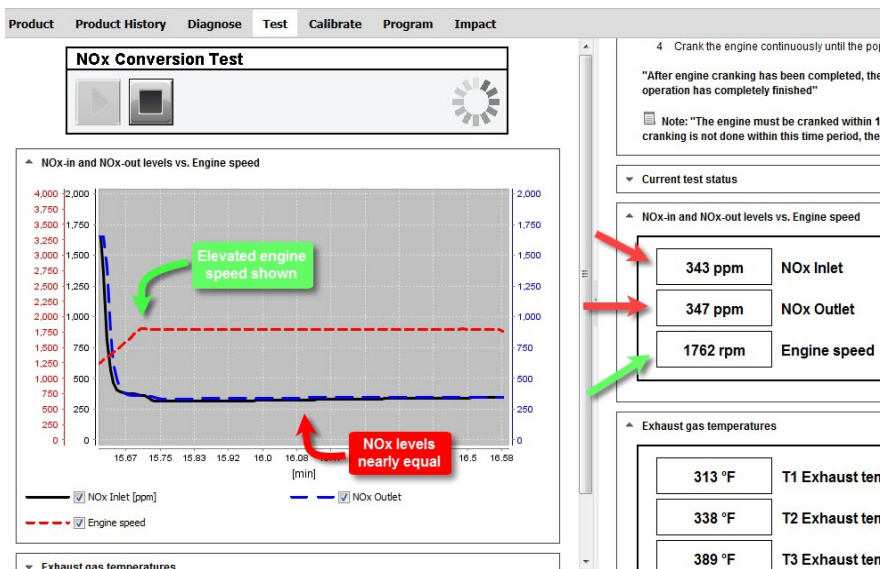
- Inlet and Outlet NOx values should be within 40 parts per million (ppm) of one another just before the engine shuts down. Shown below is an example of how a graph with two properly functioning sensors will look:

4. If no issues are found with the sensor readings from the NOx Conversion review, the sensors are not the source of the conditions causing the codes to log. Further diagnostic steps of other components will need to be performed to determine the cause of the faults.
