SERVICE BULLETIN

APPLICABILITY: 2017-21MY Impreza
 2018-21MY Crosstrek
 2018-19MY Legacy and Outback
 2019-21MY WRX and WRX STI
 2019-21MY Ascent
 2018-21MY BRZ

NUMBER: 15-221-18R

SUBJECT: Harman Audio / Infotainment: Harman Generation 3.0 and 3.1 Operating Tips

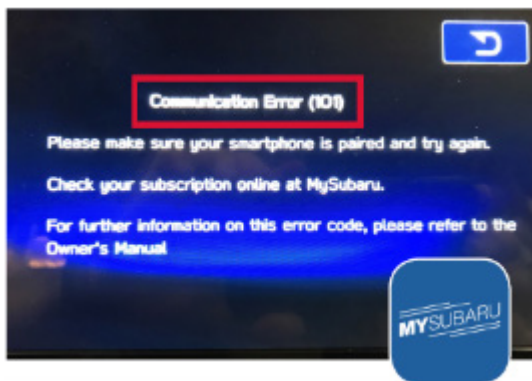
CONDITION# 0.11 When selecting the MySubaru Application on the head unit, a Communication Error may occur that displays along with a specific code. In the example image below, the error code is 101:

CAUSE: Communication Errors can occur for many different reasons. For example, the issue causing the Communication Error could be that a Smartphone had not been paired to audio head unit.

RECOMMENDATIONS:

Information about Communication Error codes can be found in the Troubleshooting Section of the 2019 SUBARU STARLINK Safety and Security Owner’s Manual.

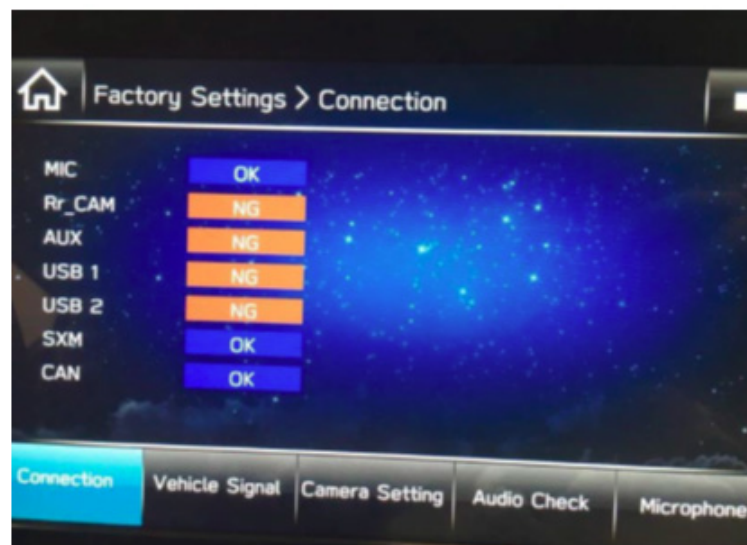
Below is an image of what the screen will look like if a line check is performed before the issue is corrected:

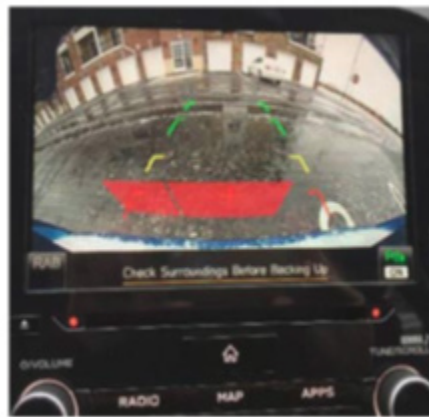
CONDITION# 1.3 On vehicles equipped with reverse automatic braking (RAB), a red area appears in backup camera display:

CAUSE: If a customer states they see a red box or area in their backup camera display, the system is most likely operating as designed. Always perform a visual check of the sensors on the rear bumper first. If any of the sensors are covered over or obstructed by ice and / or snow, the RAB system may not function properly and the red area shown in the example photo below will most likely appear.

RECOMMENDATION: When this condition occurs, the RAB system is unable to properly differentiate between what really is an obstacle and what is not. In the image below, the sensor is iced over and the red area is displayed with no obstacle present. The Owner's Manual provides a list of other potential causes for this condition to occur.

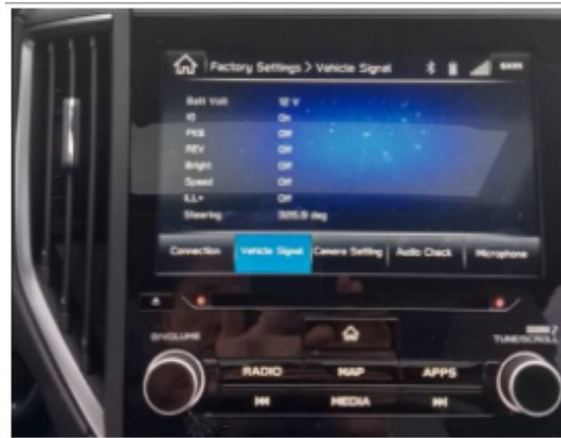
The steering angle reading is shown on the photo below (“Steering 326.9 deg”).

Rotate the steering wheel to confirm the number is changing with the steering wheel rotating.

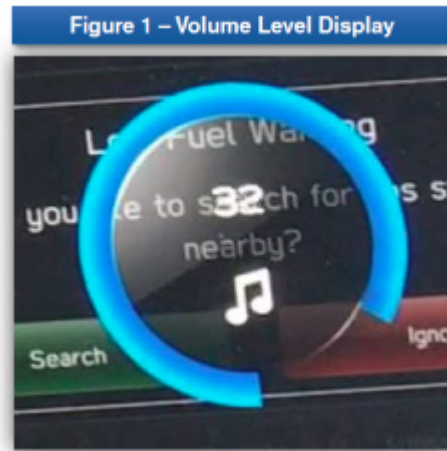
CONDITION# 4.1 Audio Volume is turned to MAX when monitoring infotainment data monitor (March 2017 TechTIPS):

CAUSE: If you are monitoring the Infotainment System Data Monitor and the volume level display (**Figure below**) appears showing the volume level increasing but the sound level remains the same, this is a normal operation of the Harman unit.

RECOMMENDATION: When a Technician accesses the Infotainment System Data Monitor, the unit enters “Diagnostic Mode” and the volume level will be displayed in this manner. No repairs should be performed to address this concern as it is a normal operating characteristic.

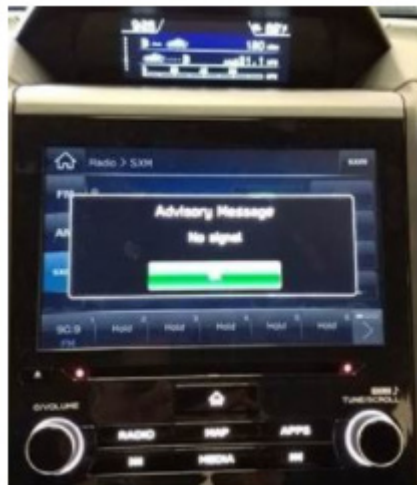
CONDITION# 5.1 Harman Gen 3 Audio/ Navigation head unit shows an “Advisory Message- No Signal” notification on the display:

CAUSE: In areas of poor or no SXM coverage, the head unit will display the message as shown above. It is not a failure condition assuming SXM service is not available.

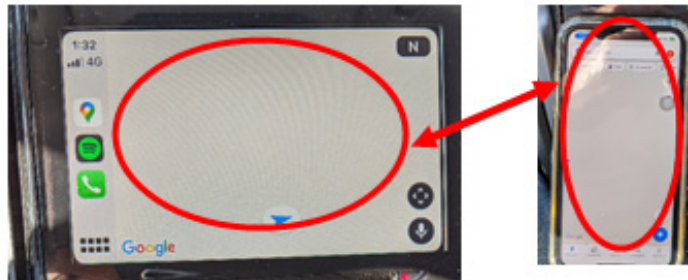
» No roads are displayed using Google Map, while running Apple CarPlay (Google Maps crashed on iPhone resulting in no roads to be displayed):

As you can see the head unit is projecting what iPhone is pushing to it and vehicle hardware replacement won't fix a concern with a crashing phone application. In cases like that we suggested frequent iPhone reboot or restart (especially after recent iOS update) or updating or reinstalling the application on the phone. Check the comments in iTunes store as this may be a known concern with the app.

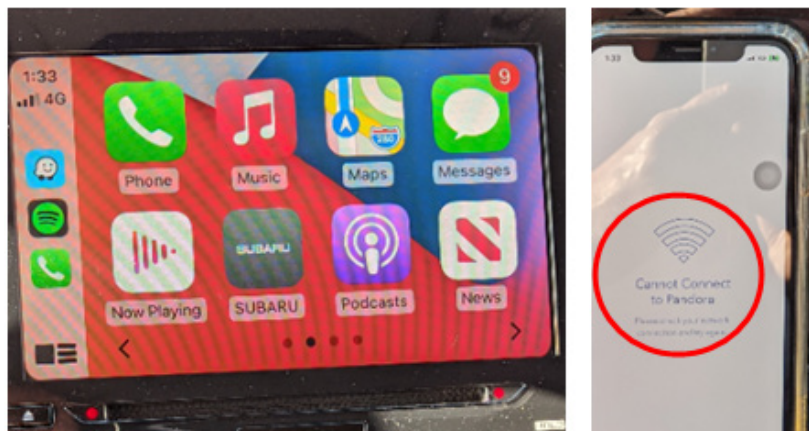
» Pandora streaming isn't working on the head unit (iPhone failed to connect to Pandora server):

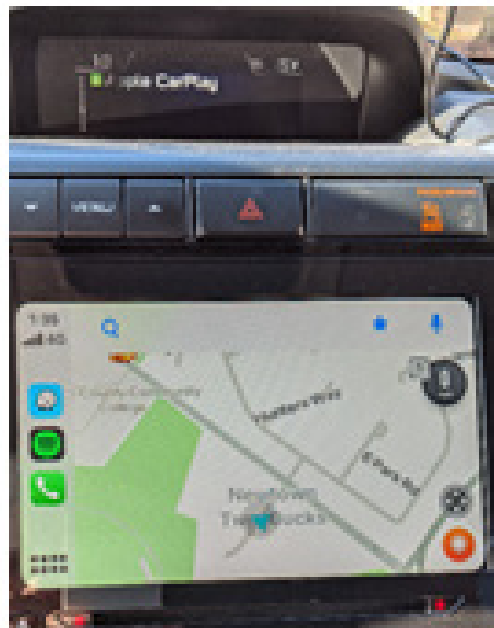
CAUSE: We have seen many reports of the Audio Output (radio, CD, USB etc.) being interrupted when the Apple CarPlay application is launched or a Navigation application (ex: Waze) or audio streaming application is (ex: TuneIn) is started from Apple CarPlay environment.

RECOMMENDATION: Please note this is a characteristic as the iPhone takes control. This may also occur when the phone is used for other purposes while CarPlay is active such as texting, replying to emails or other phone side actions.

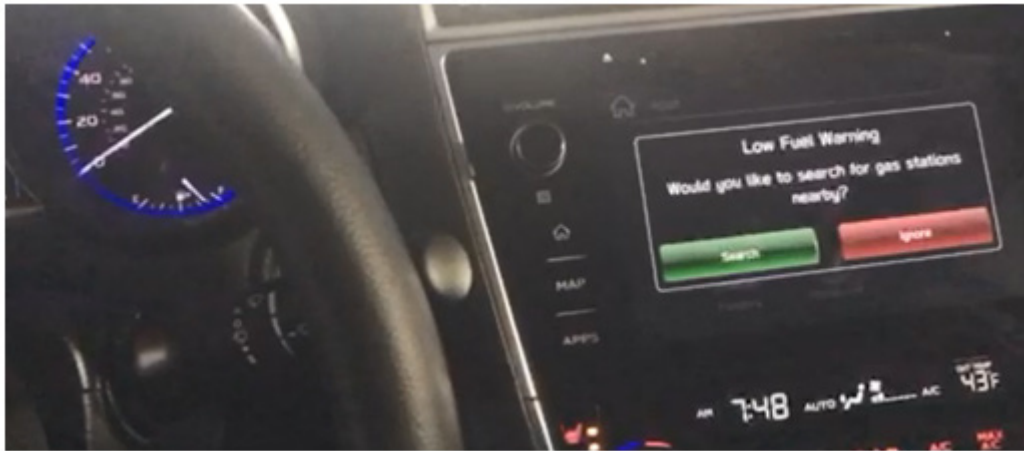
CAUSE: The head unit only displays fuel level information sent to it from the combination meter.

RECOMMENDATION: Confirm combination meter and sender functions are operating properly. Confirm the trip meter is reset following refueling. Confirm ignition key is not being left in the ON / RUN positions during refueling.
