Field campaign

Topic	Bentayga - Control Unit for Fuel Pump (SC 20/05)
Market area	China 796 VW Import Comp. Ltd (Vico), Beijing (6796),United Kingdom E01 Bentley UK (6E01),United States E05 Bentley USA and rest America (6E05)
Brand	Bentley
Transaction No.	2058764/2
Campaign number	EB47
Note	
Type	Field Campaign
US code

Bentayga

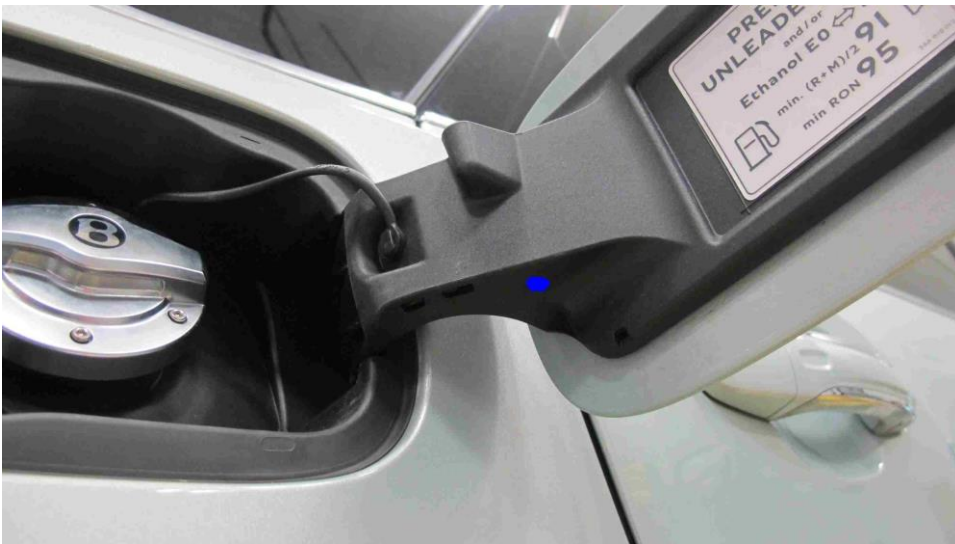
Figure 1

If the vehicle is not already listed in the "Repair History" (Elsa Pro) check for the Blue campaign identification mark on the underside of the fuel filler door hinge – figure 1.

Blue campaign identification mark on the underside of the fuel filler door hinge - figure 1.

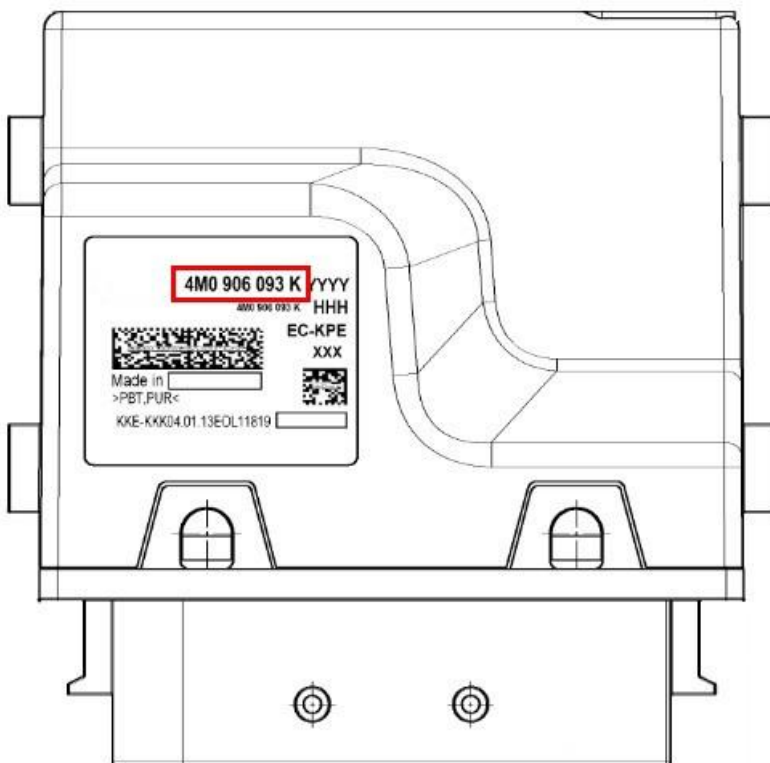
Check the part number marked on both fuel pump control units, refer to *Repair Group 20 Fuel supply, gas operation – 6.0L W12 TSI – Fuel pump control units (J538, J835) – To remove and fit.*

Check the part number marked on the fuel pump control unit, refer to *Repair Group 20 Fuel supply, gas operation – 4.0L V8 TSI – Fuel pump control unit (J538) – To remove and fit.*

If the part number on the fuel pump control unit(s) is 4M0 906 093 N or the control unit cannot be identified, proceed to replace with control unit 4M0 906 093 K. Should the original control unit(s) be identified as 4M0 906 093 K no further action is required.

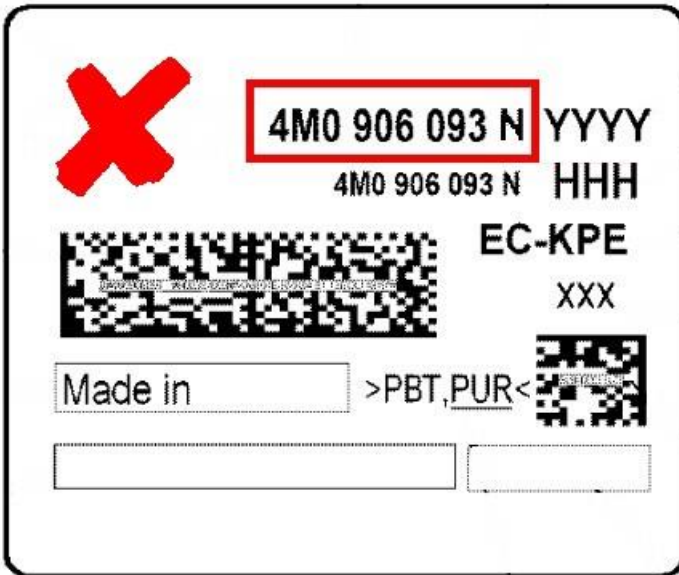
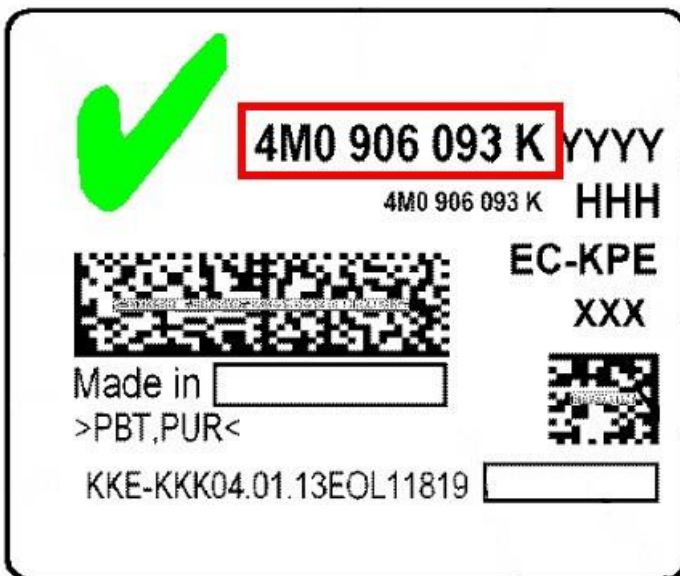
Note: It is possible on 6.0L – W12 vehicle variants there may be a mixture of 4M0 906 093 K and 4M0 906 093 N control units, only the “ N” level fuel pump control units should be replaced.
