SERVICE BULLETIN

ITB19-009a

INTELLIGENT KEY DOES NOT WORK AFTER BATTERY REPLACEMENT

APPLIED VEHICLES:
 2019 QX50 (J55)
 2019 Q50 (V37)

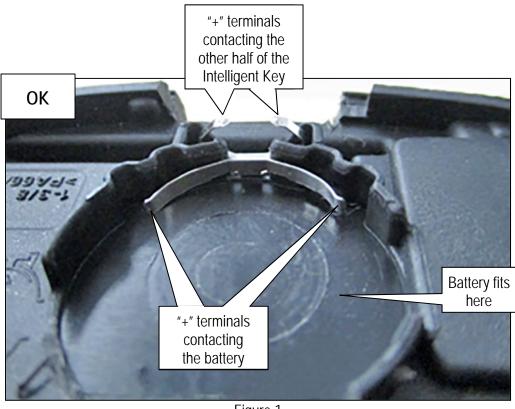
Figure 1

If the battery side of the Intelligent Key is held by pinching down on the terminals while removing the battery, it is possible to bend the terminals down far enough that they will not touch the contacts on the other half of the Intelligent Key.

If the terminals are found to be bent down, pry them back up so that they will come in contact with the other half of the Intelligent Key's contacts.
