SERVICE BULLETIN

Classification: DA19-008a	Reference: NTB19-031a	Date: February 3, 2021
------------------------------	--------------------------	---------------------------

BEEPING NOISE WHILE TRAVELING THROUGH OPEN AREA

APPLIED VEHICLES: 2017 - 2018 Rogue (T32)
2017 - 2018 Rogue Hybrid (T32)

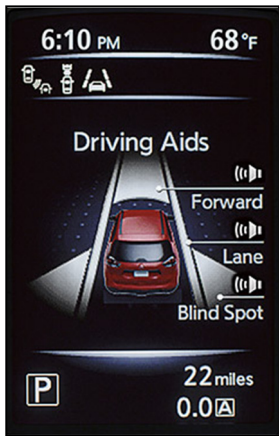
Customer reports continuous beeping noise and/or the **Driving Aids** screen shown in Figure 1 flashes, especially when driving in open areas similar to Figure 2.

Refer to **TABLE A** on page 8 to confirm if ICC/ADAS 2 control unit reprogramming is needed.

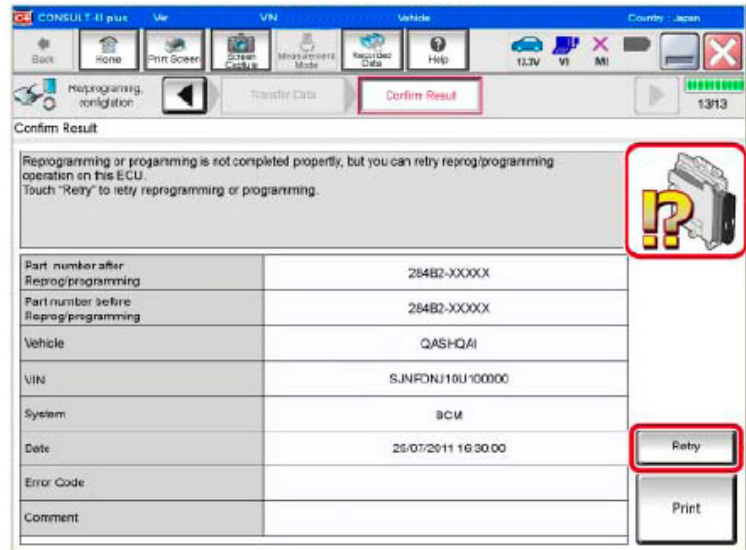
Figure 14

If reprogramming does not complete and the “!?” icon displays as shown in Figure 14:

- Check battery voltage (12.0 - 15.5 V).
- Ignition is ON, engine OFF.
- External Bluetooth® devices are OFF.
- All electrical loads are OFF.
- **Select retry and follow the on screen instructions.**
- **“Retry” may not go through on first attempt and can be selected more than once.**
