SERVICE BULLETIN

Classification: DA20-017a	Reference: NTB20-048a	Date: February 2, 2021
------------------------------	--------------------------	---------------------------

2020 ALTIMA; BLIND SPOT WARNING AND/OR REAR CROSS TRAFFIC ALERT NOT FUNCTIONING PROPERLY

APPLIED VEHICLES: 2020 Altima S with Driver Assist (L34)
2020 Altima SR (L34)

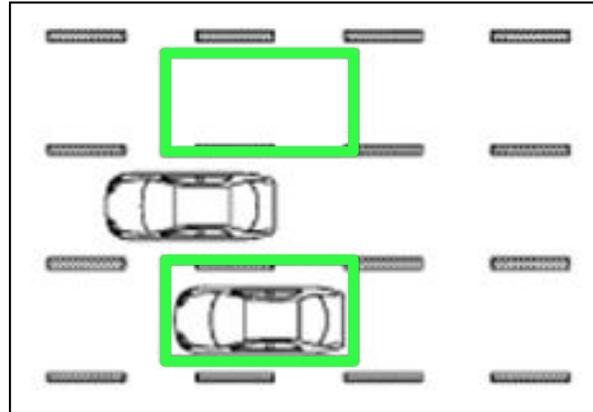
Figure 1

- The customer states the Blind Spot Warning indicator does not illuminate while driving when there is a vehicle in one of the detection zones (outlined in green in Figure 1).

- The customer states the Rear Cross Traffic Alert indicator does not illuminate while in reverse and a car is approaching the side of the vehicle near the rear bumper.

- Confirm the current ICC/ADAS 2 part number.
- Reprogram the ICC/ADAS 2 and perform the blind spot warning action test, if applicable.

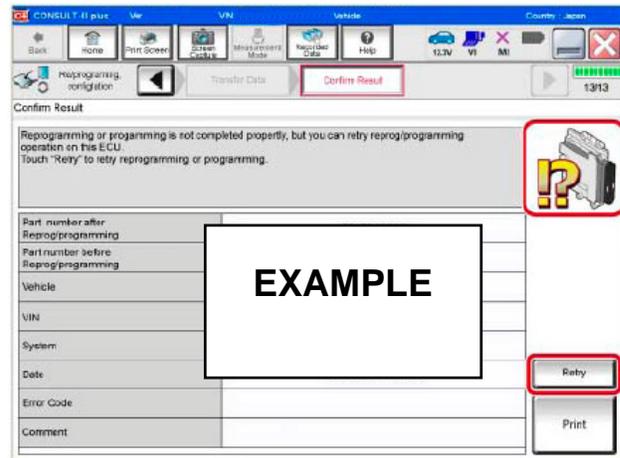
Figure 22

If reprogramming does not complete and the “!?” icon displays as shown in Figure 22:

- Check battery voltage (12.0 - 15.5 V).
- Ignition is ON, engine OFF.
- External Bluetooth® devices are OFF.
- **All** electrical loads are OFF.
- **Select retry and follow the on screen instructions.**
- **“Retry” may not go through on first attempt and can be selected more than once.**

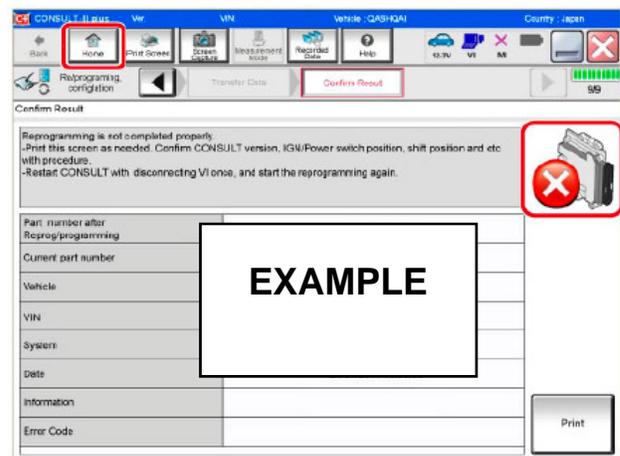
Figure 23

If reprogramming does not complete and the “X” icon displays as shown in Figure 23:

- Check battery voltage (12.0 - 15.5 V).
- CONSULT A/C adapter is plugged in.
- Ignition is ON, engine OFF.
- Transmission is in Park.
- All C-III plus / VI cables are securely connected.
- All C-III plus updates are installed.
- **Select Home, and restart the reprogram procedure from the beginning.**
