SERVICE BULLETIN

SERVICE BOLLETIII				
Classification:	Reference:	Date:		
DA20-021a	NTB20-058a	February 2, 2021

2016-2019 TITAN/TITAN XD; REAR SONAR SENSORS DO NOT DETECT OBJECTS/OBSTRUCTIONS WHEN IN REVERSE

APPLIED VEHICLES: 2016-2019 Titan/Titan XD (A61)

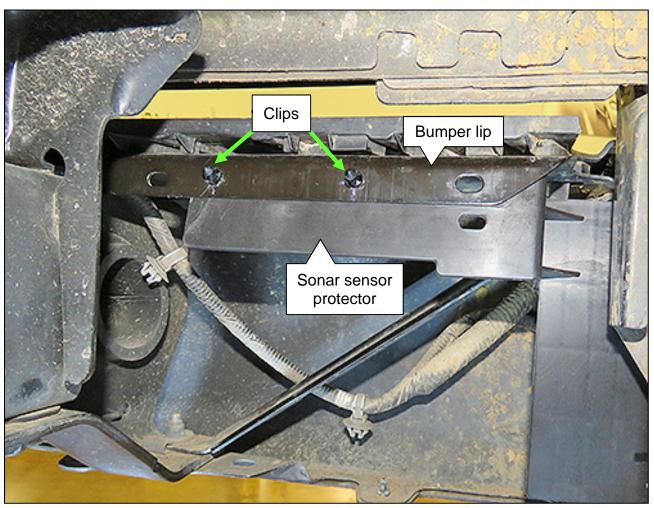
Figure 7

NOTICE Clips must be installed so that the inserted portion faces toward the front of the vehicle, or harness damage may occur.

- 5. Install the sonar sensor protector to the back side of the bumper lip (Figure 7).
 - See the **PARTS INFORMATION** on page 7.
- 6. Insert two (2) clips, first through the back side of the sonar sensor protector, and then the bumper lip, with inserted tip facing toward the front of the vehicle as shown in Figure 7.

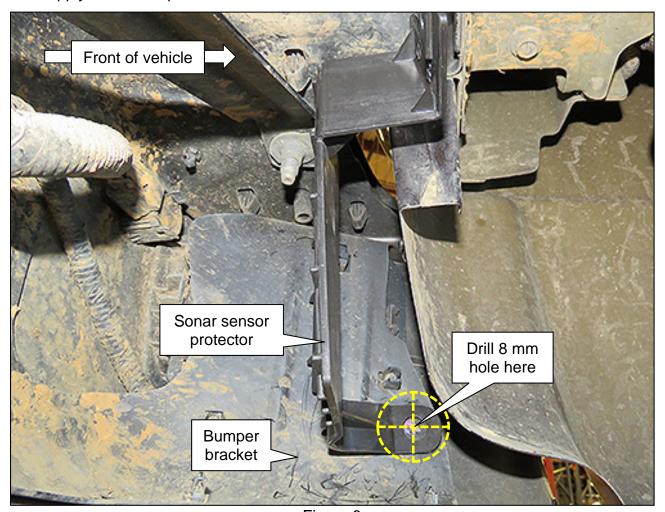
Figure 8

NOTICE When drilling a hole in the bumper bracket, take care not to contact the BSW (Blind Spot Warning) sensor as damage could occur.

7. Drill an 8 mm (5/16") hole through the sonar sensor protector's hole into bumper bracket, where shown in Figure 8.

8. Apply a zinc rich primer to the drilled hole.
