SERVICE BULLETIN

Classification: DA20-019a	Reference: NTB20-061a	Date: February 2, 2021
------------------------------	--------------------------	---------------------------

TRAFFIC SIGN RECOGNITION OR LANE DEPARTURE WARNING MALFUNCTION DISPLAYED AND MIL ON WITH DTC C2503-54 AND/OR C1F6B-54 STORED

APPLIED VEHICLES: 2020 Sentra (B18)
APPLIED DATE: Built before May 29, 2020

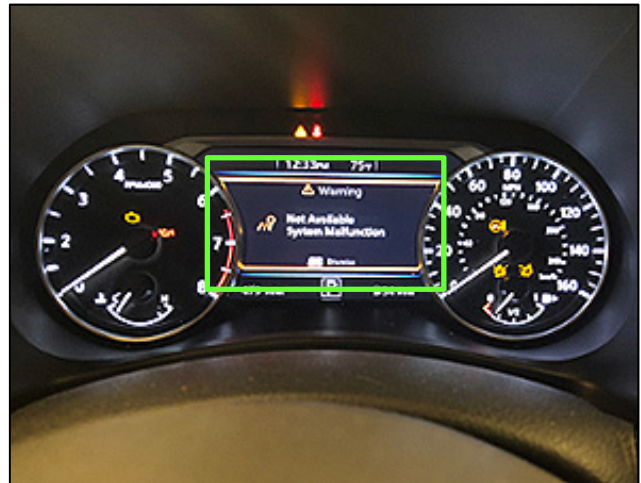
Figure 1

The customer states that one of the following warnings is displayed on the vehicle information display along with the AEB Warning Light:

- Traffic Sign Recognition Malfunction Displayed
- Lane Departure Warning Malfunction Displayed

- The MIL is ON with DTC C2503-54 (CAMERA AIMING INCMP) and/or C1F6B-54 (CAMERA UNIT MALF) stored.
