# SERVICE BULLETIN

Classification: FA99-001e	Reference: NTB99-001e	Date: February 12, 2021
------------------------------	--------------------------	----------------------------

## STRUT AND SHOCK ABSORBER REPLACEMENT GUIDELINES

**APPLIED VEHICLES:** All 1990-2021 Nissan vehicles except those listed below

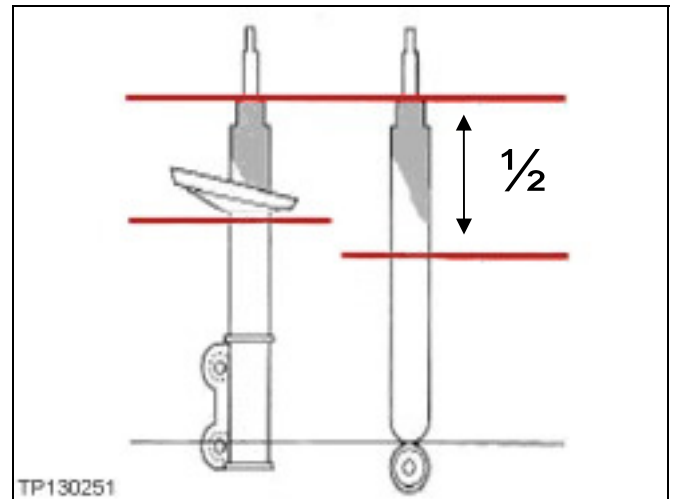
Figure 1

If oil does NOT extend beyond the spring seat or upper 1/2 of shock:

- This is **slight oil seepage**. The strut/shock absorber should NOT be replaced.

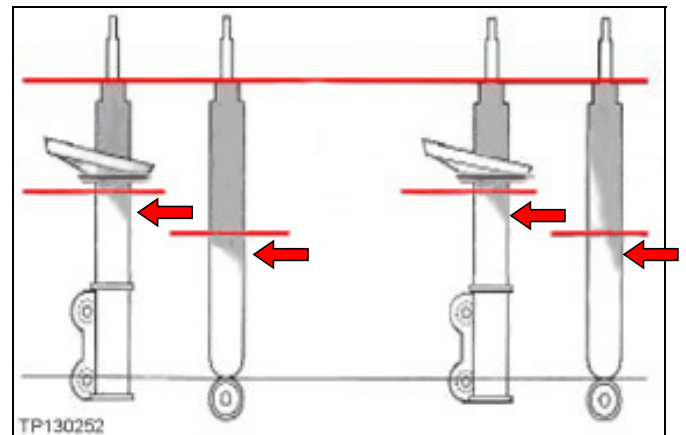
Figure 2

If oil does extend beyond the spring seat or upper 1/2 of shock:

- Use a finger to touch the oil that has extended beyond the spring seat or upper 1/2 of shock.

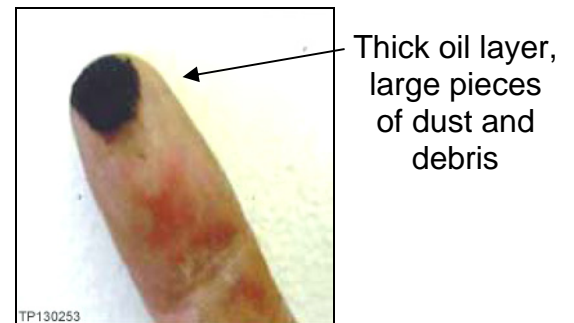
Figure 3

- If you confirm the oil layer is thick and contains large pieces of dust and debris, the strut/shock absorber **should be replaced**.

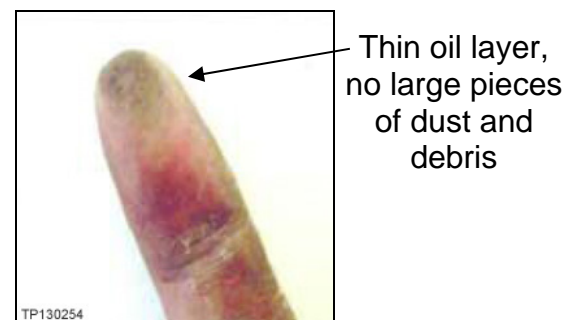
Figure 4

- If you confirm the oil layer is thin and does NOT contain large pieces of dust and debris, the strut/shock absorber should NOT be replaced.
