JTBO0604NAS1

TECHNICAL BULLETIN

501-12: Instrument Panel and Console

Creak Noise From The Instrument Panel

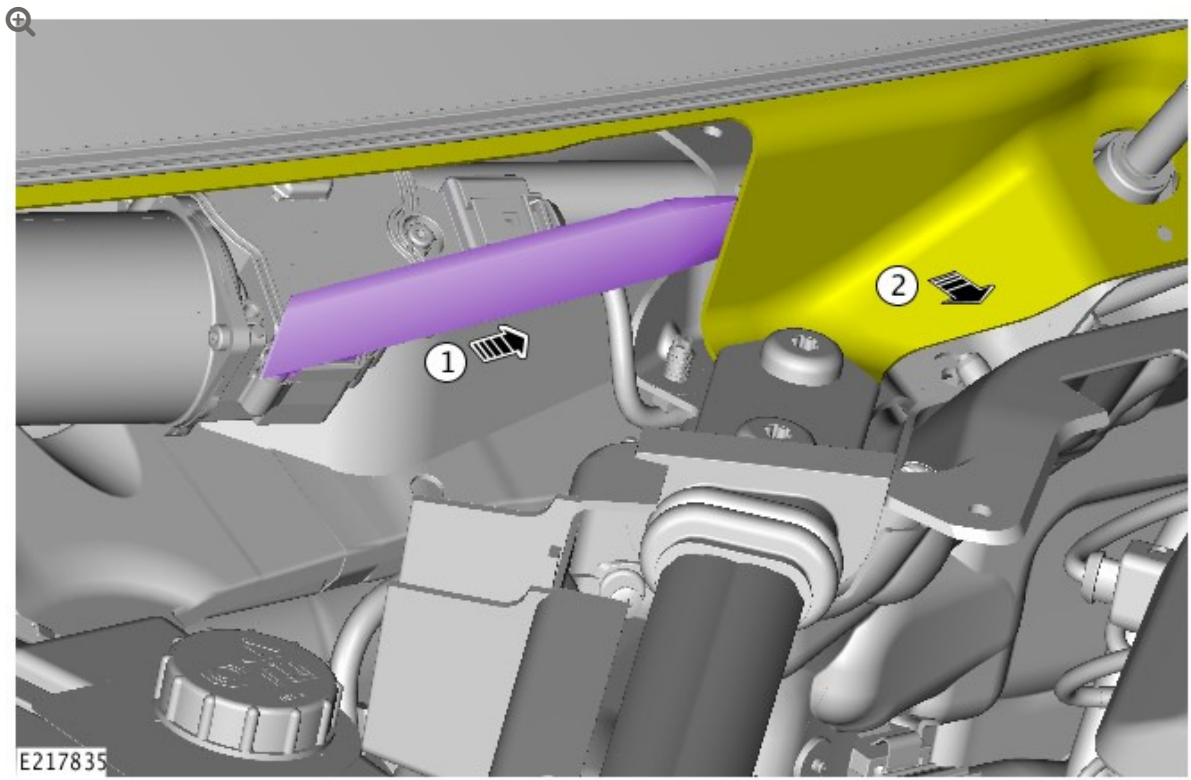
4

This may be caused by contact between body panels on the bulkhead.

Inserting the suitable trim tool **(1)** between the bulkhead baffle and bulkhead panel will move the bulkhead panel **(2)** forwards away from the baffle.
