SERVICE BULLETIN

Classification: AN18-022d	Reference: NTB18-081d	Date: February 10, 2021
------------------------------	--------------------------	----------------------------

2017-2018 PATHFINDER AND 2018 ARMADA; SOFTWARE UPDATES FOR INFOTAINMENT ISSUES

APPLIED VEHICLES: 2017-2018 Pathfinder (R52)
2018 Armada (Y62)

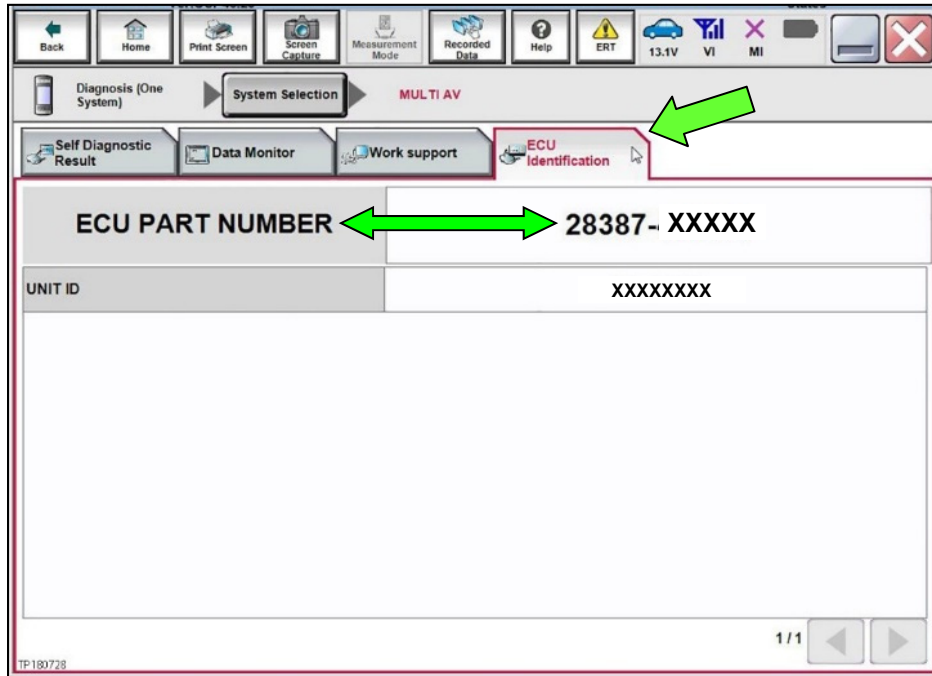
7. Select the **ECU Identification** tab.
8. When the screen in Figure 4 displays, confirm this bulletin applies as follows:
 - a. Write down the **ECU PART NUMBER** on the repair order.

- b. Compare the P/N written down to the P/Ns in the **CURRENT DCU PART NUMBER** column in **Table A** below.
 - If there is a match, proceed to step 9 on the next page.
 - If there is not a match, DCU updating does not apply. Refer to ASIST for further diagnosis.

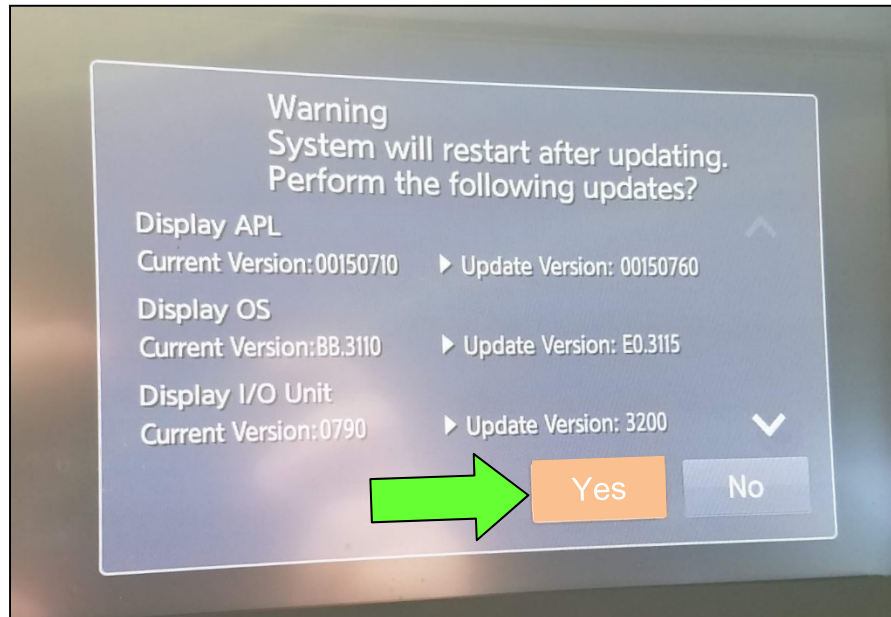
25. Wait approximately 10-30 seconds for the screen in Figure 19 or Figure 20 to appear.

- If the screen shown in Figure 19 appears, proceed to step 26 below.
- If the screen shown in Figure 20 appears, then no software update is available. Refer to ASIST for further diagnostic information.

26. Select **Yes** to begin the software update.
