60-17-04 - Water Leak from Panoramic Roof (U.S. Only)

Release date: 3/8/2021

Applicable Vehicles					
Model(s)	Year	Eng. Code	Trans. Code	VIN Range From	VIN Range To
Golf Sportwagen, Golf Alltrack	2015-2019	All	All	AU_FM500001	AU_KM515272

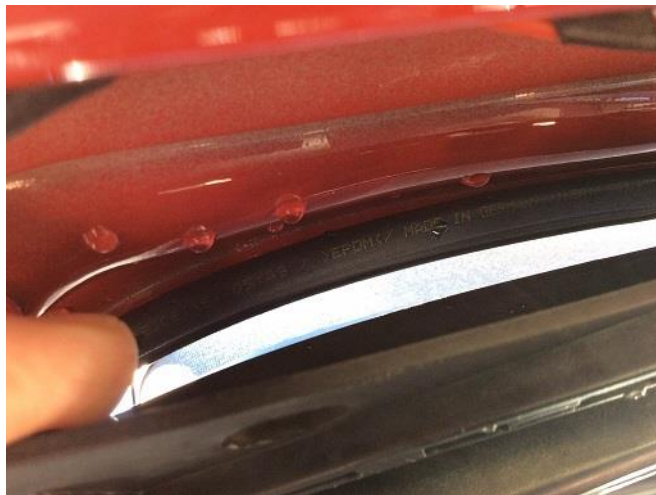
Verify the customer complaint. Water leaks may occur around the perimeter of the sunroof frame, between the frame and body of vehicle (See Figure 1). Water may also be found leaking through the sunroof cable guides in the sunroof frame (See Figure 2).

Figure 1: water leaking between sunroof frame and body

Incorrect rework in production of the welding points of the sunroof frame area. Spot welds around the perimeter of the sunroof opening may be too large. This prevents the outer sunroof seal from properly adhering to the body of the vehicle, allowing water to leak through the seal.

Insufficient cleaning process prior to applying outer sunroof seal. The sunroof frame opening may have been improperly cleaned prior to application of the acrylic tape on the outer sunroof seal. This prevents the outer sunroof seal from properly adhering to the body of the vehicle, allowing water to leak through the seal.

- Thoroughly clean the body flange using cleaning solution D 00940104 and a microfiber cloth.
- Install a new outer sunroof seal according to the repair instructions in ELSA. See repair manual group 60 in ELSA.
- Reinstall the sunroof frame. See repair manual group 60 in ELSA.
- Water test the vehicle to verify there are no further water leaks.
- Reinstall the headliner. See repair manual group 70 in ELSA.

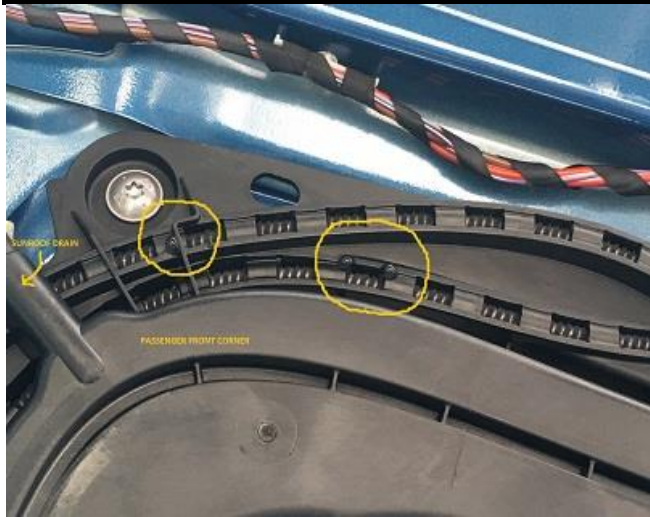
Figure 2: water leaking through sunroof cable guides

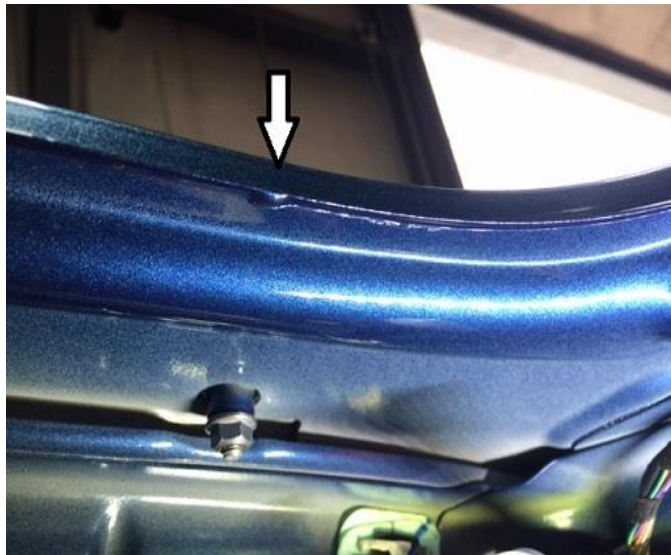
Figure 3, large spot weld

- Remove the sunroof frame. See repair manual group 60 in ELSA.
- Remove the outer sunroof seal and inspect the spot welds around the inside edge of the body flange.
- If large spot welds are found (See Figure 3), grind the weld(s) down smooth and repaint the area(s).
