Technical Service Bulletin

19 MIL on, DTCs P218100, P017B00, P308100, and/or P01E400 are stored in the ECM

19 21 13 2058767/7 March 2, 2021. Supersedes Technical Service Bulletin Group 01 number 20-82 dated August 26, 2020 for reasons listed below.

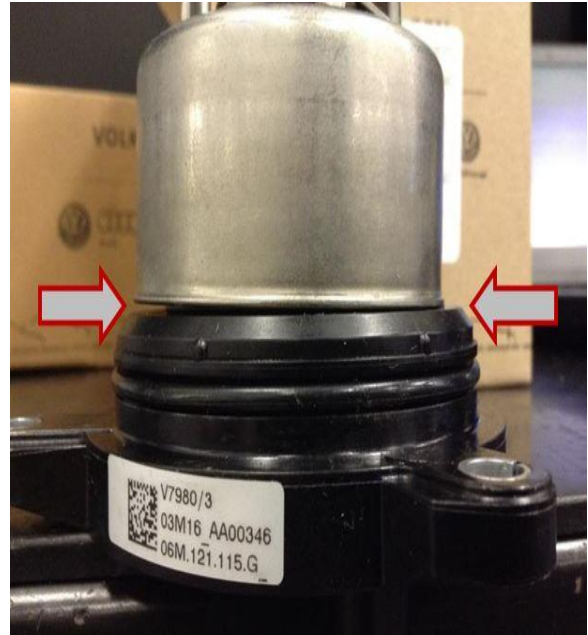
1. Remove the thermostat and check whether it closes completely. If the coolant is still warm, put the thermostat in cold water to restore its original condition. If there is a gap between chamber and seal, the thermostat is faulty and needs to be replaced.

Figure 1. Gap between chamber and seal.

After the repair, fill with G12evo coolant in the coolant circuit.
