# Technical Service Bulletin

## 19 Coolant leak in area of coolant thermostat housing/coolant pump - 2.0TFSI

19 21 14 2061604/2 March 8, 2021. Supersedes Technical Service Bulletin Group 19 number 20-10 dated December 14, 2020 for reasons listed below.

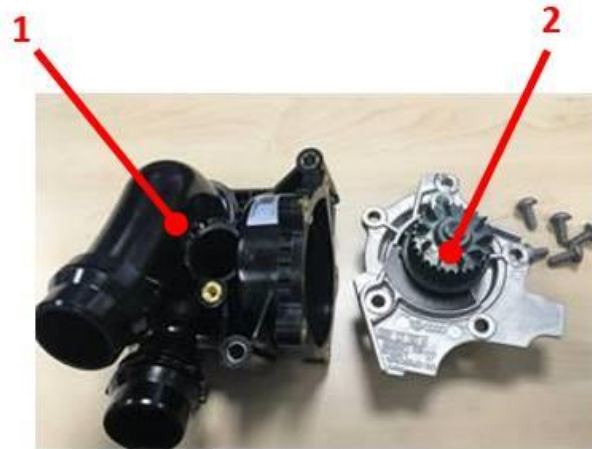
Coolant loss from the coolant thermostat housing (Figure 1, position 1) or the coolant pump (Figure 1, position 2).

**Figure 1.** Coolant thermostat/coolant pump. Parts are available separately, see parts table below.

Only replace the leaking component (coolant pump or coolant thermostat housing).

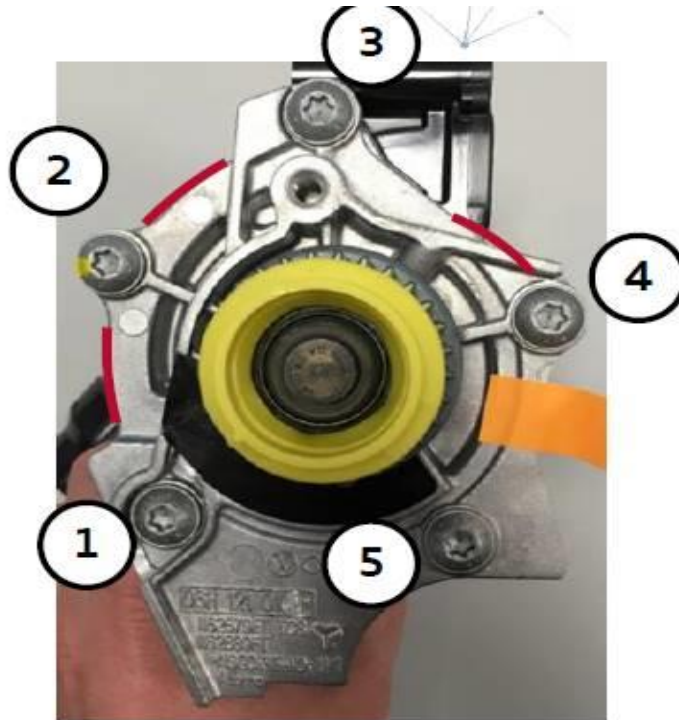
**Figure 2.** Securing bolts of the coolant pump (1 to 5).

- Assemble the coolant thermostat housing and the coolant pump and attach the five connecting bolts.
- Align the two components against one another in such a way that both components are flush to one another in the areas marked in red (Figure 2). The thermostat housing must not be higher/lower than the coolant pump (run your finger over the three areas to check).
- Torque the connecting bolts of the two components to 10 Nm.

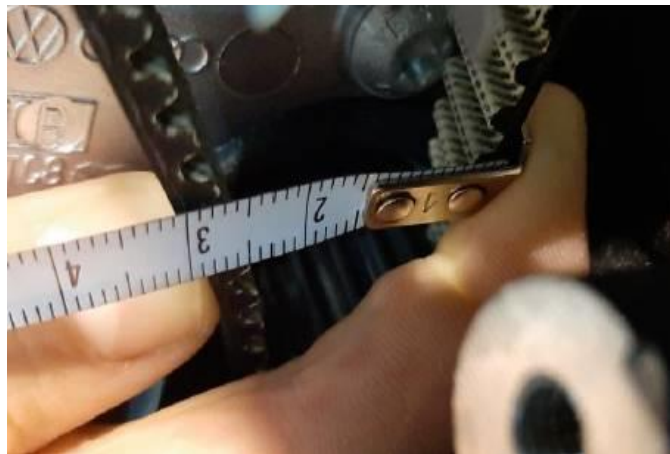
**Figure 3.** Checking the toothed belt tension.

- 5) Check the toothed belt tension (Figure 3) by pressing the toothed belt together centrally between the two toothed belt sprockets. The measured distance of the backs of the toothed belt should be between 28mm and 30mm. A measuring caliper can also be used for toothed belt compression and measurement.

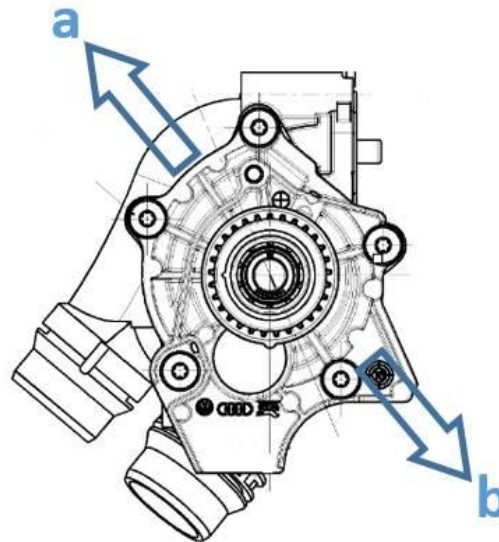
Figure 4. Adjusting the toothed belt tension.

- Note down the measured value (e.g. 26mm) from step 5).
- Remove the cooling module from the engine again, loosen the coolant pump bolts (Figure 2) and make adjustments as outlined below.
- If the measured distance of the backs of the toothed belt (pressed together) is less than 28mm (e.g. 25mm), then the belt tension is too low. A slight adjustment away from the balance shaft is necessary (**direction "a"**).
- If the distance of the backs of the toothed belt (pressed together) is greater than 28mm (e.g. 32 mm), then the belt tension is too great. A slight adjustment towards the balance shaft is necessary (**direction "b"**).

8. Tighten the five securing bolts of the coolant pump and repeat steps 4 and 5.
