Technical Service Bulletin

39 Four-wheel drive malfunction message, DTC C05ED00 is stored in the all-wheel drive control module

39 21 42 2051558/6 March 2, 2021. Supersedes Technical Service Bulletin Group 39 number 20-39 dated December 10, 2020 for reasons listed below.

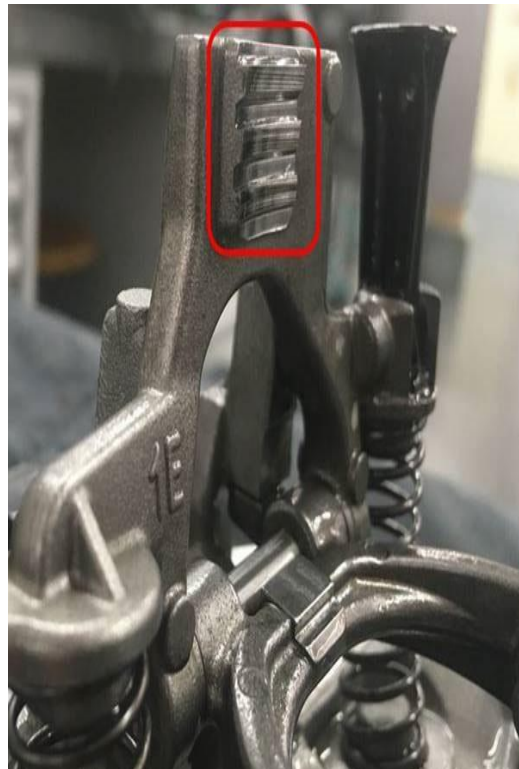
Quattro Ultra shift fork inside the rear differential is worn/faulty (Figure 1).

Figure 1. Worn/faulty shift fork.

- If the result of the test plan leads to replacing the rear differential or finds no defect, perform a short test drive. If the same DTC returns after the test drive with the same symptom, the shift fork inside the rear differential is at fault and must be replaced. Perform the repair as follows. Do **not** replace the complete differential.
 - If the result of the test plan leads to replacing or repairing a different part (The All-Wheel Drive Clutch, Driveshaft Speed Sensor G970, All Wheel Drive Clutch Actuator 2 V623, or any other part), follow the Guided Fault Finding repair advice and this TSB does not apply.
1. Drain the oil of the rear differential according to the repair manual.
 2. Remove the rear differential per the repair manual.
